Alma Mater Studiorum – Università di Bologna

DOTTORATO DI RICERCA IN
INGEGNERIA DEI MATERIALI

EXPERIMENTAL ASSESSMENT OF ENVIRONMENTAL DECAY EFFECTS
IN MASONRY
VIA NON DESTRUCTIVE DIAGNOSTIC TECHNIQUES
AND
MECHANICAL TESTS

Esame finale anno __2014__

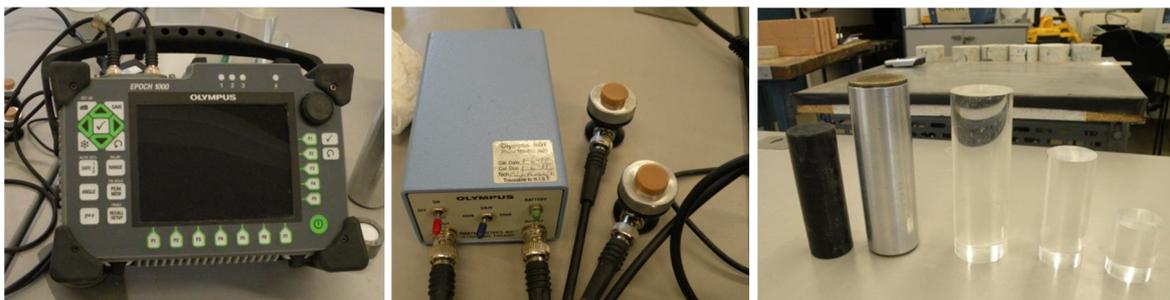
Figure 3.2: Ultrasonic tests: testing equipment and probes (left and centre), calibration bars (right)

In this experimental work, ultrasound tests were performed by means of a commercial Olympus EPOCH 1000 available at the LAGIRN laboratory of our department and made of a portable unit and a signal amplifier was employed. This system is characterized by a pulse rate frequency up to 6 kHz, an equivalent measurement rate for the receiver, a gain range from 0 to 110 dB and full EN 12668-1 compliance [3]. A couple of 1MHz frequency probes for P-wave detection, 13mm in diameter, were used. These probes were chosen taking into account on the one hand, the small dimensions of the specimens to be tested (single units of bricks and mortar prisms, see chapter 5) and on the other hand the high resolution signals required which were capable of detecting also small anomalies and/or differences between the mortar prisms belonging to diverse sets.

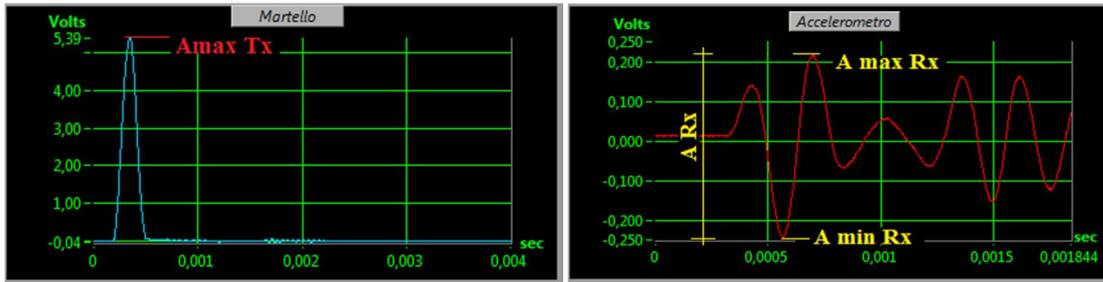
Figure 3.6: Sonic tests, measure of the amplitude of transmitting (left) and receiving signals (right)

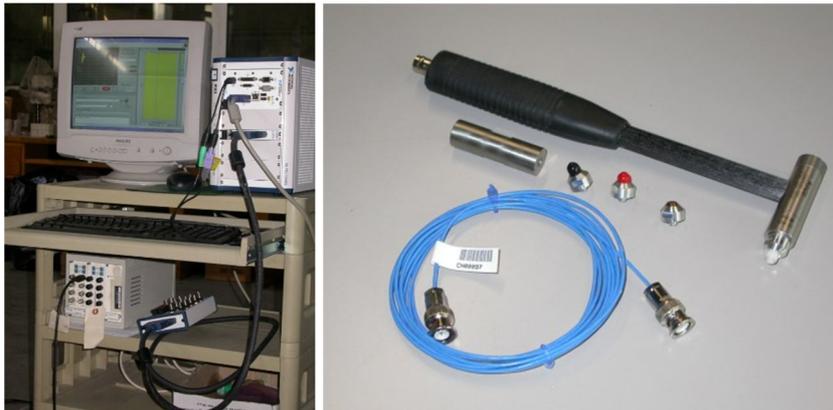
Hammer with a beryllium tip,

Micro-accelerometer

Figure 3.7: Sonic tests, testing equipment, hammer and receiver

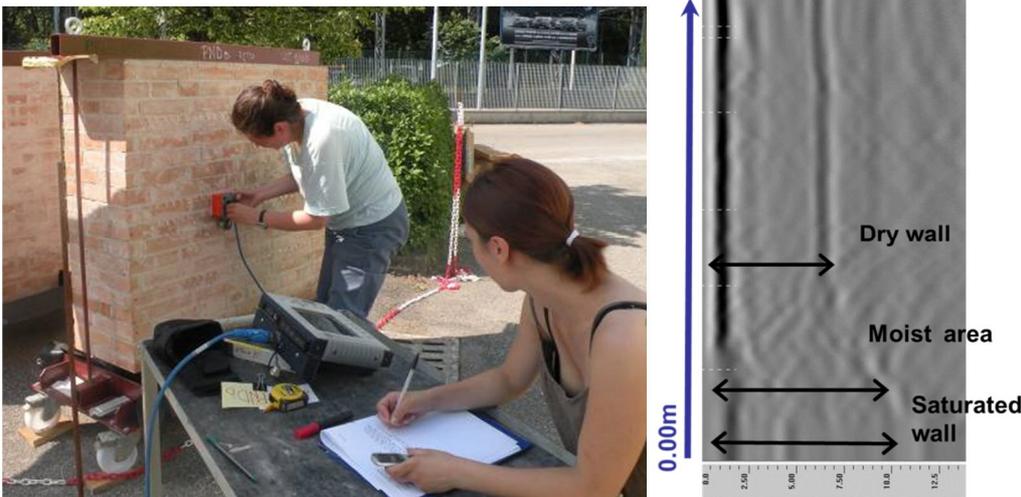
Figure 3.11: Data acquisition and example of radargram

Choice of antenna frequency must be suited to characteristics and thickness of materials investigated, dimensions and location of defects sought. Necessity to access a sufficiently wide testing surface in function of penetration depth and antenna dimension.

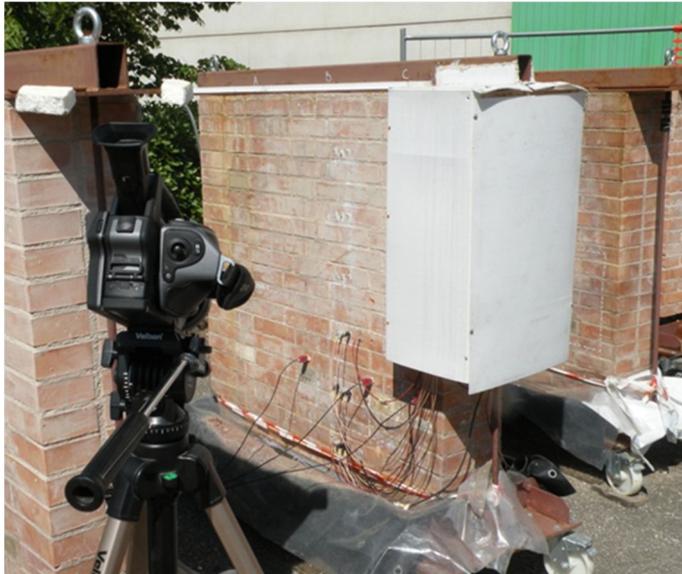
Figure 3.12: Data acquisition

Infrared thermo camera with a specific wavelength window (depending on the material to be tested), different kinds of lens (depending on the distance from the analyzed surface, on the surface dimensions and on the minimum dimensions of the expected defect), PC, post-processing software.

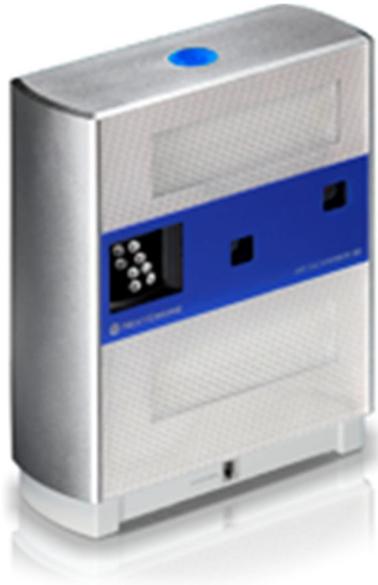
NextEngine HD

(desktop triangulation scanner)

The laser scanner used in this work is produced by NextEngine Inc. and is based on Multi-stripe Laser Triangulation (MLT) technology. The laser scanner acquires the data in two different modes corresponding to two different baselines: Macro mode and Wide mode. Some constraints on the distance between the object and the scanner are given for each mode (Tab. 1). The choice of the scan mode depends on the object's size and the desired output accuracy.

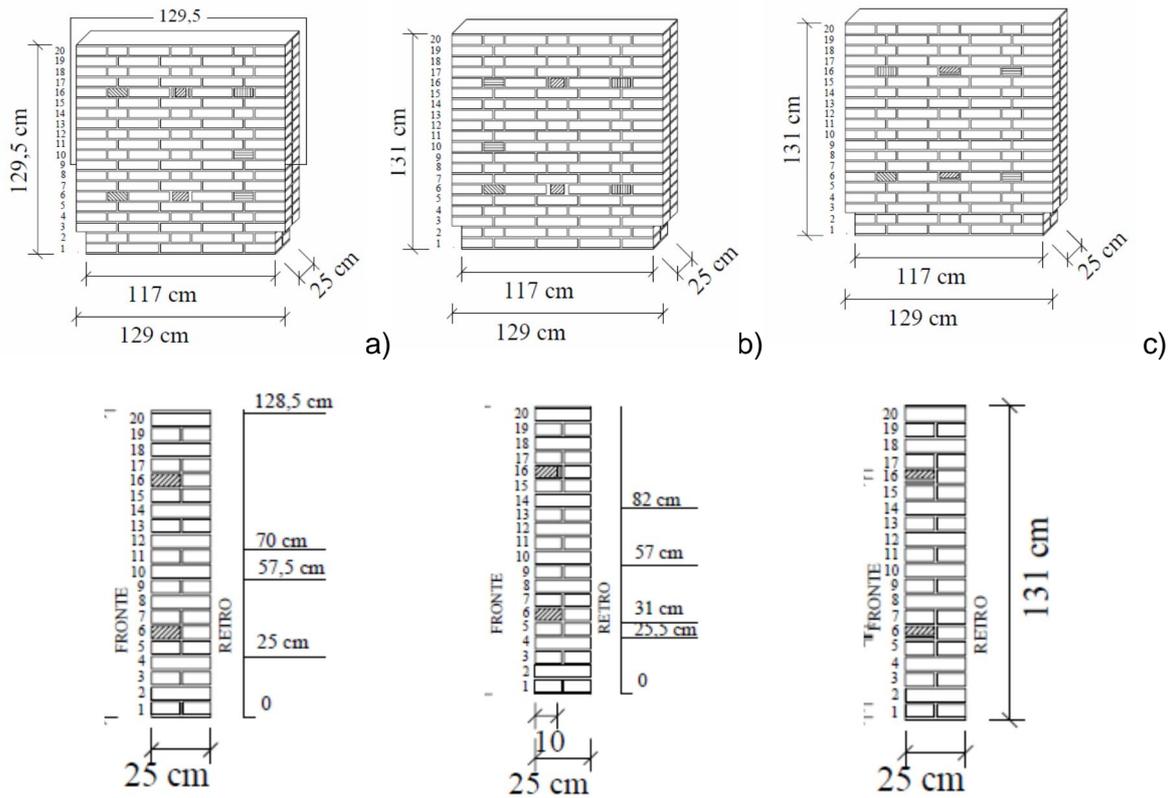
Figure 4.10: Full-scale 2-header walls brick masonry walls, with stone inclusions. From left to right side PNDA, PNDB, PNDC: wall masonry layouts (top) and vertical centre sections (bottom)

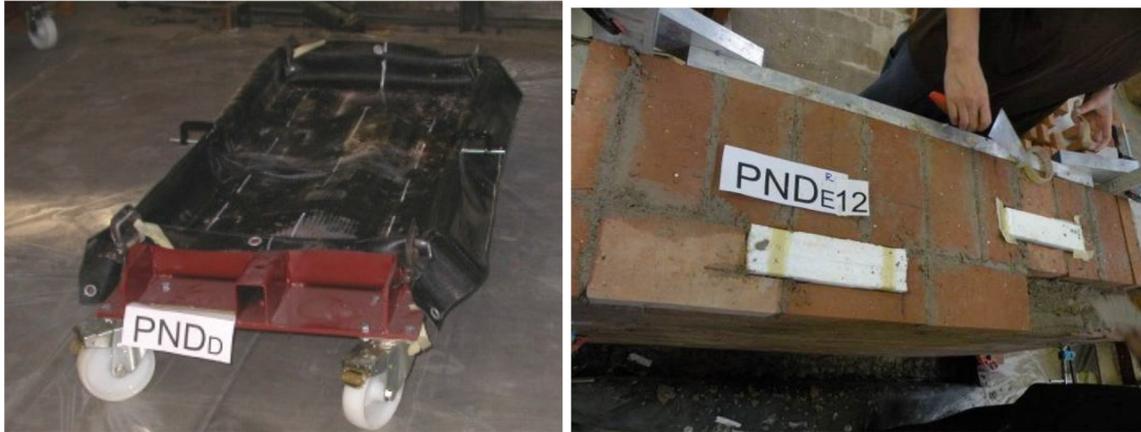
Figure 4.12: Steel metal tub with black waterproof and acid-proof lining for later pouring of the brine (left), manufacturing of one brick course in wall PNDE with 2 voids simulated by polystyrene blocks (left side).

For the purpose of simulating moisture and salt supply at the base of the specimens during a later weathering exposure, the walls were built into metal basins. The basins are part of more complex, on-purpose designed, steel frames in which the basins on one hand support the weight of the walls and on the other hand contain water or salt solutions to be added for simulating the capillary rise phenomenon. Thus, these basins are slightly larger than the brick wall base areas but of limited height to allow water evaporation (dimensions l x w x h: 160 x 60 x 10 cm³). They were lined with a waterproof and acid proof sheet, few millimeters thick, as a protection to the metal and separation between metal and masonry. Moreover, the basins were equipped below with four castor wheels to allow the movements of the walls which were intended to be stored outside the lab after a proper period of curing indoors. In addition to the basin, each steel frame consisted in a superior plate, designed to protect the top part of the walls from rain water intrusion, and in two vertical metal tie bars to connect top and bottom plates with eyelets as extra rigid transportation possibility (Figure 4.12).

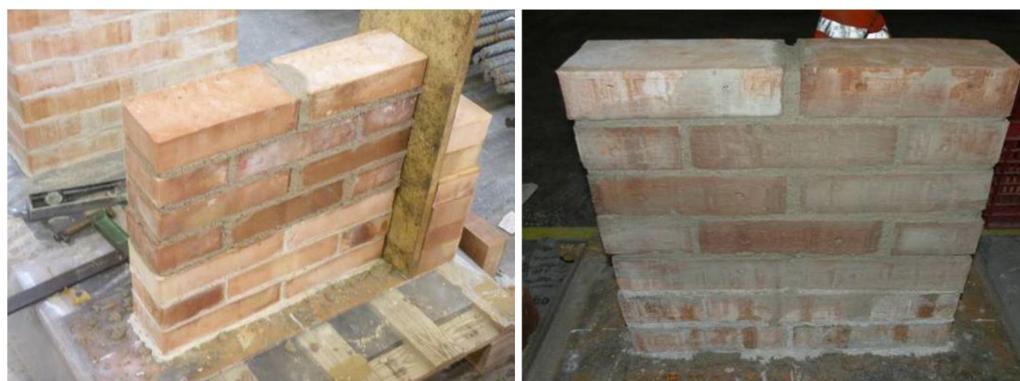
Figure 4.14: Manufacturing of small walls of nominal dimensions 50 x 12 x 50 cm

Instead, the 2nd set of 4 small walls were subjected to a diverse number of accelerated ageing cycles simulated by means of a complete immersion in high-concentrated sodium sulphate solution followed by an on-purpose designed treatment in climatic chamber (§4.6). These wallets, after the constructions were mounted into steel frames, later described, and realized to facilitate their movements.

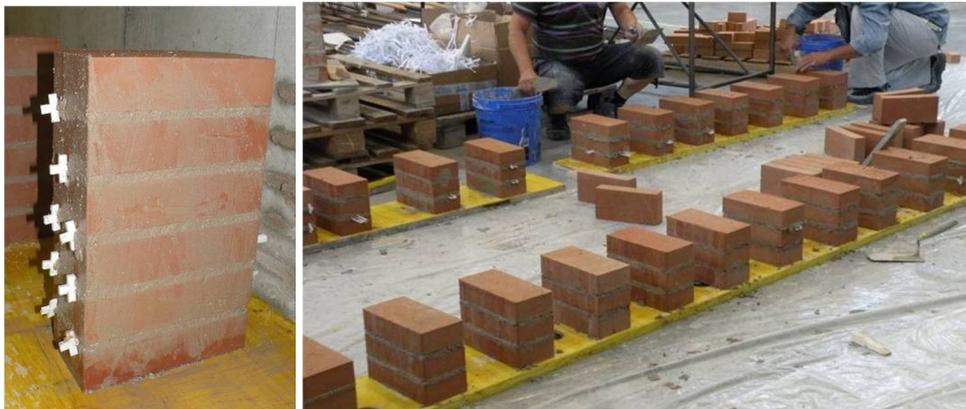
Figure 4.18: Phases of the construction of six-brick columns (left) and triplets (right)

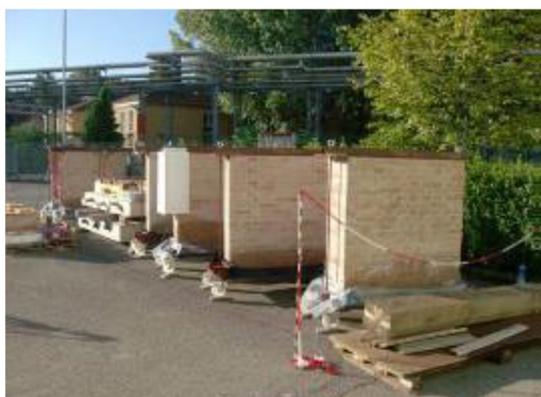
Figure 4.19: General view of the outdoor exposed full-scale walls

In the following sections these periods are called, respectively, 1st, 2nd and 3rd ageing seasons. During the three ageing seasons, the amount of brine into the tubs, prepared by using tap water, has been kept constant at a level of about 2 cm.

This thin layer of solution allowed the capillary rise from the base and, during evaporation, in certain microclimatic conditions depending also on the salt type, the crystallization of salts on the upper part of the specimens themselves.

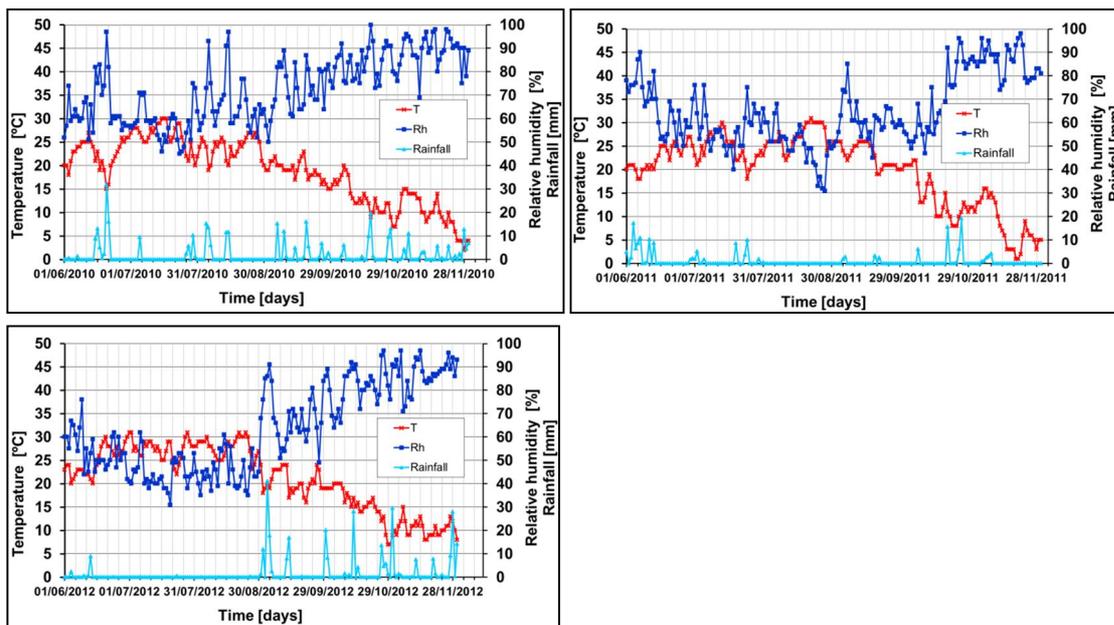
Figure 4.20: Environmental parameters monitored during the 1st (top, left), 2nd (top, right) and 3rd ageing season (bottom)

These parameters are important to roughly estimate the number of possible salt hydration/crystallization cycles occurred in the different time periods and thus to better understand the evolution and appearance of the degradation processes. This estimation, however, could be done only after having established the critical conditions, at least in terms of air temperature and relative humidity, which cause the crystallization of the two different salts considered in this study. At this purpose, different research studies were already carried out with reference to either sodium chloride or sodium sulphate. From the literature review [4, 16, 17], it appears reasonable to set the following threshold: air temperature above 20°C and RH below 75%, as critical conditions for the crystallization of sodium chloride. As the main cause of degradation in presence of sodium sulphate, has been demonstrated to be the change from mirabilite ($\text{Na}_2\text{SO}_4 \cdot 10\text{H}_2\text{O}$, large crystals) to thenardite (Na_2SO_4 , small and compact crystals) [18, 19], the critical conditions have not been defined as a fixed threshold but as those values of air temperature and relative humidity which allow the passages between these two phases of the salt, by using the diagram of Steiger [20], as already shown in [11].

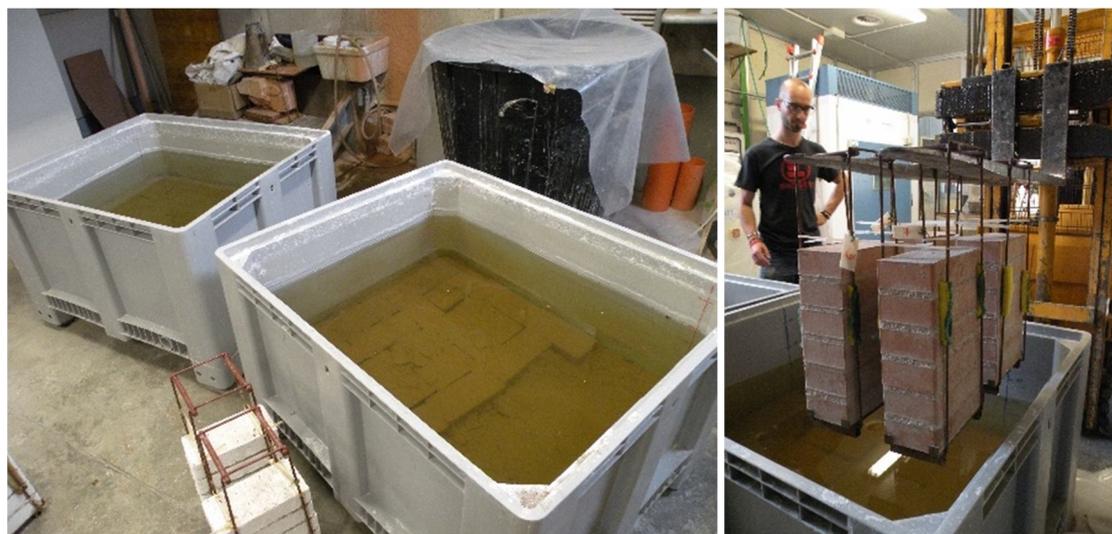
Figure 4.22: Tanks for the complete immersion of the masonry assemblies (left) and positioning of six-brick walls into the tanks.

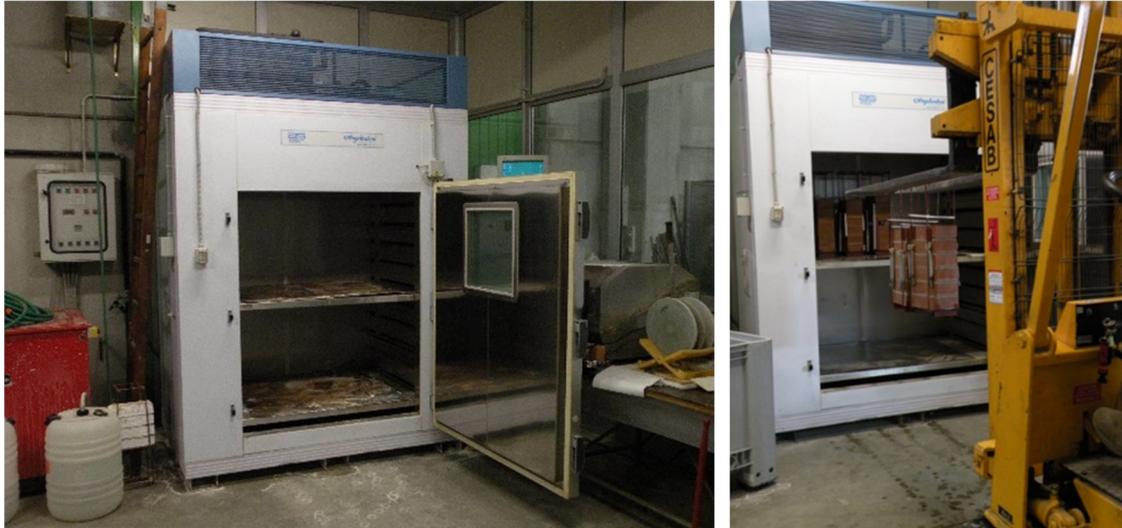
Figure 4.23: Climatic chamber used for the accelerated ageing tests

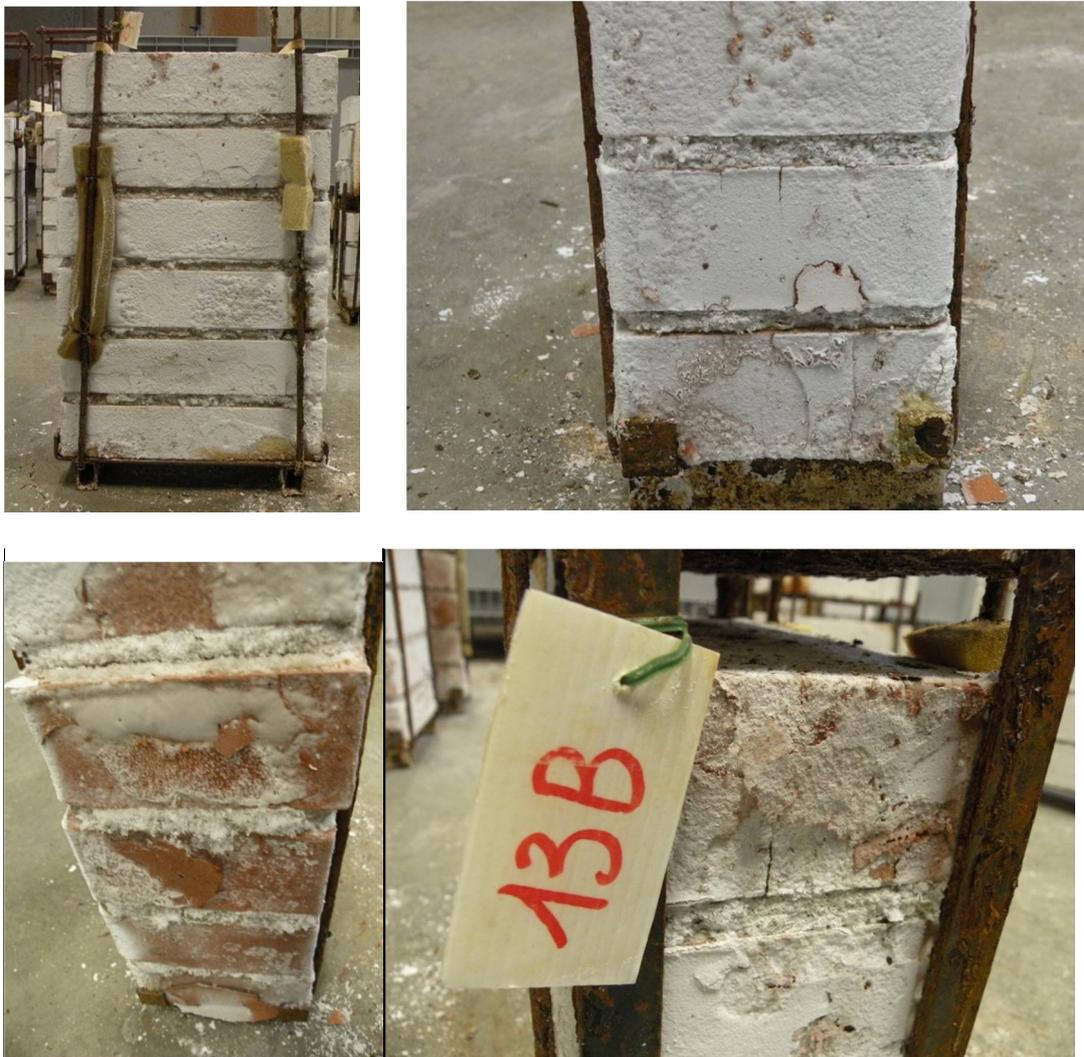
Figure 4.24: Appearance of a six-brick column at the end of

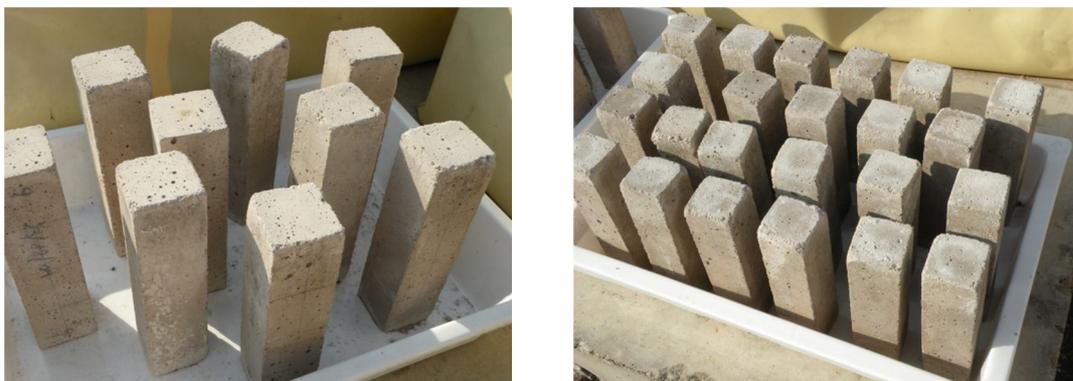
Figure 5.2: Visual decay on mortar prisms during the 3rd ageing season: dry (left) and water (right)

With the passing of time, on all the sets of mortar prisms, other effects of the weathering process started to appear. These were mainly surface discoloration, powdering, scaling, surface erosion as well as material losses. The latter effect was testified by the substantial amount of dust collected from the basins bottom at the end of each ageing season (§5.1.2). Nonetheless, the spreading and seriousness of the decay effects was different for the different sets of prisms. As a further example, the “dry” mortar prisms appeared the healthiest after 3 ageing seasons, followed by those subjected to water rise (Figure 5.2). On the contrary, the prisms contaminated with sodium chloride brine were more degraded than those in contact with sodium sulphate brine (Figure 5.3, Figure 5.4). This is in line with the estimations made from the monitoring of real environmental conditions about the possible number of salt crystallization cycles occurred for the two types of salt considered (§4.4): over the whole ageing period of three summers a number of sodium chloride crystallization cycles almost double than for sodium sulphate was estimated (133.5 cycles vs. 78.5).

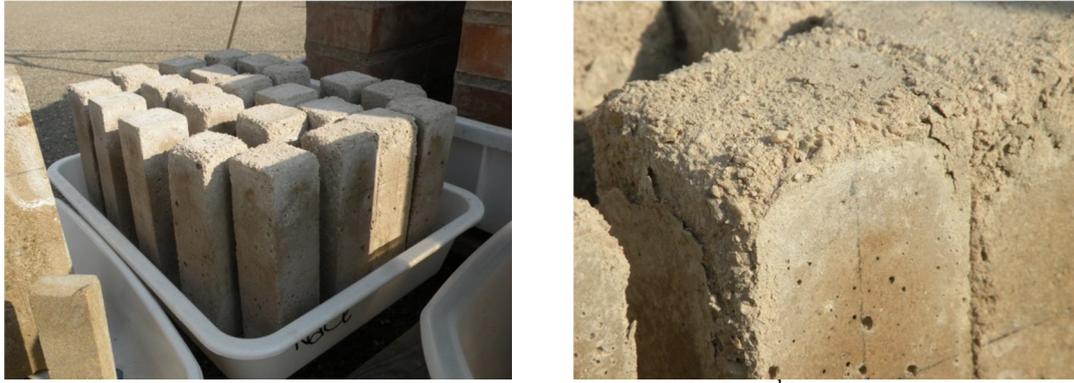
Figure 5.3: Visual decay on mortar prisms during the 3rd ageing season. Sodium chloride contamination: general view (left) and detail (right)

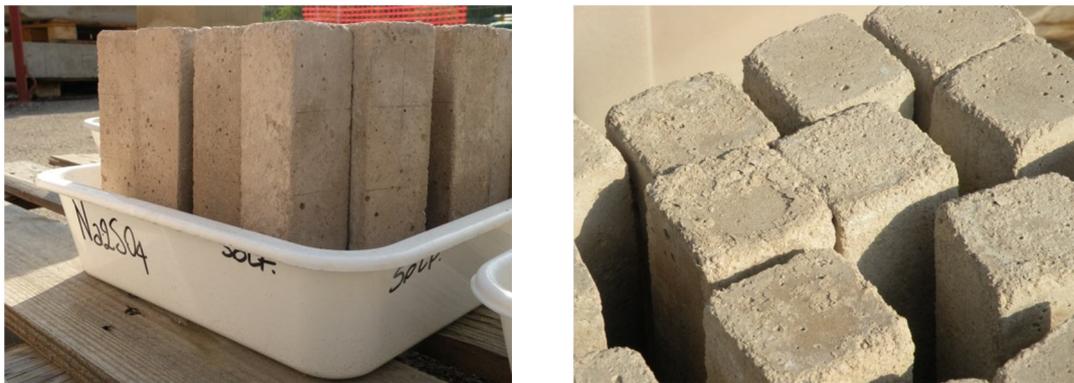
Figure 5.4: Visual decay on mortar prisms during the 3rd ageing season, subjected to sodium sulphate rise: general view (left) and detail (right)

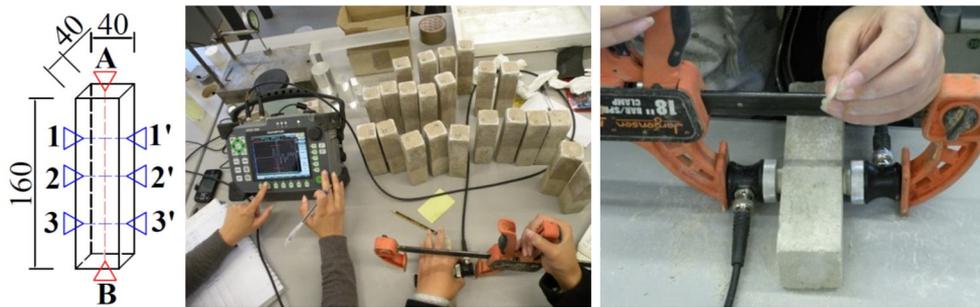
Figure 5.8: Mortar prisms: US measurement paths (left), testing equipment (centre), detail of the position of the probes for ultrasound tests along a transversal path (right).

On each mortar prism, the ultrasound measures were performed in direct transmission along 4 paths: 1 longitudinal path (A-B), along the main dimension of the specimens which was nominally equal to 16 cm, and 3 transversal paths (1-1', 2-2', 3-3'), 4 cm long, at three different specimens' heights (Figure 5.8 left).

These 4 measurements paths were considered in order to evaluate possible variations of the material properties within the same material's unit, caused by the natural ageing process. The longitudinal path, crossing the whole specimen length and thus passing through areas subjected to different degradations, should provide an averaged estimation of the decay in the entire sample. Instead, the US measures along the transversal paths should gave more localized information in function of the position and distance of each path from the face in contact with the brine and from the brine evaporation level. Indeed, the central transversal path may present diverse conditions than the other two paths with the same length as the latters were located near or above the crystallization areas.

As explained in 3.1, a plastic clamp was used to set in place the probes and a dry coupling of them with the surfaces was ensured. Calibration was performed, for each set of samples, before starting the data acquisition.

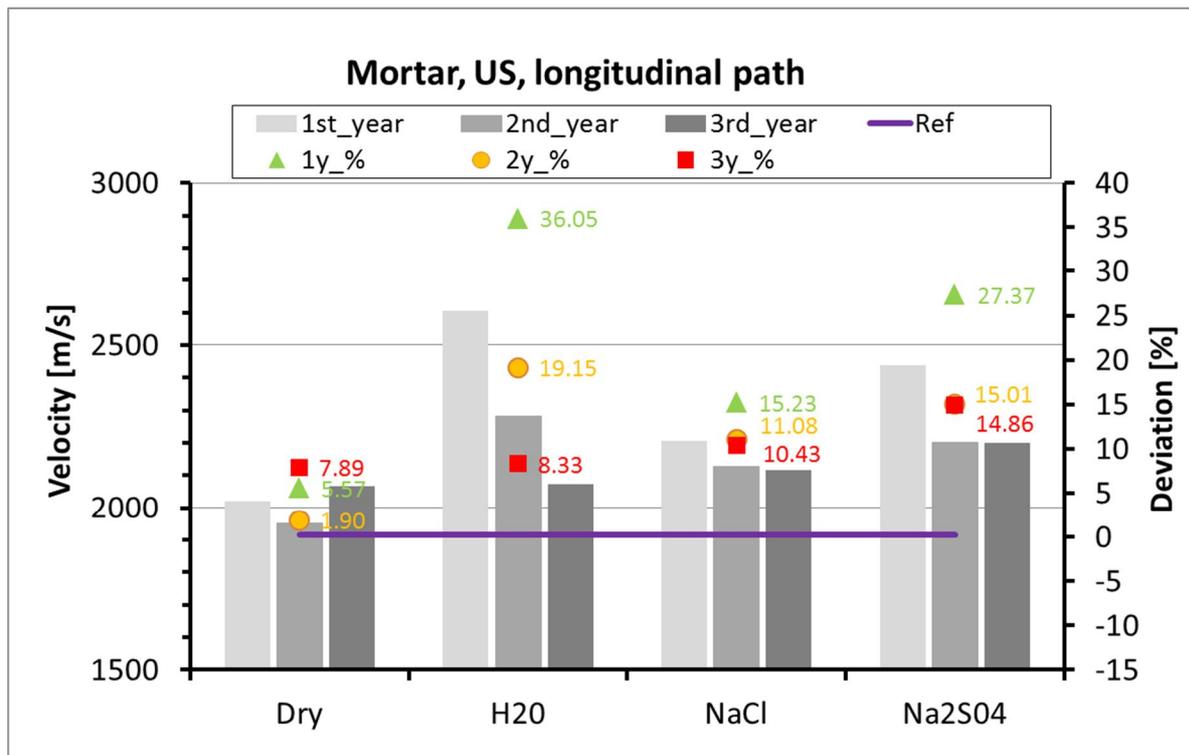
Figure 5.9: Mortar prims, US longitudinal measurements at the end of each ageing season: average values of velocity

Additional observations can be drawn by comparing the behaviour of the two sets of mortar subjected to sodium chloride or sodium sulphate brines. On average, at the end of the three ageing seasons, the US velocity along the longitudinal path were lower for the mortar subjected to NaCl rise than for Na₂SO₄ rise. This is an index of the greater damage occurred on the mortars of the first set. Although it is known that, for porous construction materials, sodium sulphate is more aggressive than sodium chloride, this result is in line with the much higher (almost double) estimated numbers of possible chloride crystallization cycles over the three summers (Table 5.5).

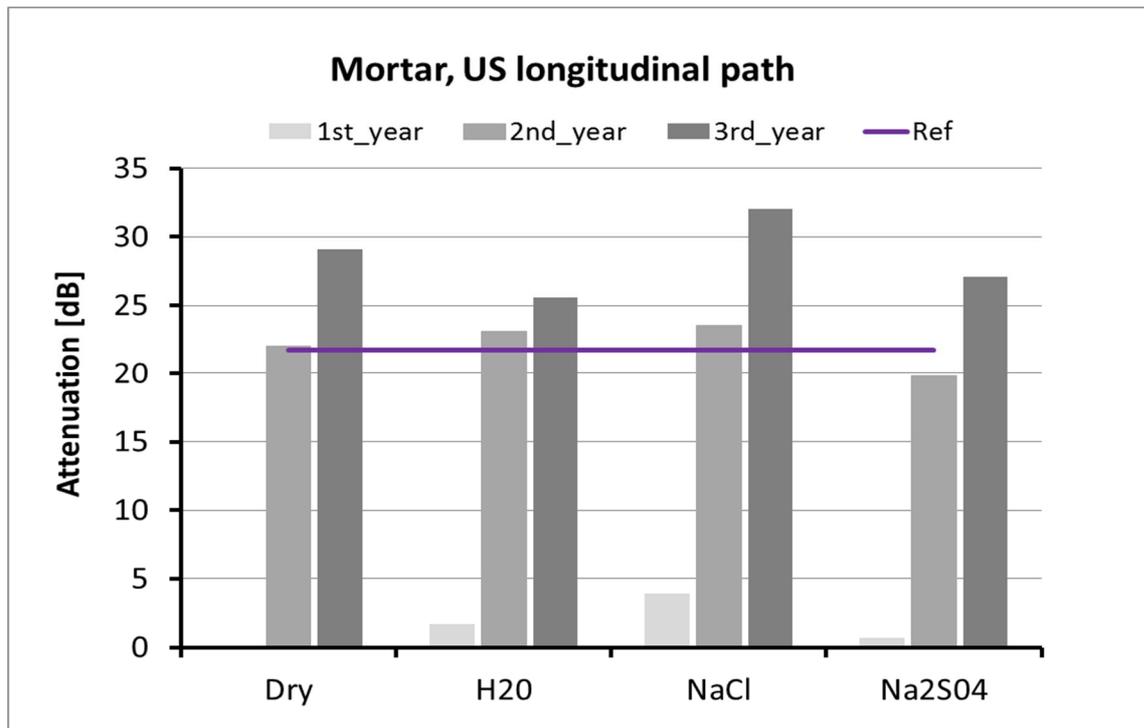
Figure 5.10: Mortar prims, US longitudinal measurements at the end of each ageing season: average values of attenuation

Na_2SO_4 rise, suggested that a greater damage occurred on the first sets of samples, probably due to the greater number of hydration/crystallization occurred for this salt.

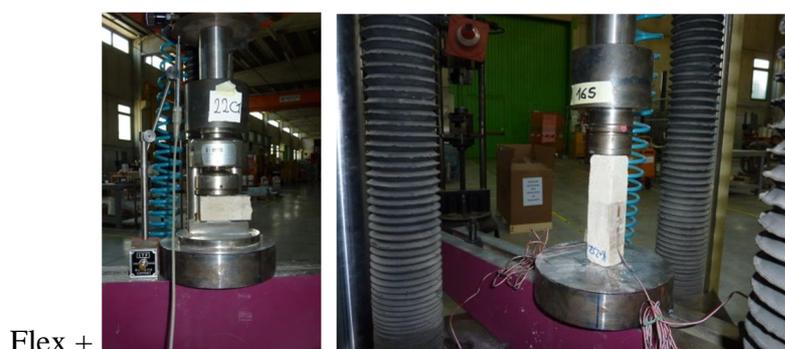
Figure 5.14: Mortar prisms: set-up of the mechanical tests: bending tests, compression tests and determination of the modulus of elasticity, from left to right

Three types of mechanical tests, bending tests, compression tests on the stumps obtained from bending and longitudinal compression tests for the evaluation of the modulus of elasticity were performed in order to evaluate and measure possible changes due to natural ageing in the resistant capacity of the mortar.

The tests were carried out following the indication reported in international standards [13, 14]. The testing equipment and set-up procedure used were the same employed to tests the sound mortar prisms, see §4.2 (Figure 5.14). Anyhow, the principal characteristics of the set-up are herein summarized for convenience (Table 5.9).

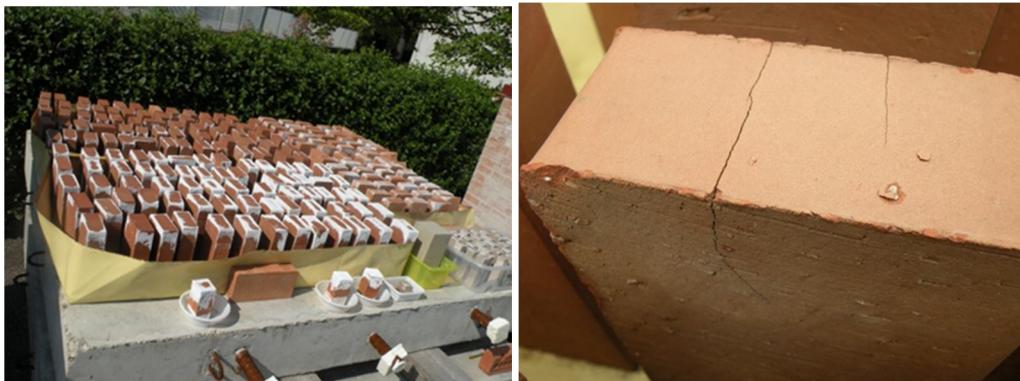
Figure 5.17: Appearance of the fired-clay brick sets during the first ageing season (left) and detail of one brick at the end of the 2nd ageing season (right)

The repeated visual observation and photographic documentation taken showed the appearance of salt efflorescences as white superficial deposition in the upper part of the specimens since the beginning of the test on all the brick units of the three sets although with some differences. In the case of specimens contaminated with water, indeed, these salt depositions were softer and more similar to dust depositions than in the other two sets. In the bricks contaminated with sodium sulphate, these were more dense (Figure 5.17 left).

In addition, cracks on the top and bottom faces of the brick units were later recognized as a visible weathering effects. These were more evident on the set of bricks contaminated with sodium sulphate and at the end of the 3rd ageing season, despite the higher number of hydration/crystallization cycle of sodium chloride than sodium sulphate (Figure 5.17 right).

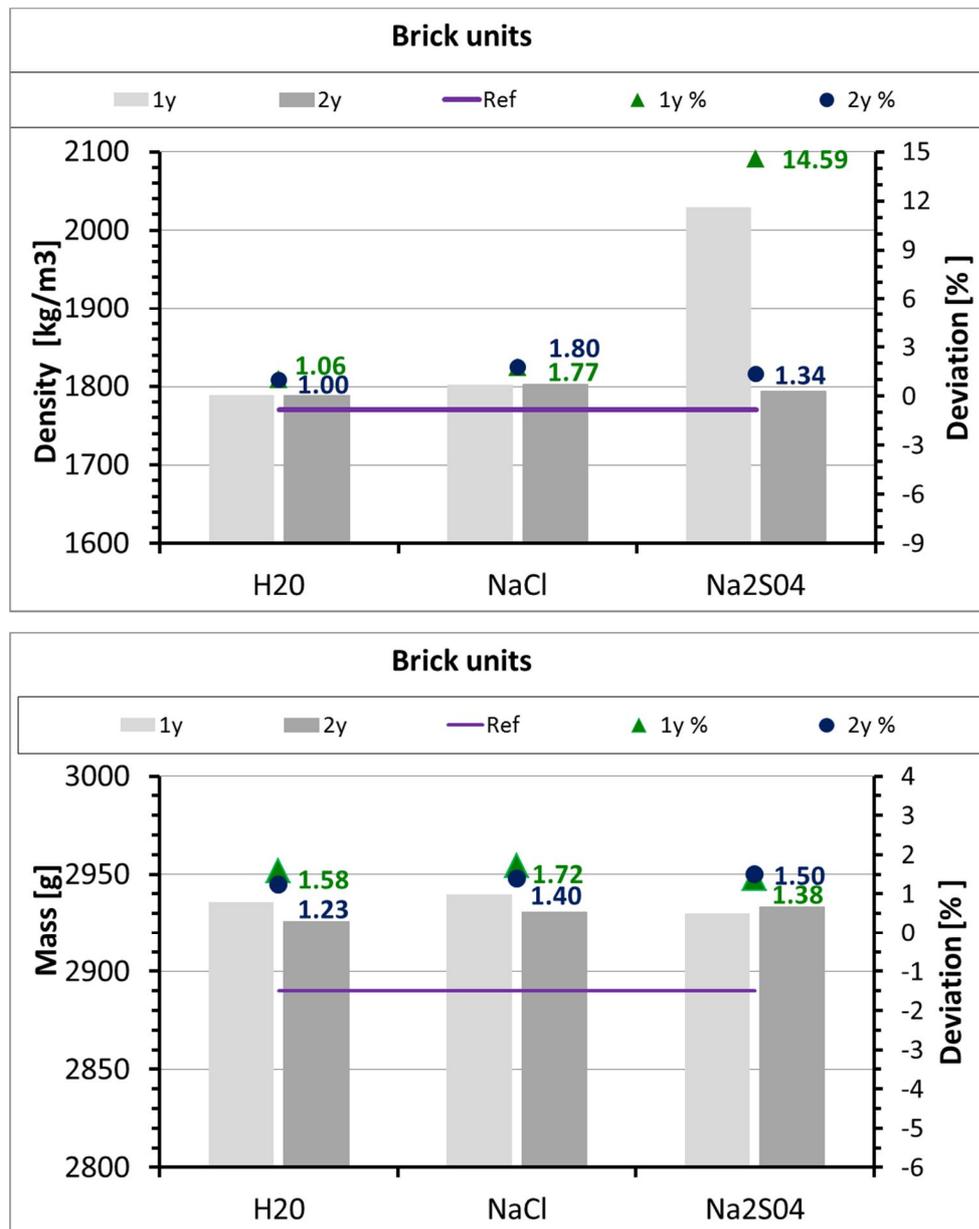
Figure 5.18: Fired-clay bricks: variations of density (top) and mass (bottom) per set per year

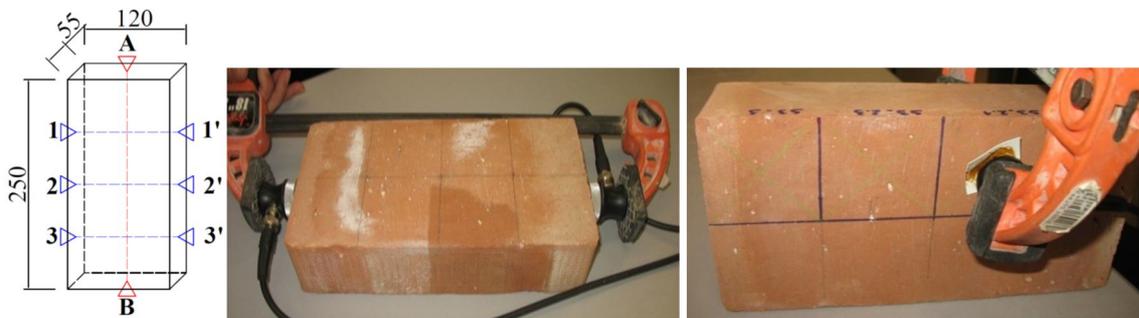
Figure 5.19: Brick units: scheme of the US measurements (left), longitudinal measure (centre) and transversal one (right)

For each set of samples, the ultrasonic measurements were performed in direct transmission, along one longitudinal path (A-B) and three transversal paths (1-1', 2-2', 3-3'), according to the scheme reported in (Figure 5.19). This procedure was followed to evaluate possible variations in the different portions of the materials as may not be affected in the same way by the natural ageing. The three transversal paths, being placed at different distances from the areas in which crystallization occurs, could allow obtaining helpful information to describe the spread of damage along each specimen, while the longitudinal measure, crossing areas at different degradation level, provides an averaged estimation of the decay of the entire sample.

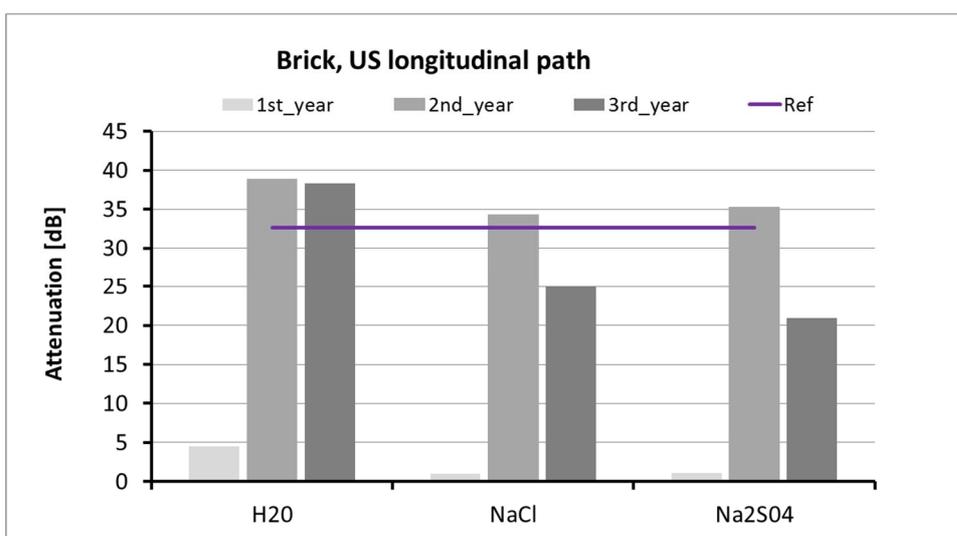
Figure 5.21: Fired-clay bricks: US signal attenuation along the longitudinal path

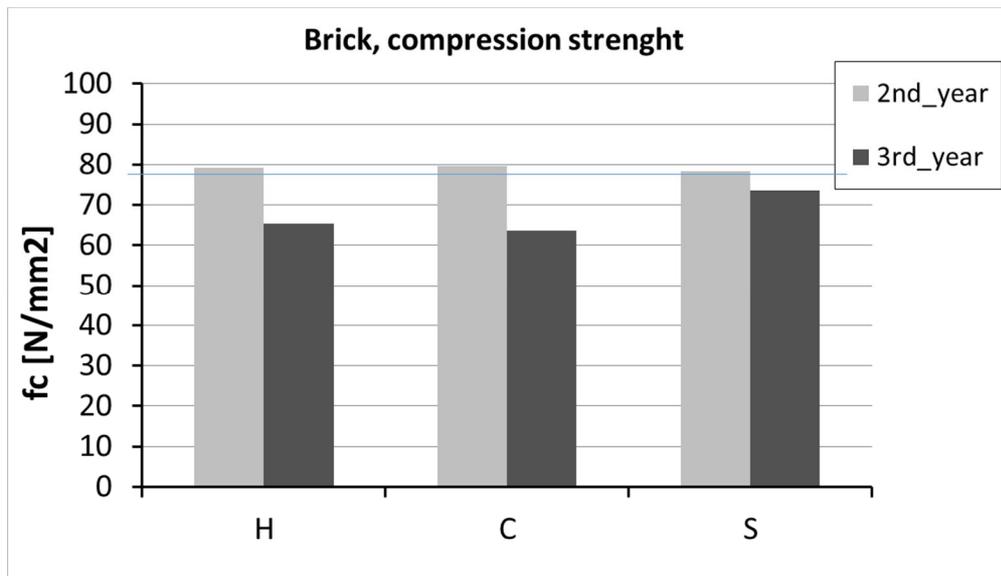
Figure 5.26: Fired-clay bricks: average values of compressive strength measured at the end of two different ageing seasons

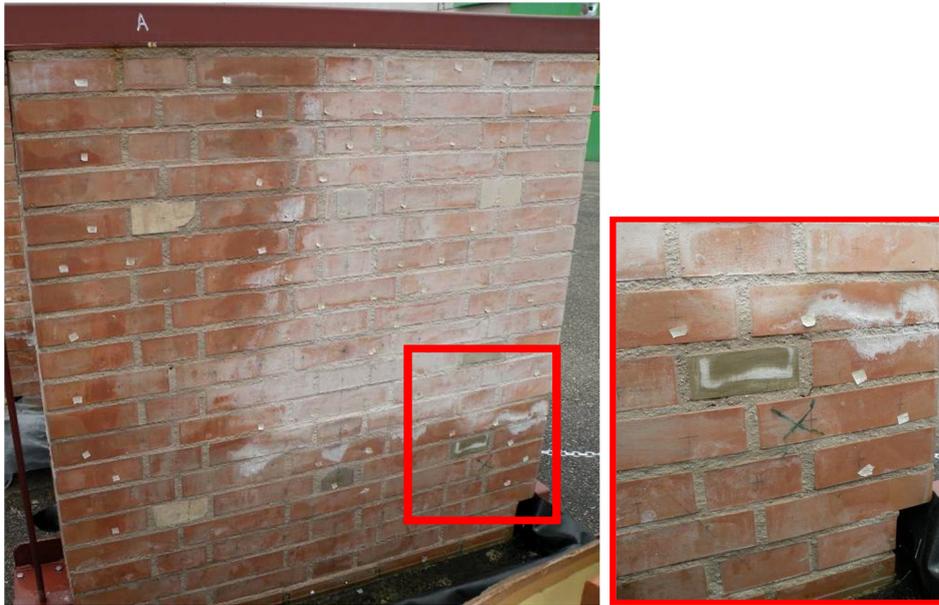
Figure 6.2: PNDA, front side at the end of the 1st ageing season (Nov. 2010)

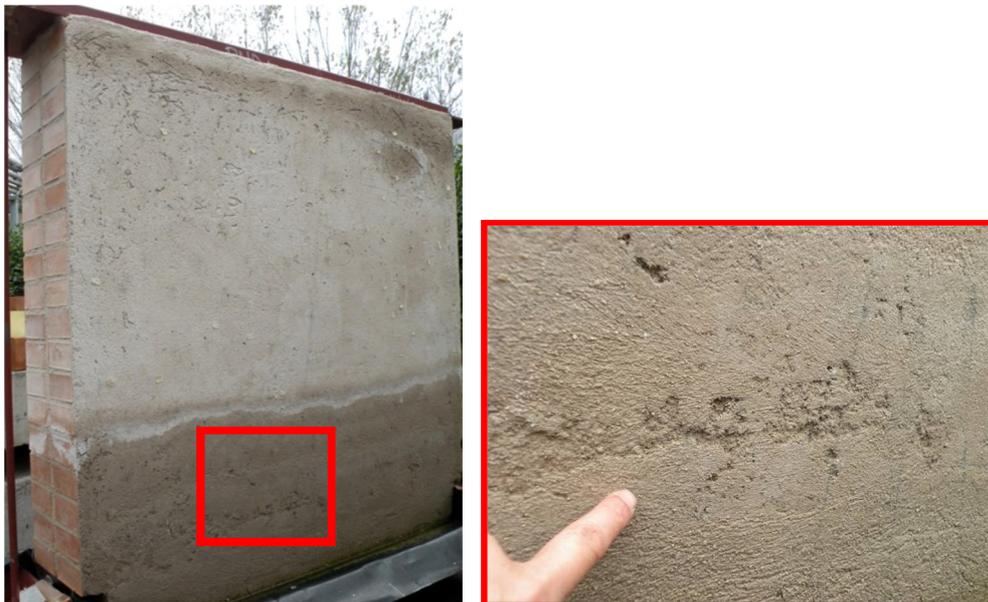
Figure 6.3: PNDA, plastered rear side at the end of the 1st ageing season (Nov. 2010)

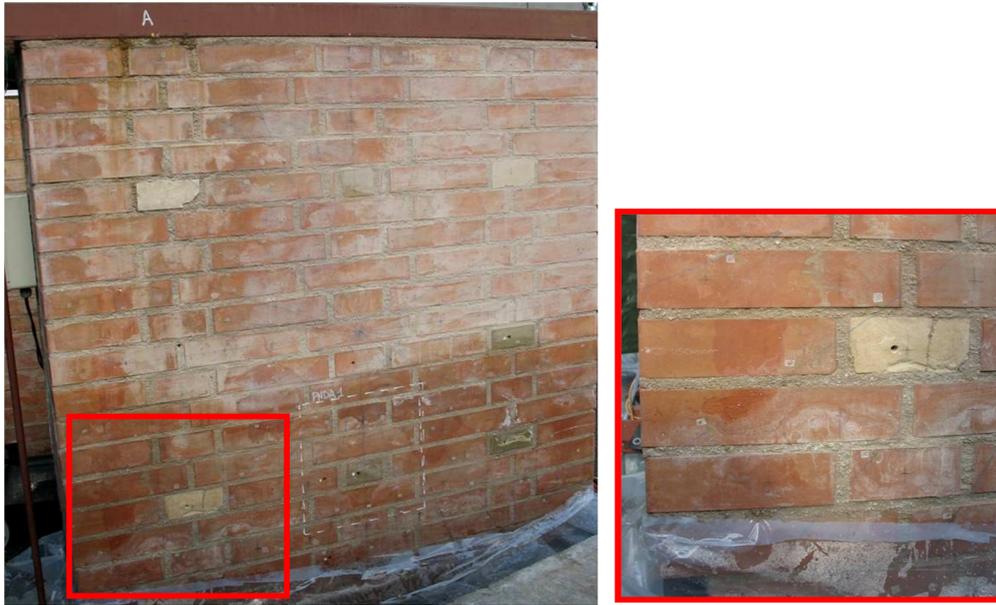
Figure 6.4: PANDA, front side at the end of the 2nd ageing season (Nov. 2011)

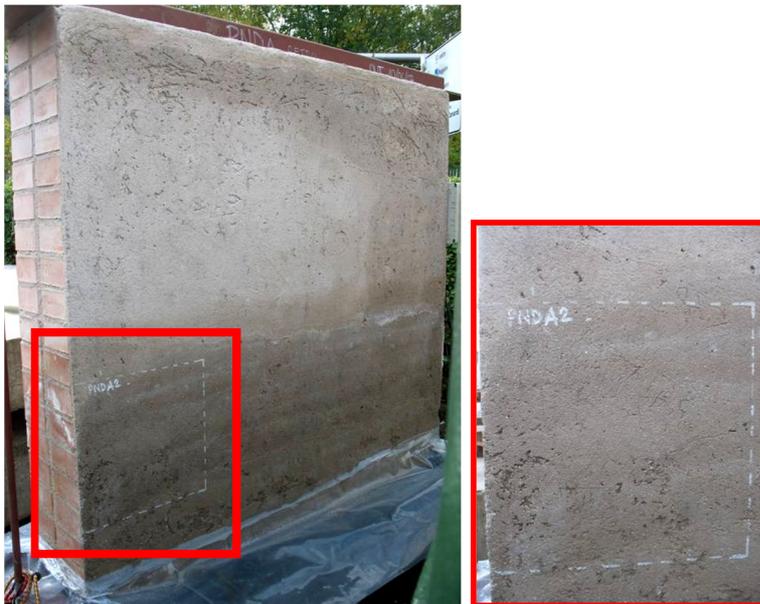
Figure 6.5: PANDA, rear side status at the end of the 2nd ageing season (Nov. 2011)

This decay worsened with the passing of time: at the end of the 2nd summer, some localized pitting phenomena and brick flakes detachments were visible in the front side while the extensions of degraded areas in the rear side increased (Figure 6.4, Figure 6.5).

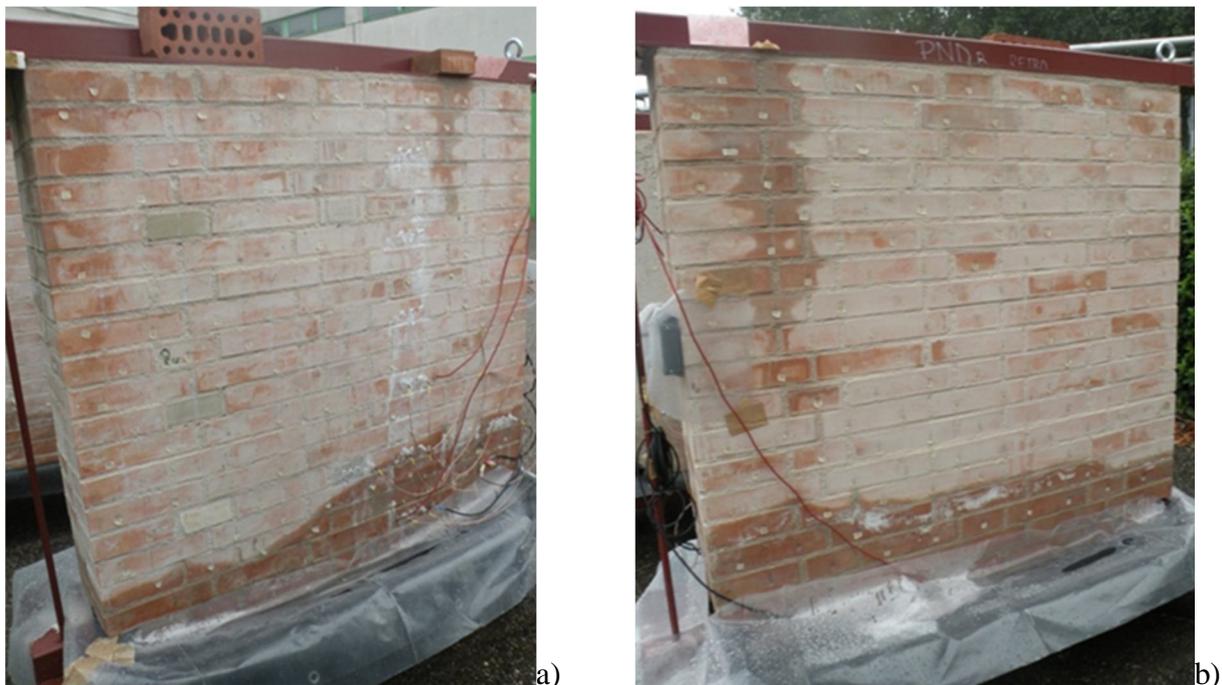
Figure 6.6: PNDB, July 2010, 15 days after pouring the brine: a) front, b) rear side

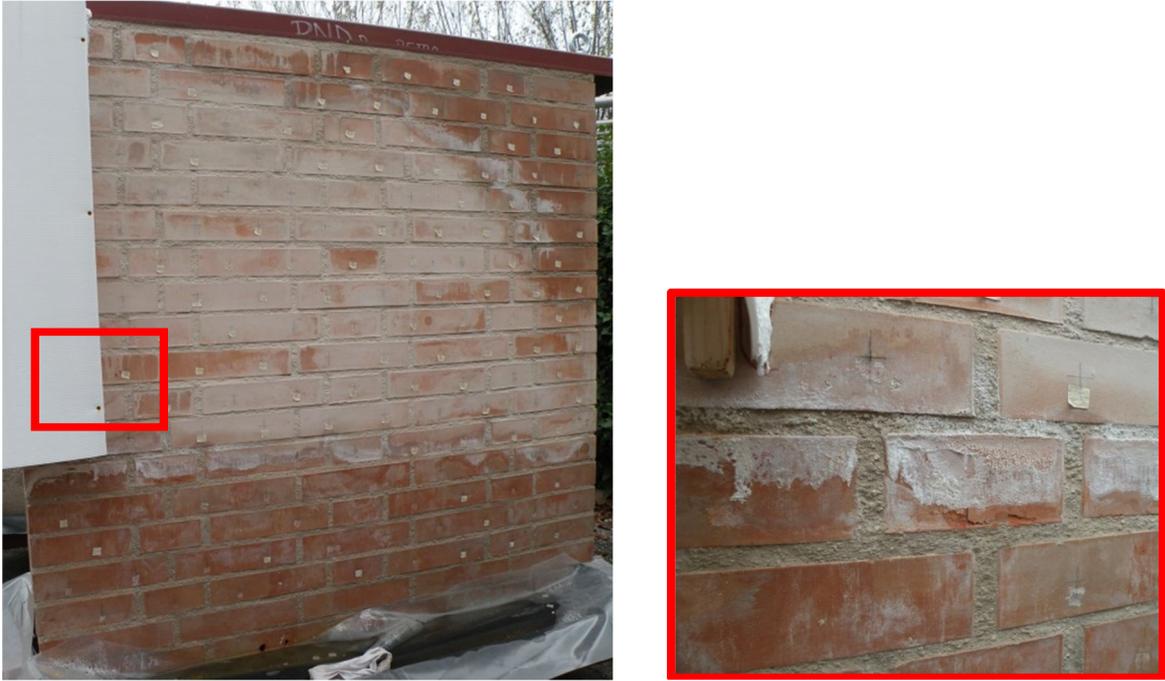
Figure 6.7: PNDDB, rear side at the end of the 1st ageing season (Nov. 2010)
