Alma Mater Studiorum – Università di Bologna

DOTTORATO DI RICERCA IN
INGEGNERIA DEI MATERIALI

EXPERIMENTAL ASSESSMENT OF ENVIRONMENTAL DECAY EFFECTS
IN MASONRY
VIA NON DESTRUCTIVE DIAGNOSTIC TECHNIQUES
AND
MECHANICAL TESTS

Esame finale anno __2014__

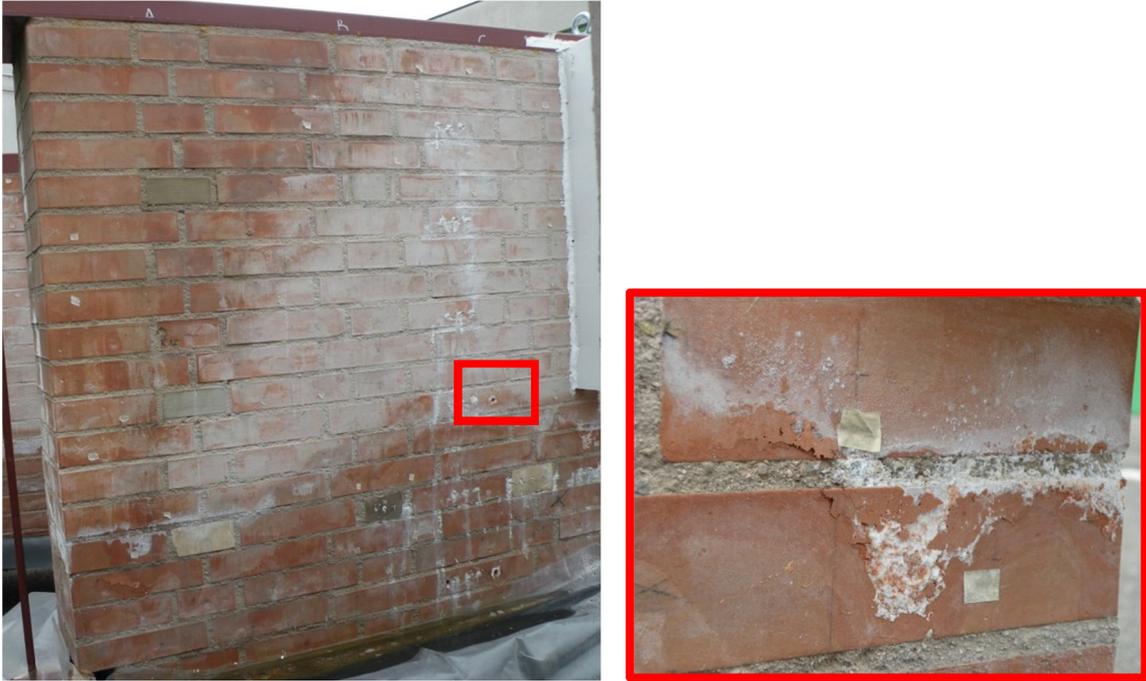
Figure 6.8: PNDDB, front side at the end of the 1st ageing season (Nov. 2010)

Sparse salt subflorescences were detected on the front side, below the rise level, on bricks positioned near the wall's edges where the evaporation is more accentuated (Figure 6.8). These crystallizations were visible because they had already provoked material's expulsion or detachments (exfoliation). The presence of degradation on both masonry components is well in line with their properties, especially considering their similar values of porosity (15thIBMAC). Localized pitting phenomena on bricks were also observed.

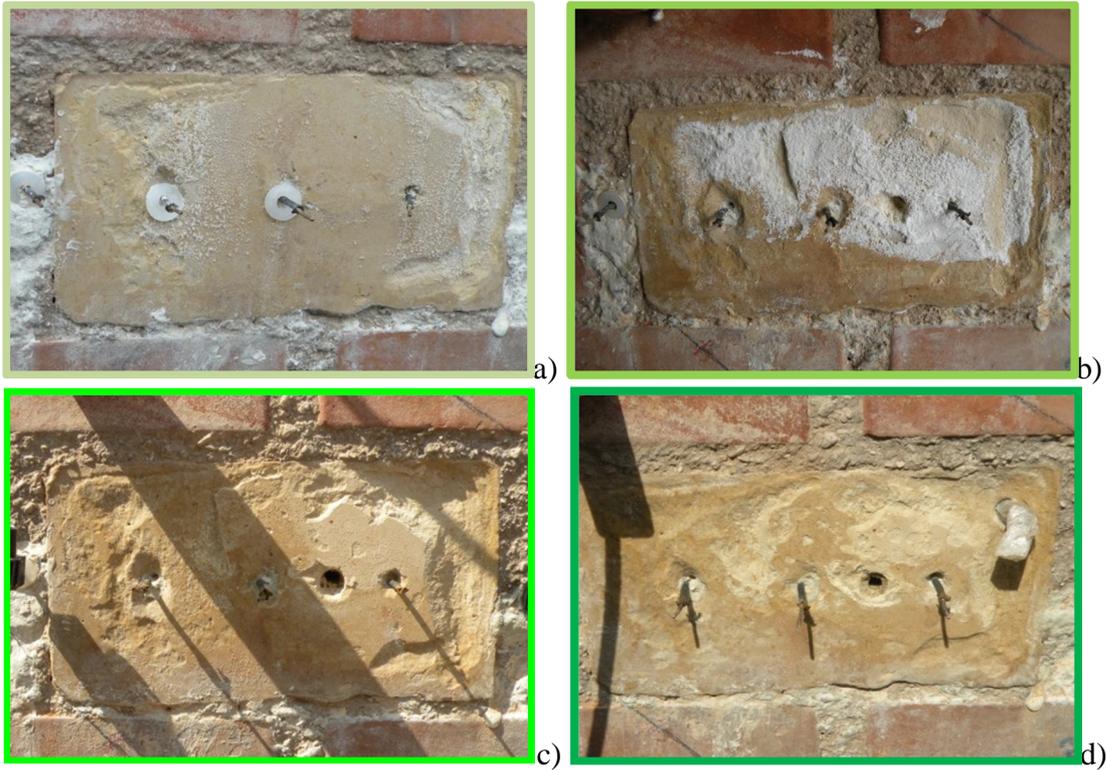
Figure 6.9: PNDB, front side, progress of deterioration in the Palestine stone: a) November 2010, b) April 2012, c) August 2012, d) September 2013

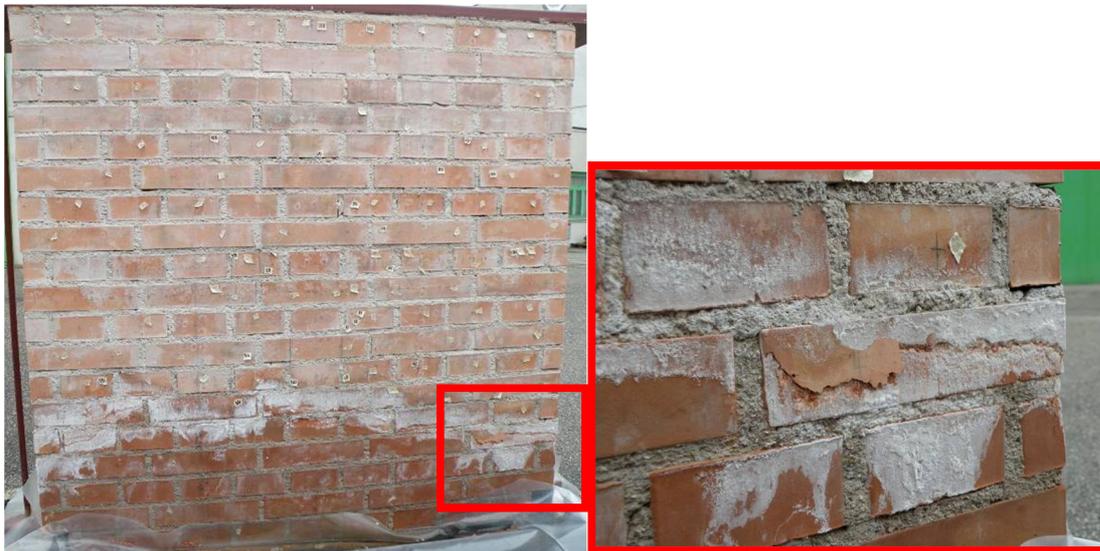
Figure 6.11: PNDD front side, at the end of the first ageing season (Nov. 2010)

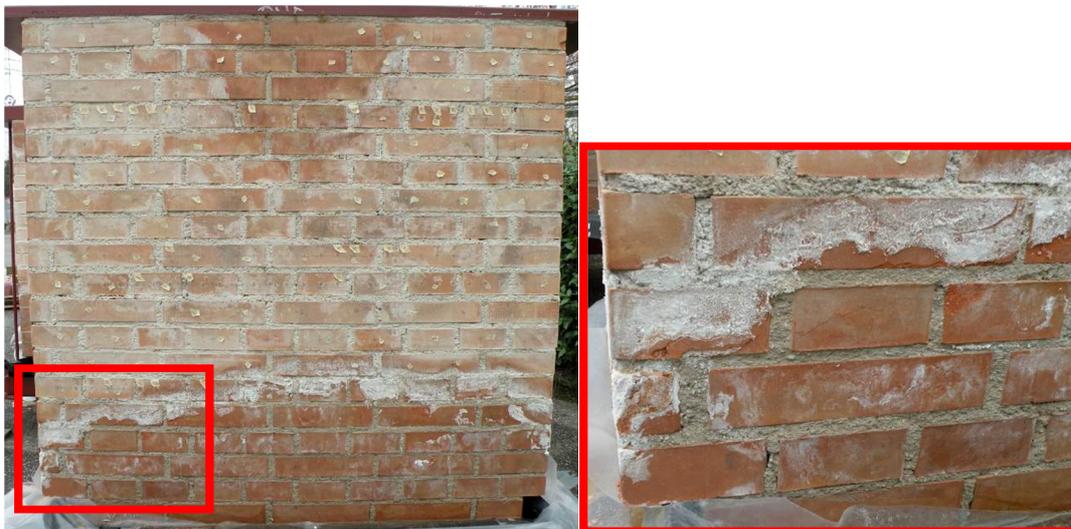
Figure 6.12: PNDD rear side, at the end of the first ageing season (Nov. 2010)

Since the end of the first ageing period, both salt efflorescences and sub-florescences were visible as blistering and detachment of brick flakes occurred near the evaporation band of both sides of the wall (Figure 6.11, Figure 6.12). Mortar scarification was also quite evident, especially in the wall front side which was more exposed to sun radiations (report).

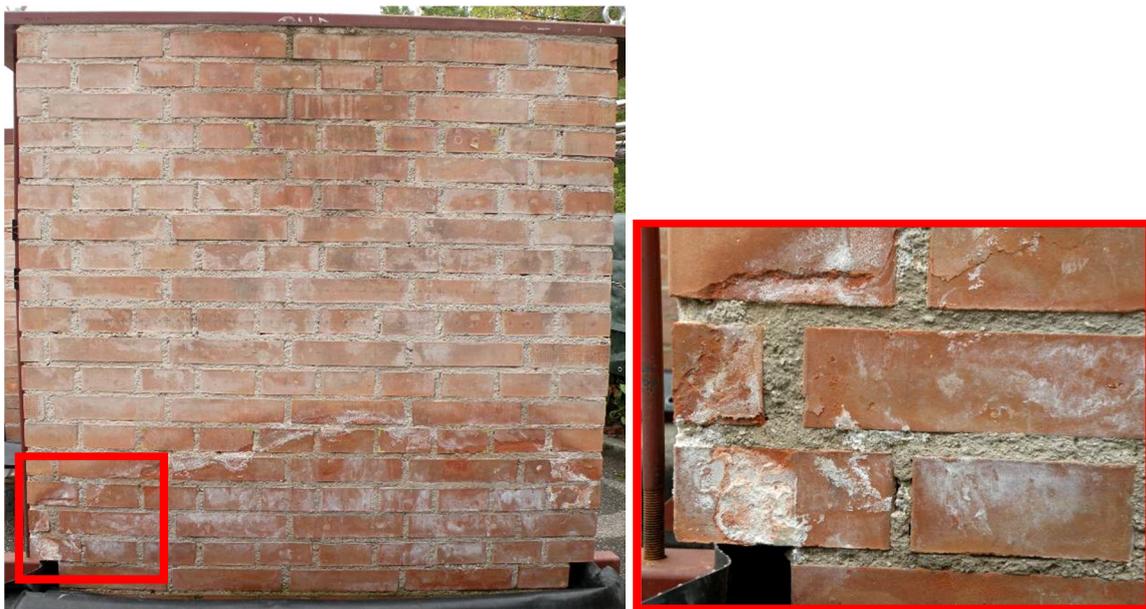
Figure 6.14: PNDD rear side, Nov. 2011, evident blistering of bricks and losses of materials on the mortar joints

This degradation phenomena became more pronounced with the passing of time (Figure 6.13, Figure 6.14), causing consistent losses of materials portions both from brick surfaces and mortar joints, especially near the edges of the wall (Figure 6.15).

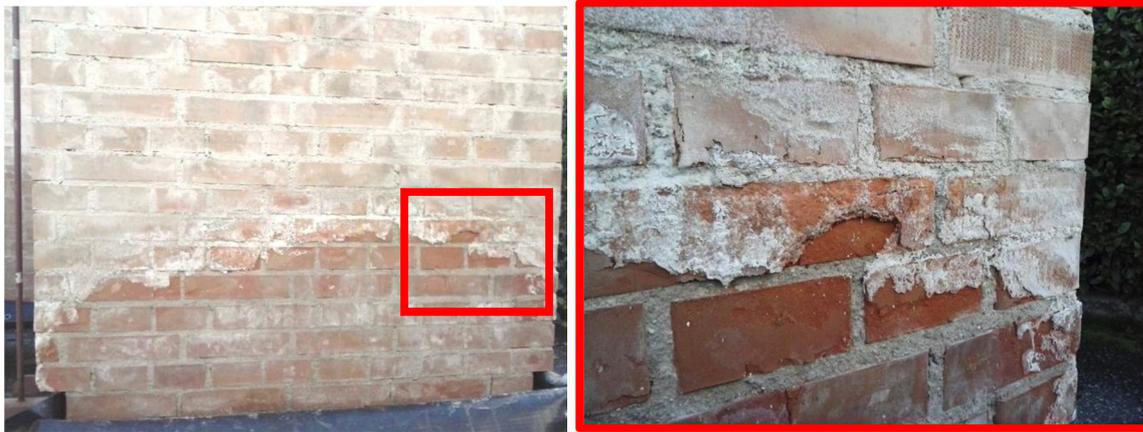
Figure 6.15: PNDD, rear side at the end of the 3rd ageing season (November 2012)

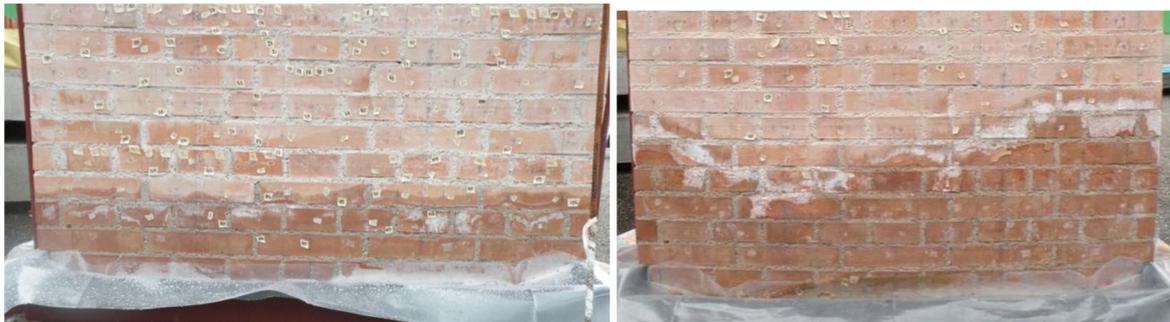
Figure 6.16: PNDE, front side, July 2010 (left) and November 2010 (right)

As seen for the previous walls, moist areas and salt crystallization on the surfaces or beneath them were visible since the very beginning of the ageing period (Figure 6.16). In this case, different white crystals correspond to the sodium sulphate phases were noted: some of them appeared as hard and persistent bubbles (subflorescences) whilst others, very thin and delicate, looked like a dust deposition (efflorescence). Probably because of the aggressiveness of the type of salt employed for the damp rise (sodium sulphate), the first detachment of brick flakes already occurred after 5 months of ageing (Figure 6.17). (Ibmac)

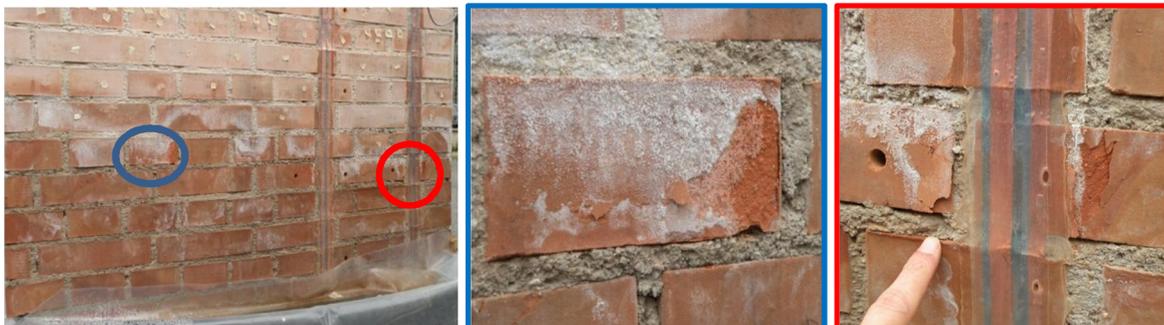
Figure 6.17: PNDE, Nov. 2010, rear side (left) and 2 brick degradation details (right)

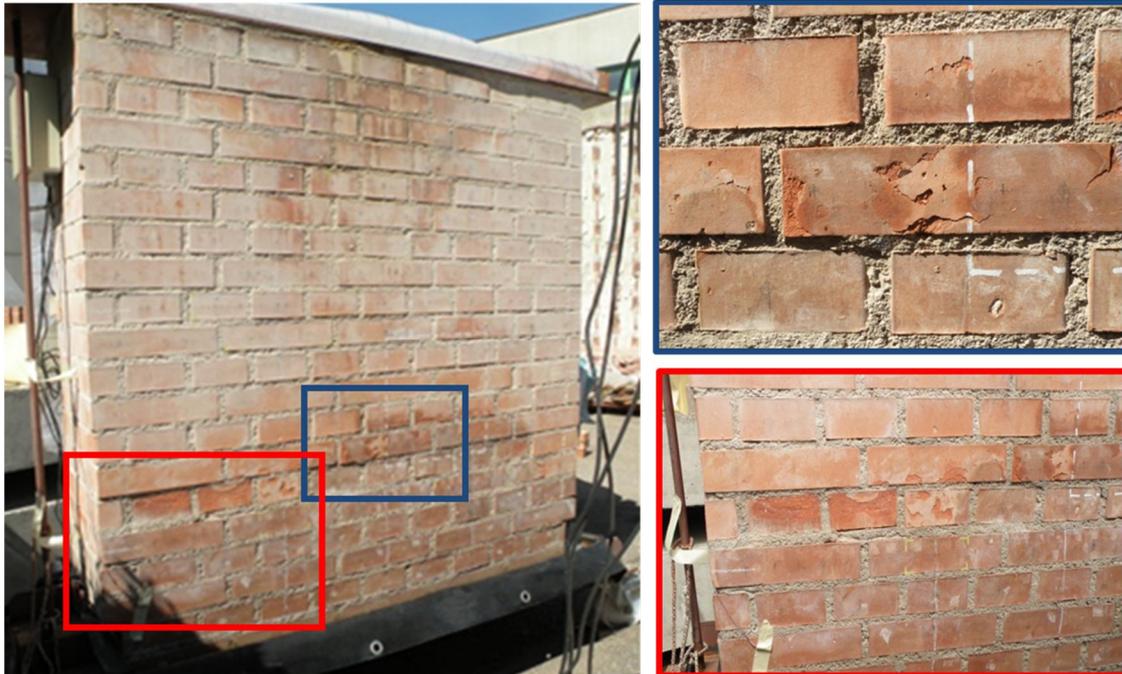
Figure 6.18: PNDF, front side, during the 3rd ageing season (June 2012)

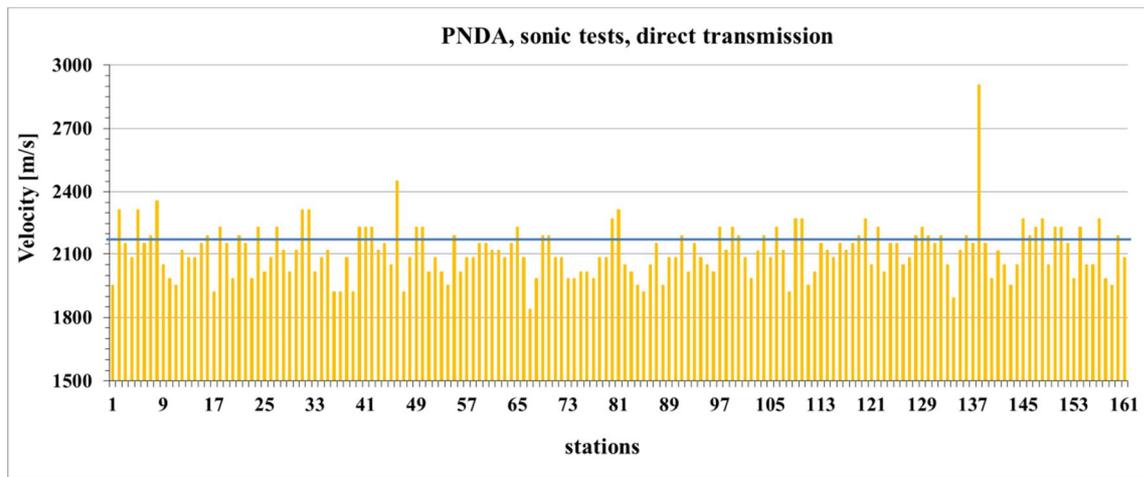
Figure 6.21: Wall PNDA in as-built conditions, sonic tests in direct transmission, signal velocity. The blue line represents the average velocity (2116m/s).

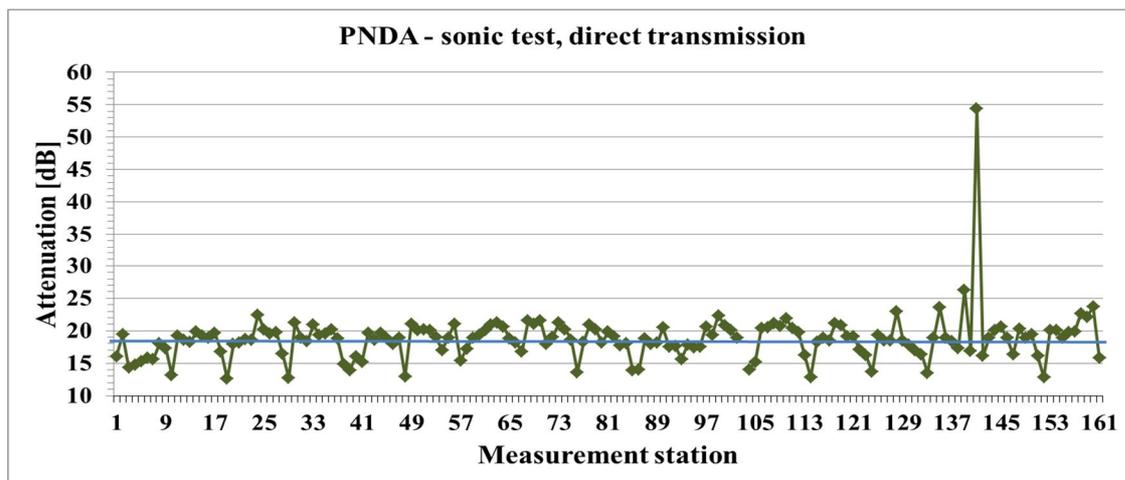
Figure 6.22: Wall PNDA, in as-built conditions, sonic tests in direct transmission, signal attenuation. The blue line represents the average signal attenuation (18.72 dB).

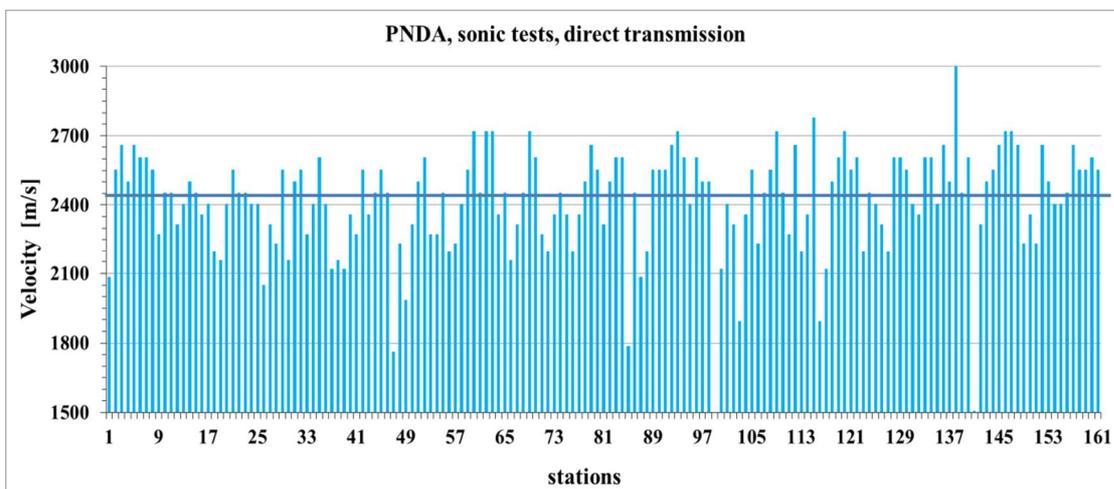
Figure 6.23: Wall PANDA, sonic tests in direct transmission after 2 years of natural ageing, signal velocity. The blue line represents the average velocity (2424 m/s).

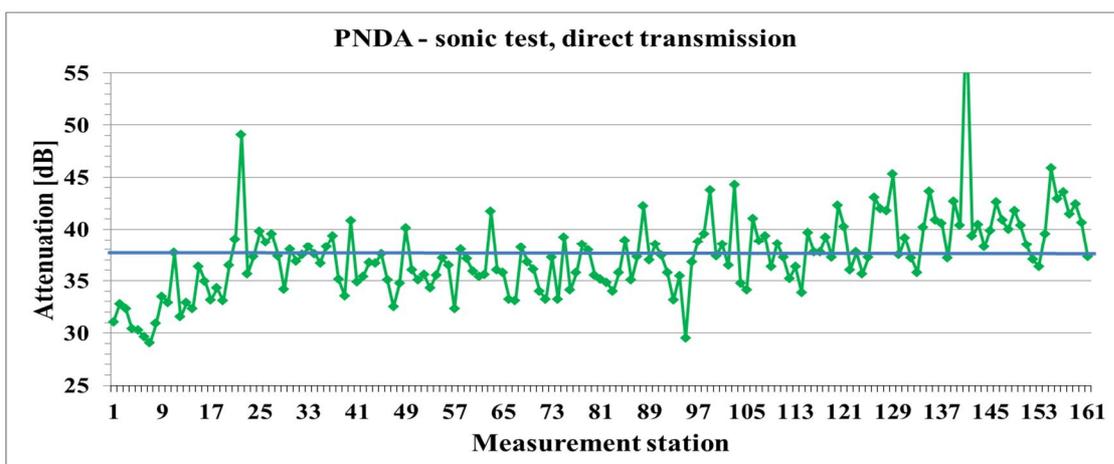
Figure 6.24: Wall PANDA, sonic tests in direct transmission after 2 years of natural ageing, signal attenuation. The blue line represents the average value (37 dB).

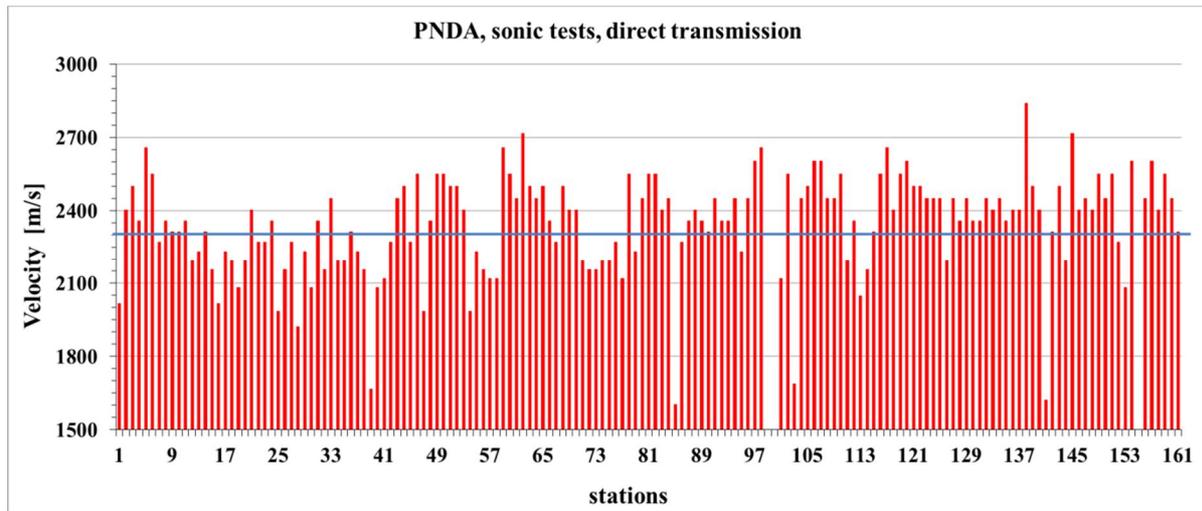
Figure 6.25: Wall PNDA, sonic tests in direct transmission after 3 years of natural ageing, signal velocity. The blue line represents the average velocity (2346 m/s).

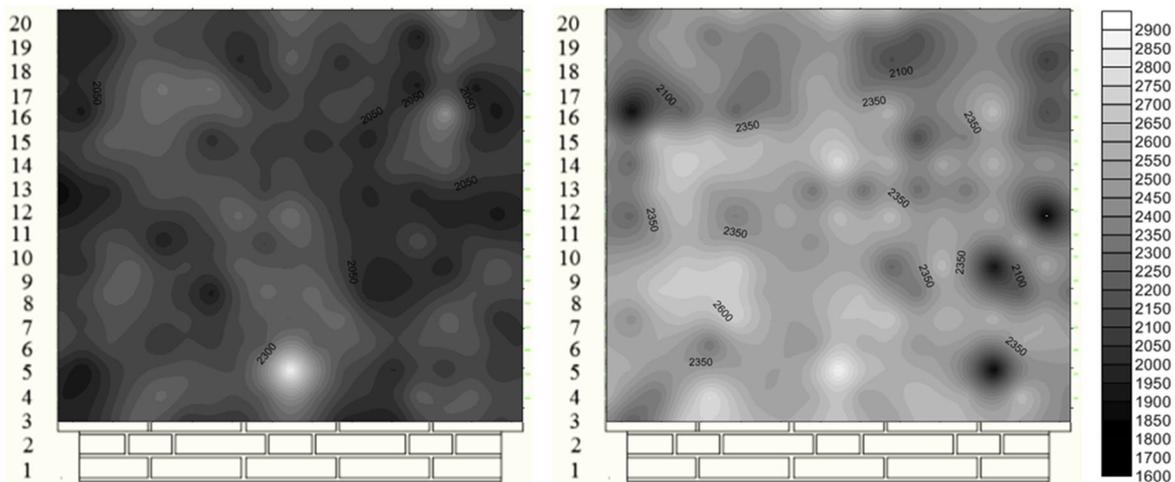
Figure 6.29: PNDAs, grey-scale maps of sonic velocities isoclines superimposed to the wall layout, front side in undamaged conditions of the wall (left) and after three years of ageing (right)

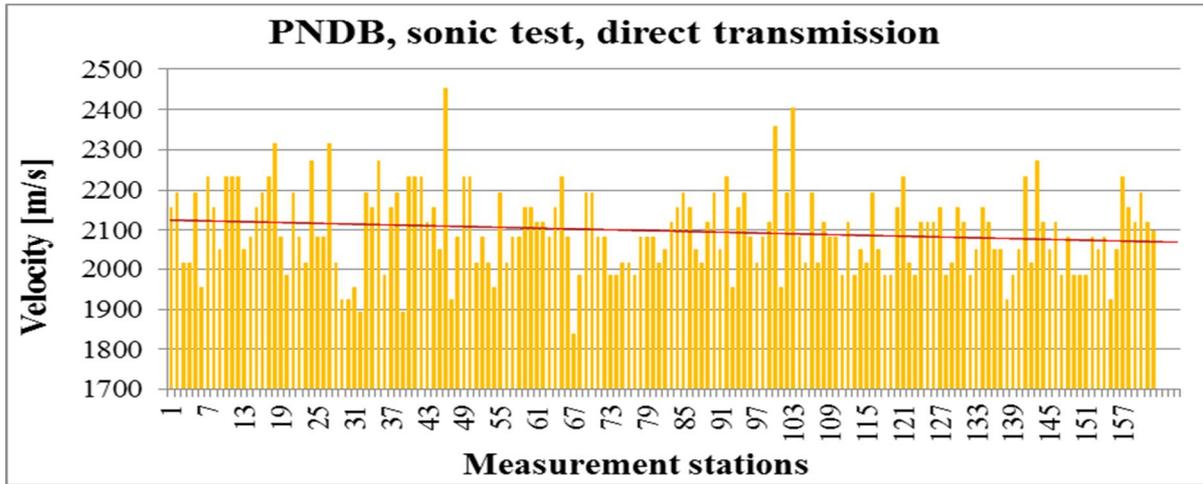
Figure 6.31: PNDB in as-built conditions, sonic tests in direct transmission, values of signal velocity. The red line represents the average velocity (2097 m/s).

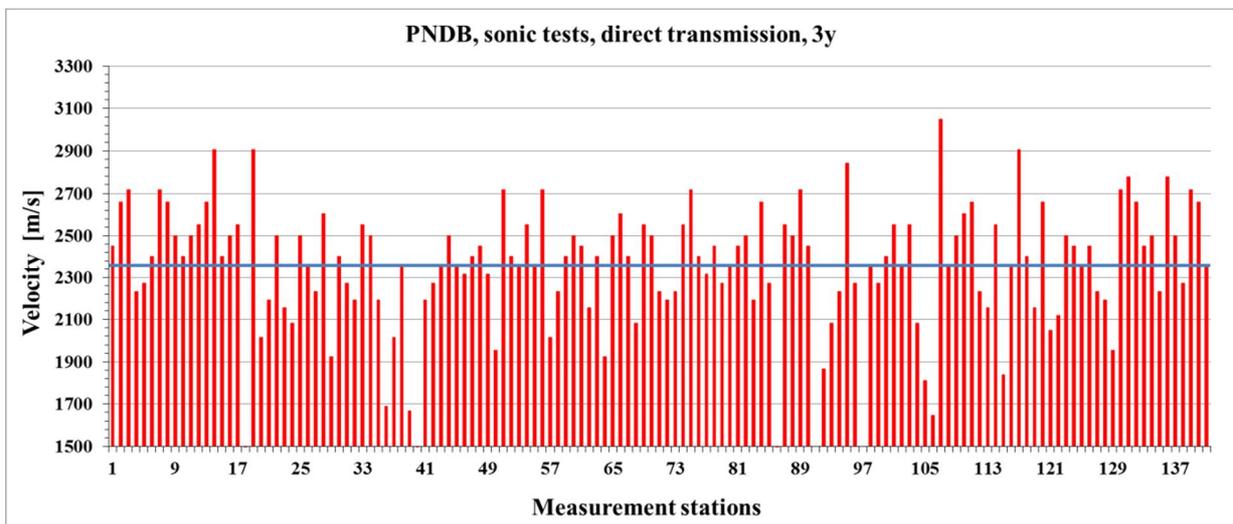
Figure 6.32: PNDB, sonic tests in direct transmission after 3 years of natural ageing, signal velocity. The blue line represents the average velocity (2360 m/s).

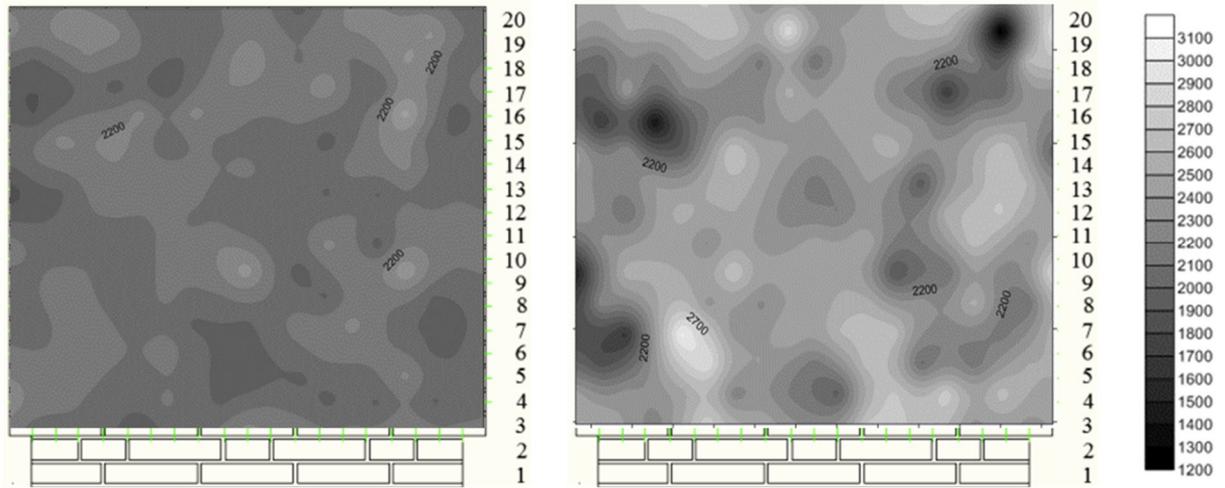
Figure 6.34: PND, sonic test: maps of direct velocities superimposed to the wall geometry, in undamaged conditions of the wall (left) and after three years of ageing (right)

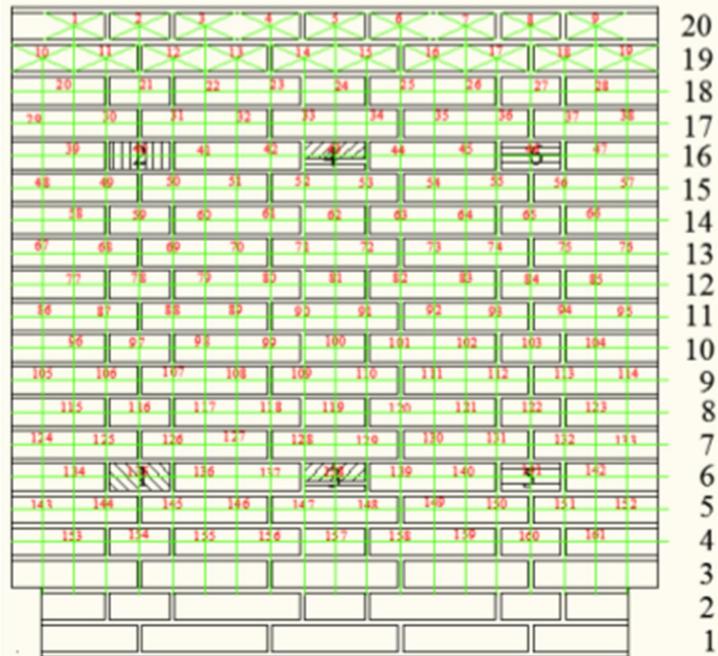
PNDC

Figure 6.35: PNDC, measurement grid for sonic tests in direct transmission

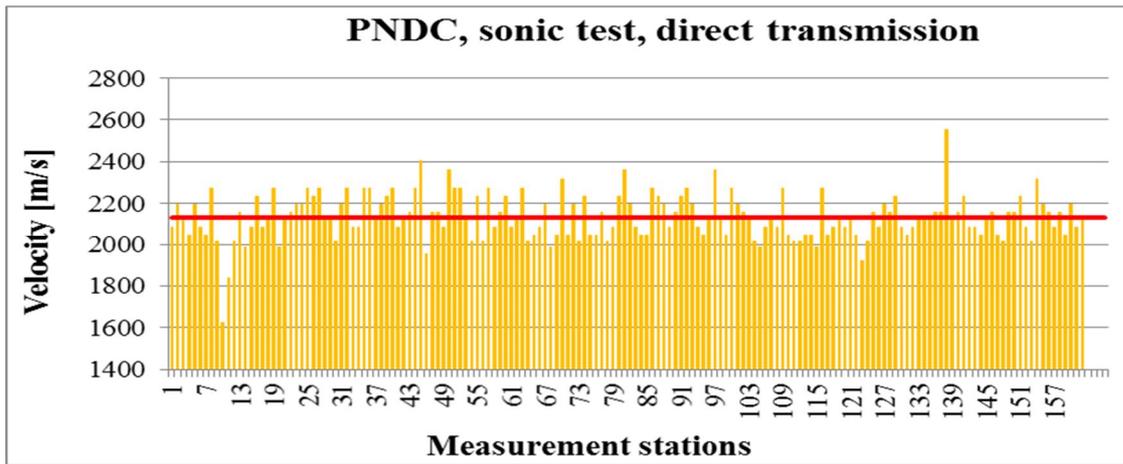
Figure 6.36: PNDC in as-built conditions, sonic tests in direct transmission, values of signal velocity. The red line represents the average velocity (2132 m/s).

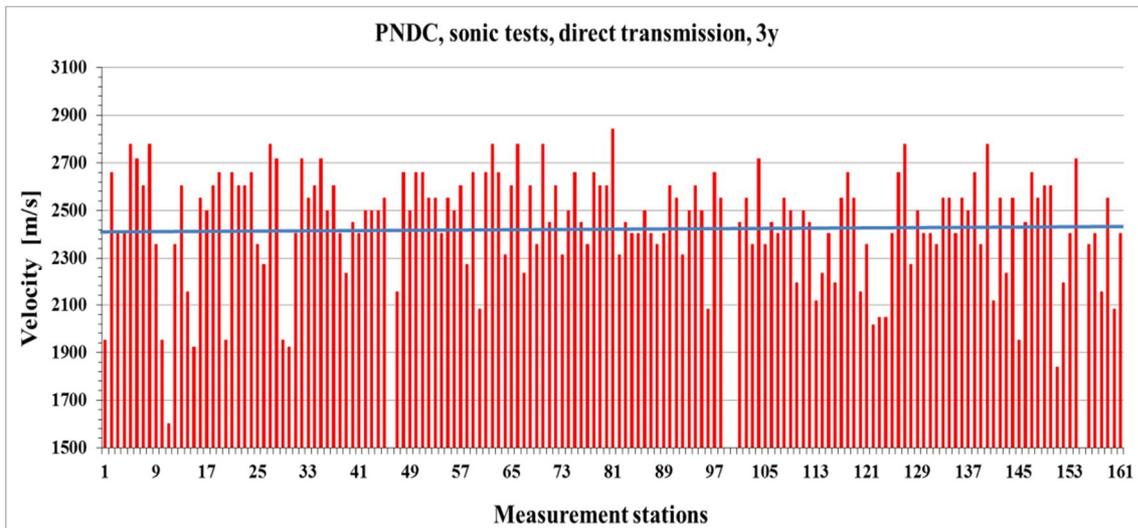
Figure 6.37: PNDC, sonic tests in direct transmission after 3 years of natural ageing, signal velocity. The blue line represents the average velocity (2441.35 m/s).

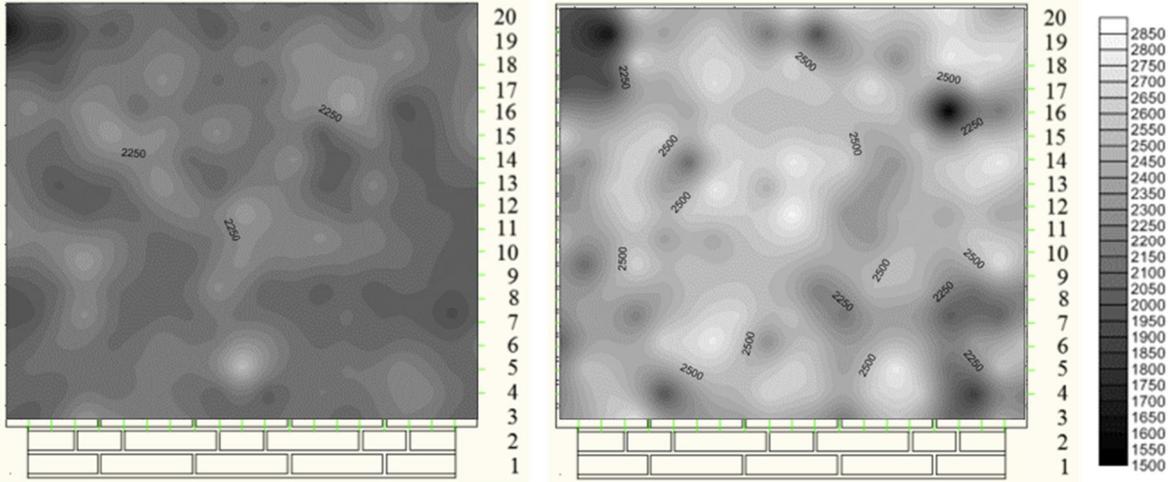
Figure 6.39: PNDC, grey-scale maps of sonic velocities isoclines superimposed to the wall layout, front side in undamaged conditions of the wall (left) and after three years of ageing only by rain water (right)

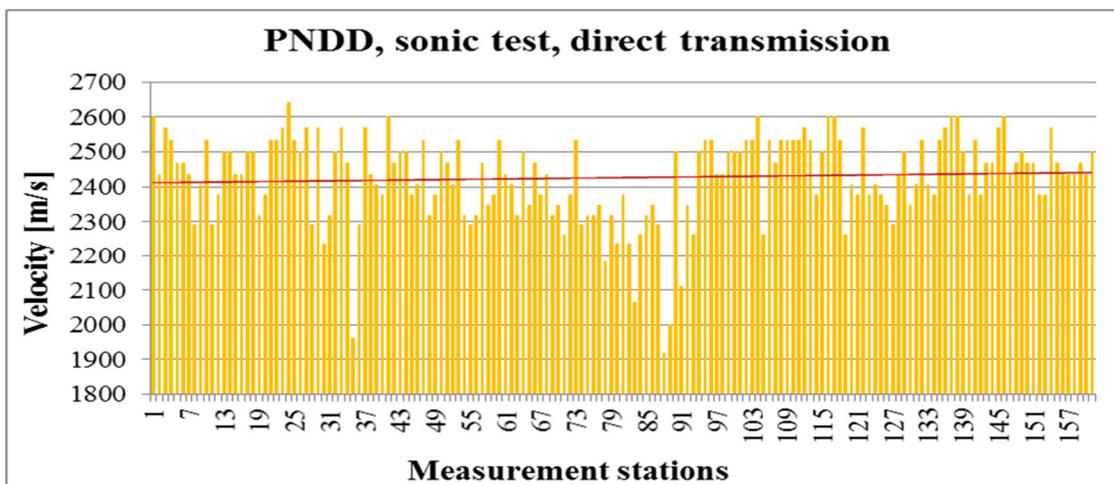
Figure 6.41: PNDD in as-built conditions, sonic tests in direct transmission, values of signal velocity. The red line represents the average velocity (2427 m/s).

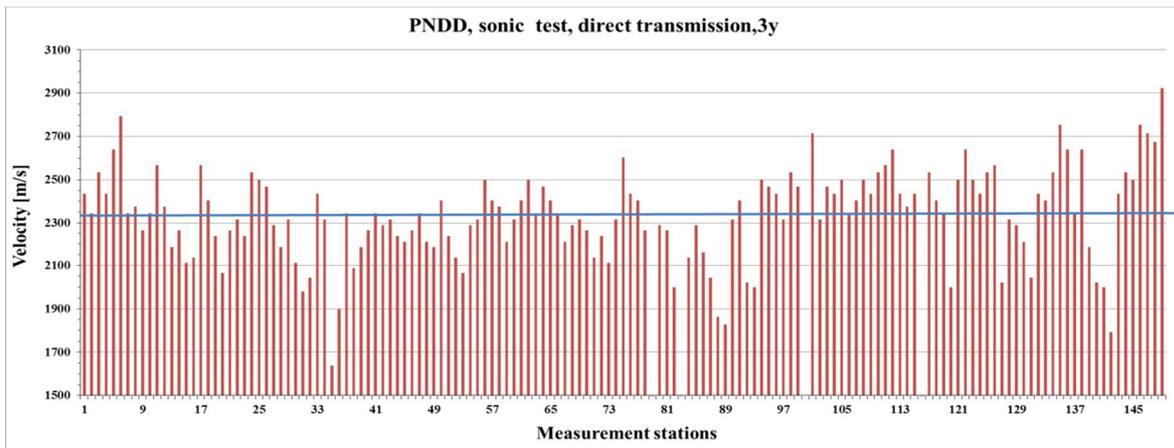
Figure 6.42: PNDD, sonic tests in direct transmission after 3 years of natural ageing, signal velocity. The blue line represents the average velocity (2328 m/s).

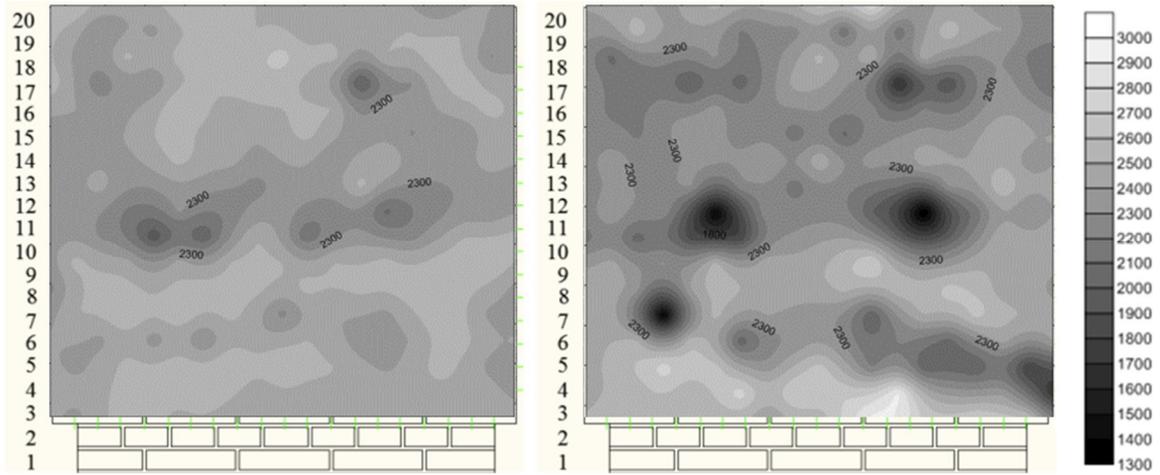
Figure 6.44: PNDD, grey-scale maps of sonic velocities superimposed to the wall layout, front side in undamaged conditions of the wall (left) and after three years of ageing (right)

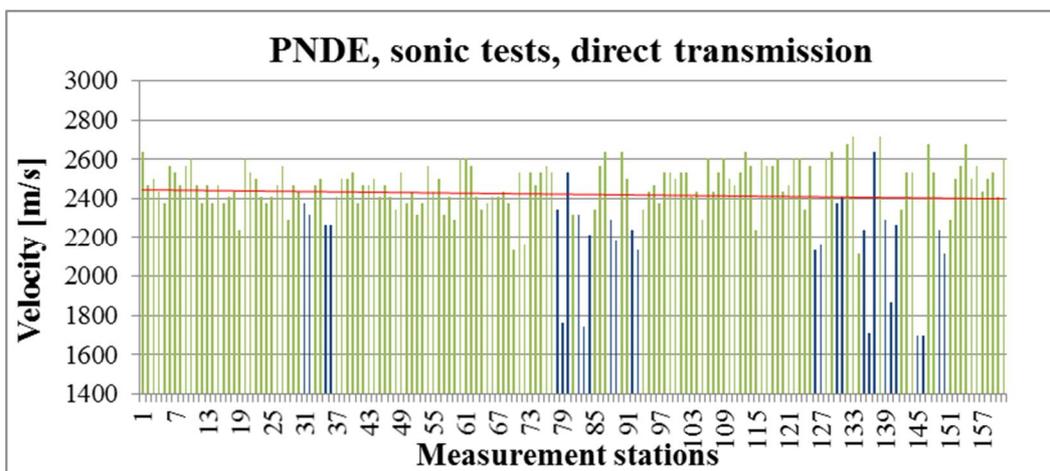
Figure 6.46: PNDE in as-built conditions, sonic tests in direct transmission, values of signal velocity. The red line represents the average velocity (2422 m/s).

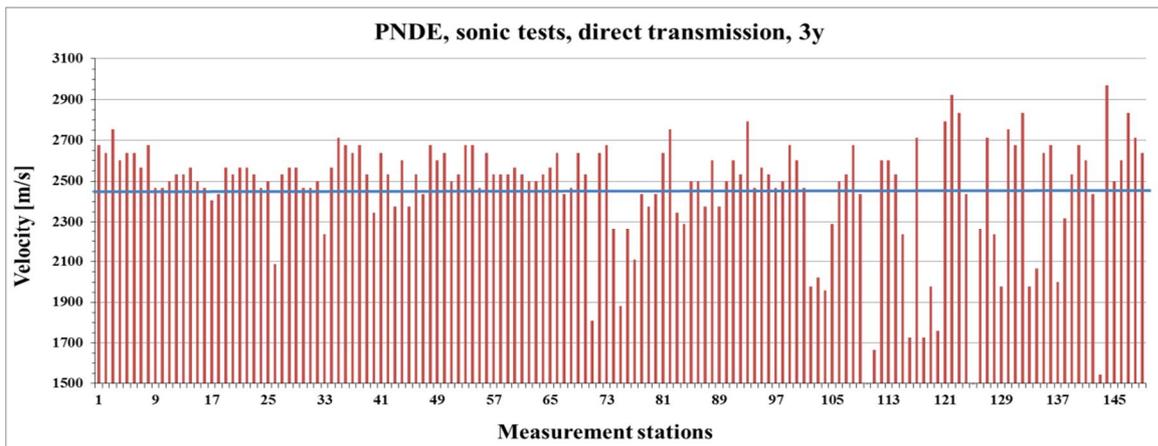
Figure 6.47: PNDE, sonic tests in direct transmission after 3 years of natural ageing, signal velocity. The blue line represents the average velocity (2450 m/s).

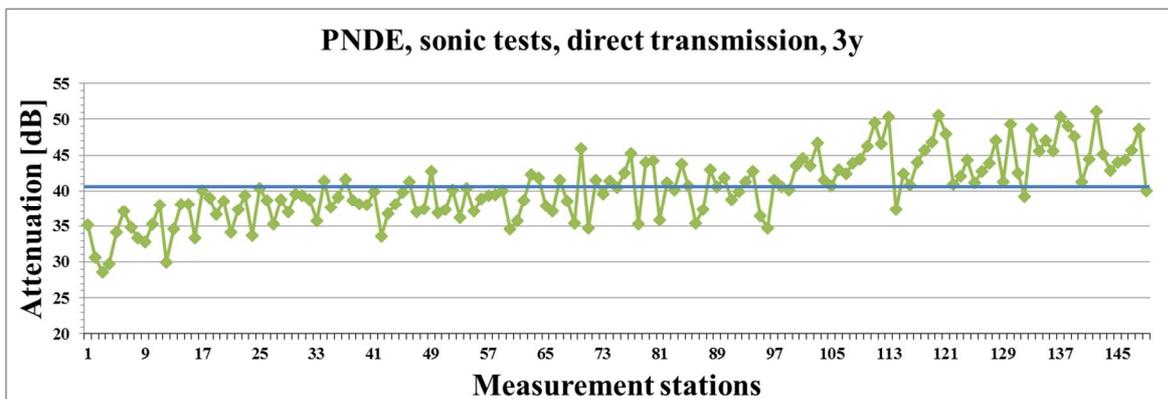
Figure 6.48 PNDE, sonic tests in direct transmission after 3 years of natural ageing, signal attenuation. The blue line represents the average value (40.30 dB).

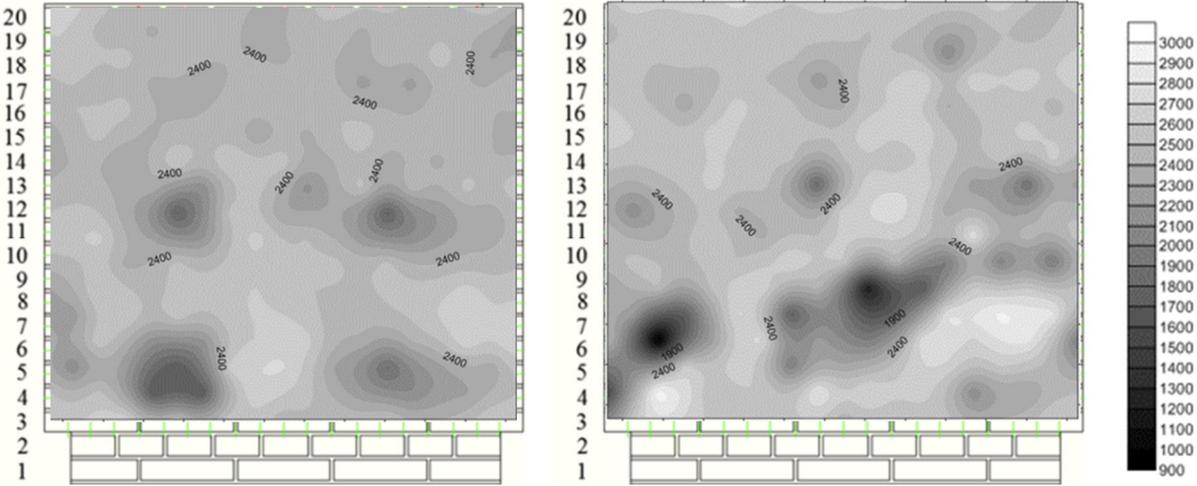
Figure 6.49: PNDE, grey-scale maps of sonic velocities superimposed to the wall layout, front side in undamaged conditions of the wall (left) and after three years of ageing (right)

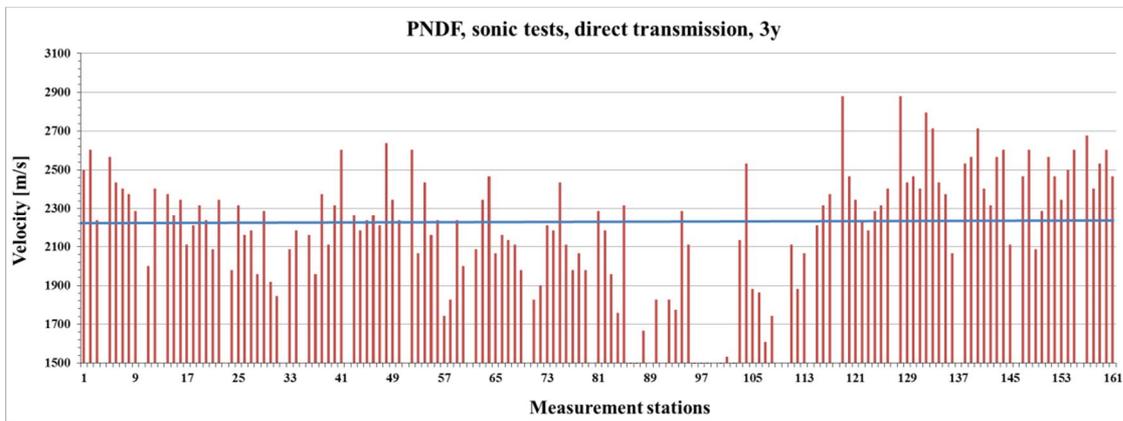
Figure 6.52: PNDF, sonic tests in direct transmission after 3 years of natural ageing, signal velocity. The blue line represents the average velocity (2203 m/s).

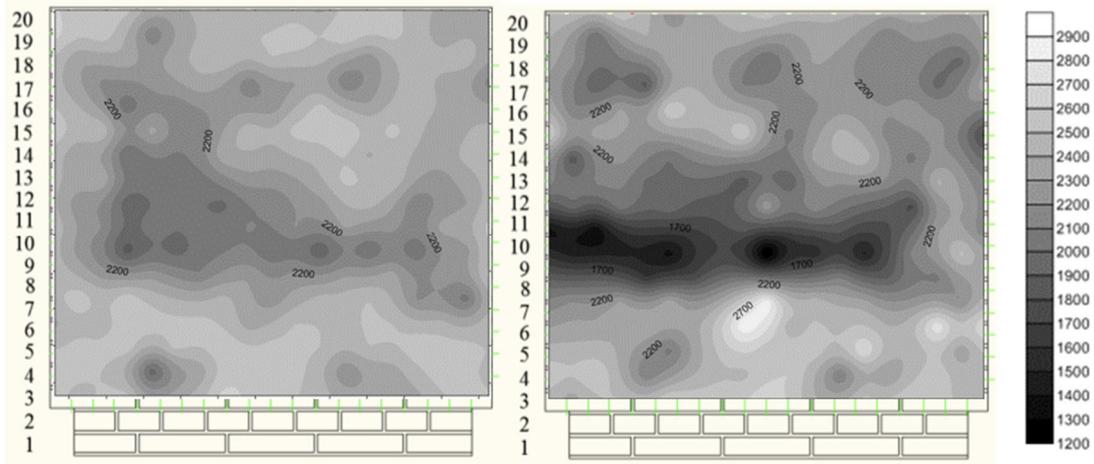
Figure 6.54: PPDF, grey-scale maps of sonic velocities superimposed to the wall layout, front side in undamaged conditions of the wall (left), after three years of ageing (right)

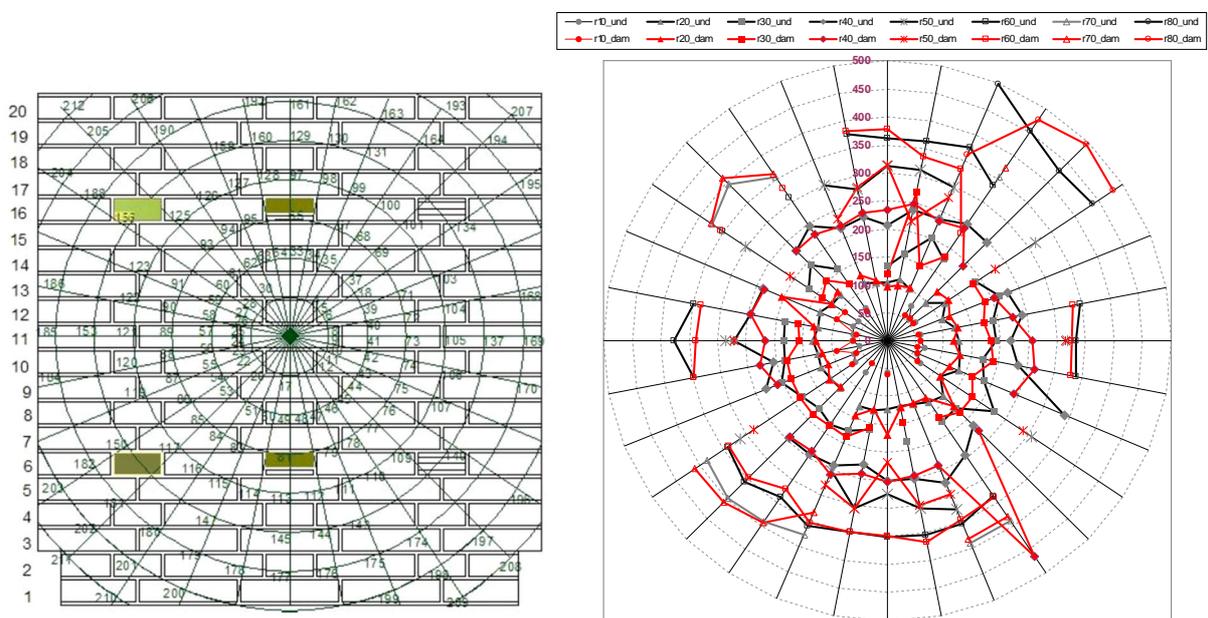
Figure 6.55: PNDC, front side: measurement grid overlapped onto the wall layout (left) and time of flight values collected in two different periods

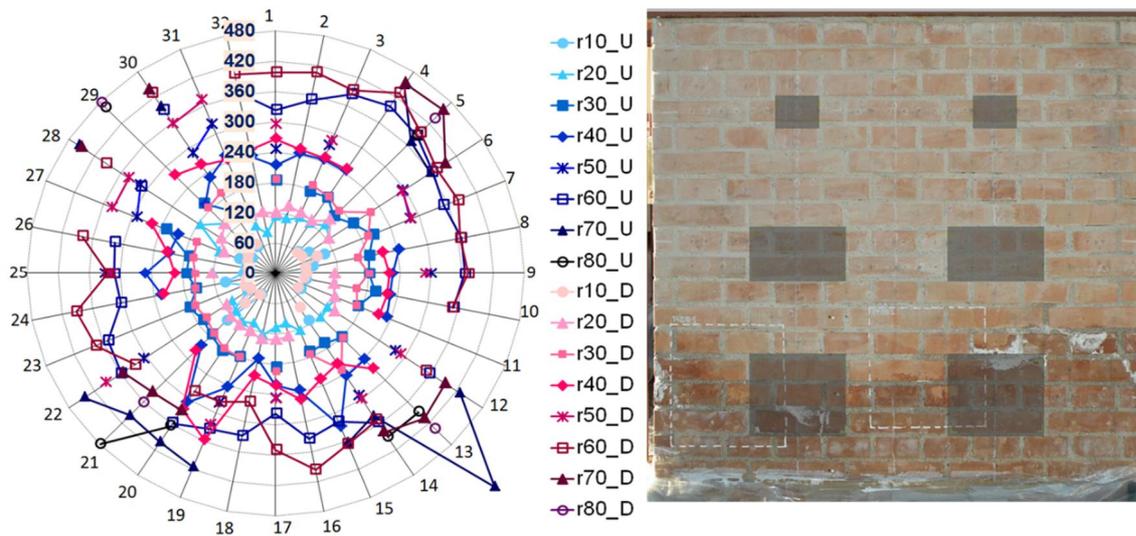
Figure 6.57: PNDE front: a) measurement grid of sonic superficial transmission tests overlapped to wall layout (numbers refer to the stations of the hammer), b) position of the defects within the wall thickness

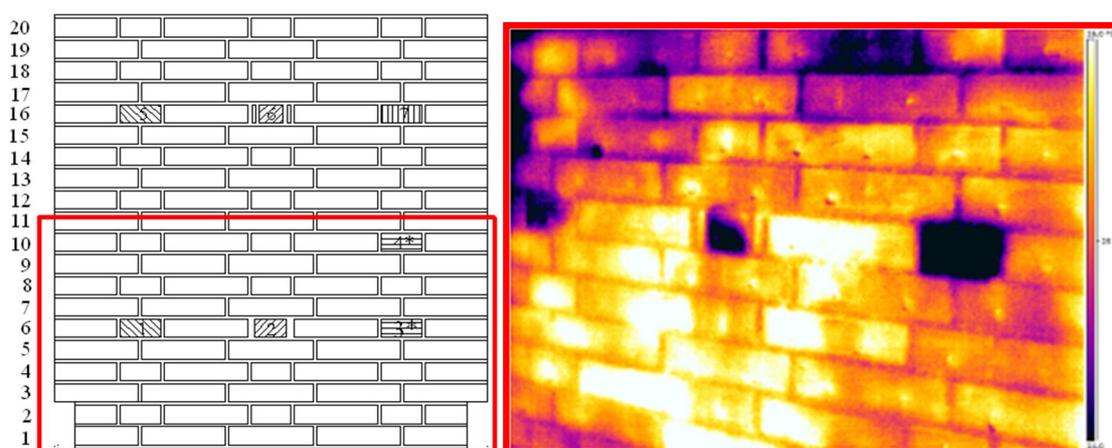
Figure 6.59: PNDA, front side, September 2010, early morning: material discontinuities visible as cold spots

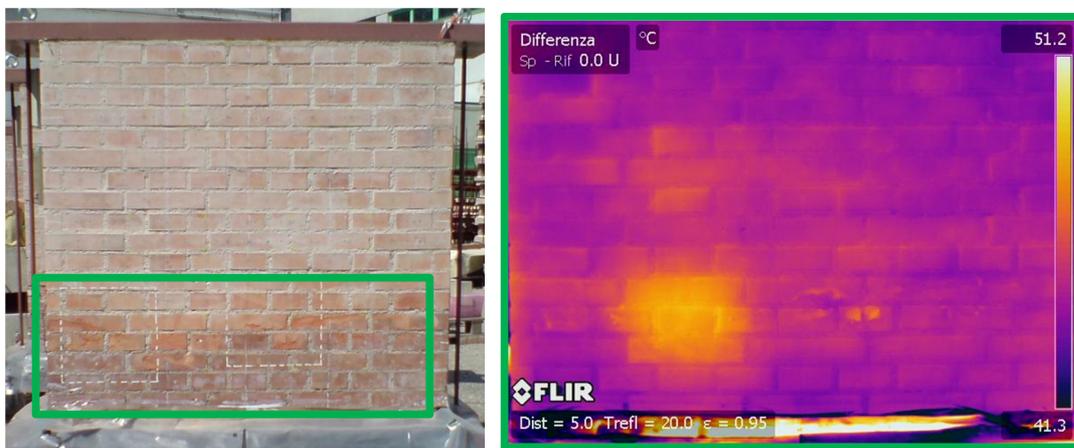
Figure 6.61: PNDE, front side, September 2011, early morning: clear detection of a simulated void within the wall thickness

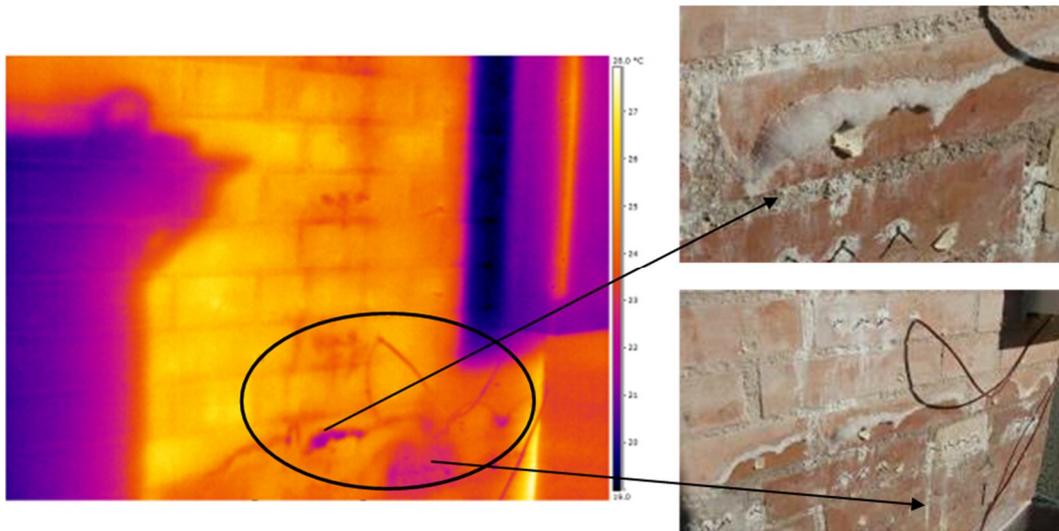
Figure 6.62: PNDB, front side, early morning: salt efflorescences and bricks with different thermal properties were detected

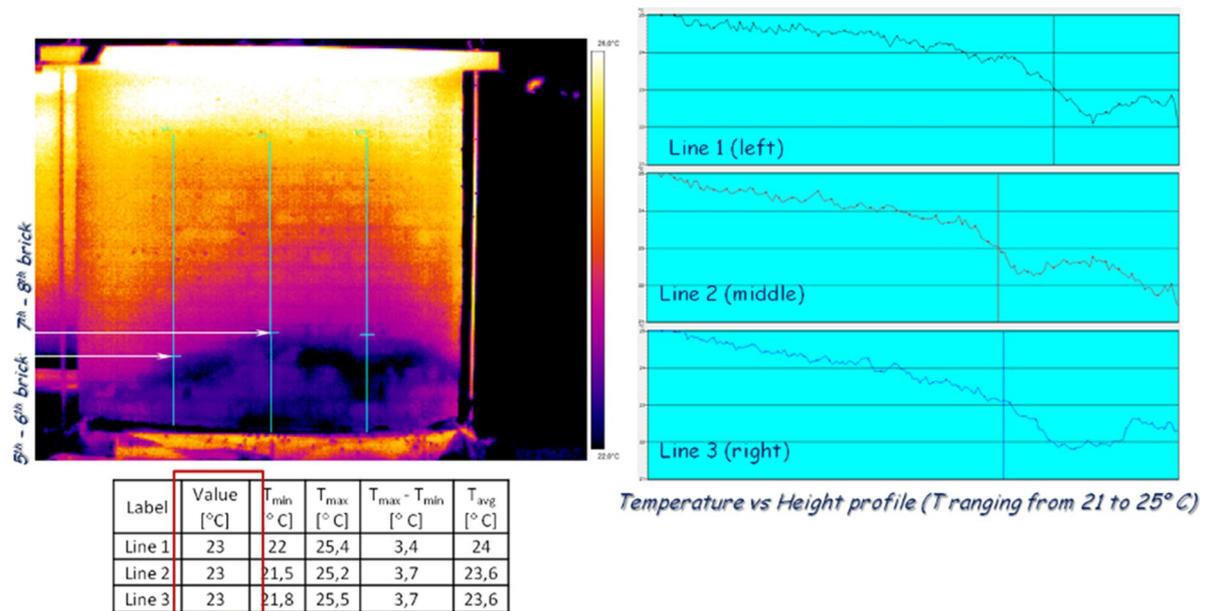
Figure 6.64: PNDD, rear side, September 2011, afternoon. Evaluation of moisture content [Largo]
