Alma Mater Studiorum – Università di Bologna

DOTTORATO DI RICERCA IN
INGEGNERIA DEI MATERIALI

EXPERIMENTAL ASSESSMENT OF ENVIRONMENTAL DECAY EFFECTS
IN MASONRY
VIA NON DESTRUCTIVE DIAGNOSTIC TECHNIQUES
AND
MECHANICAL TESTS

Esame finale anno __2014__

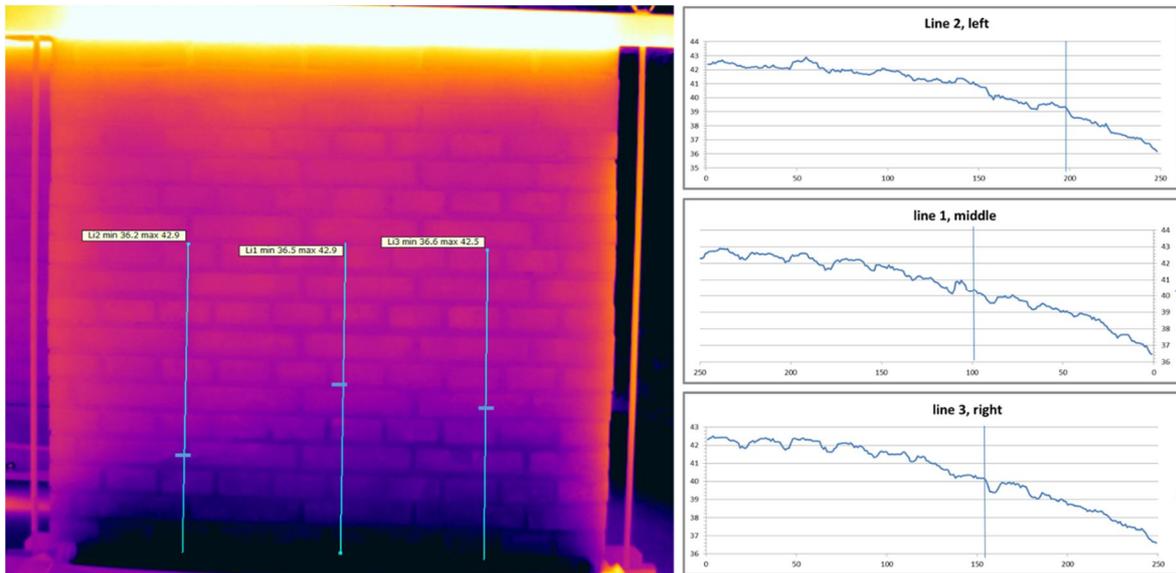
Figure 6.65: PNDD, rear side, September 2012, afternoon. Evaluation of moisture content trough vertical profiles of temperature

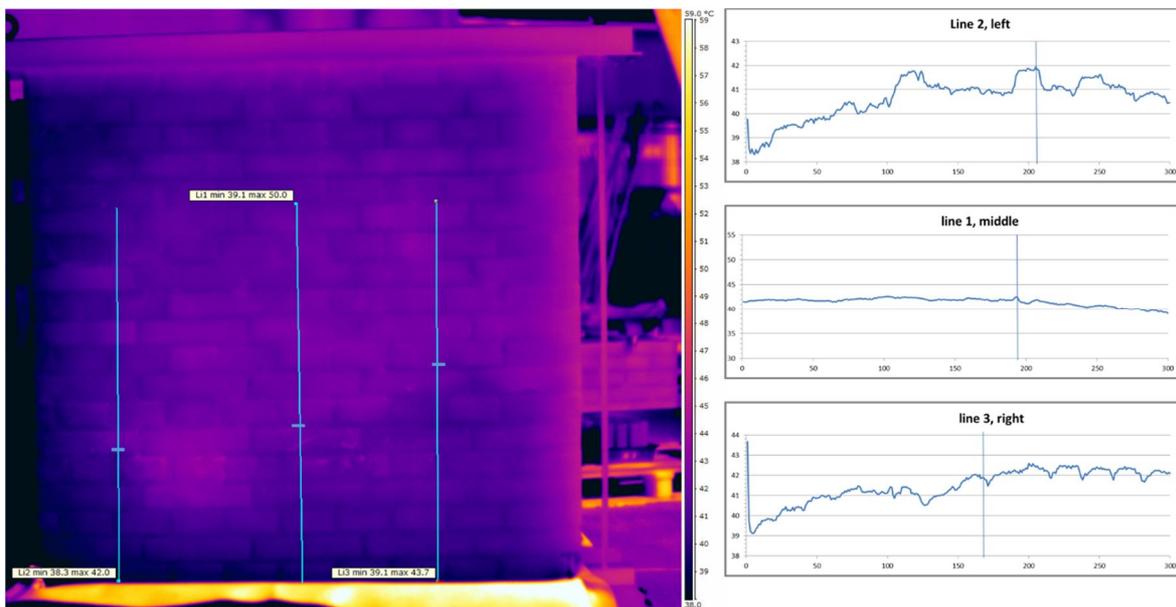
Figure 6.66: PNDE, front side, September 2012, afternoon. Evaluation of moisture content trough vertical profiles of temperature

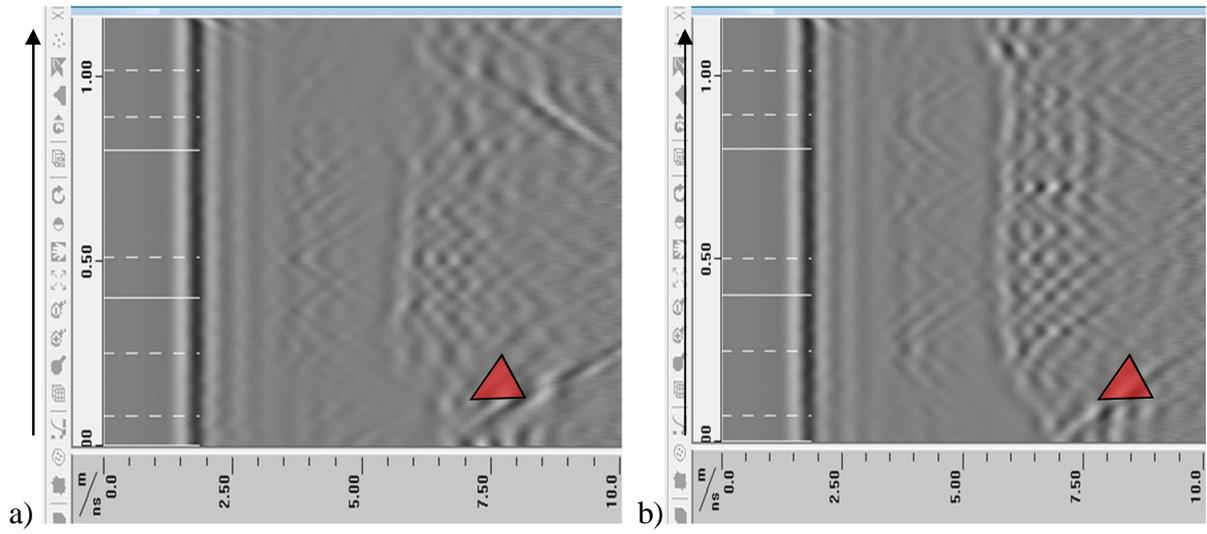
Figure 6.68: a) GPR survey along vertical line 11; b) GPR survey along vertical alignment 14.

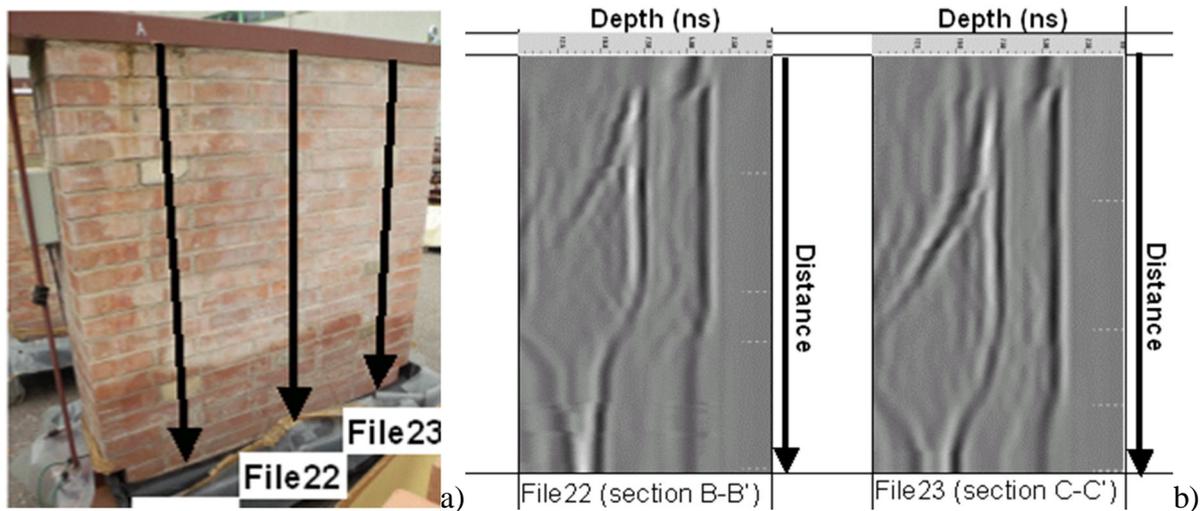
Figure 6.69: a) status of wall PND and superimposed GPR survey alignments; b) modification of wave reflection at the bottom as a function of rising damp height. See the greater modification on file 22 respect to file 23 due to the higher rising damp level in correspondence of the first survey alignment

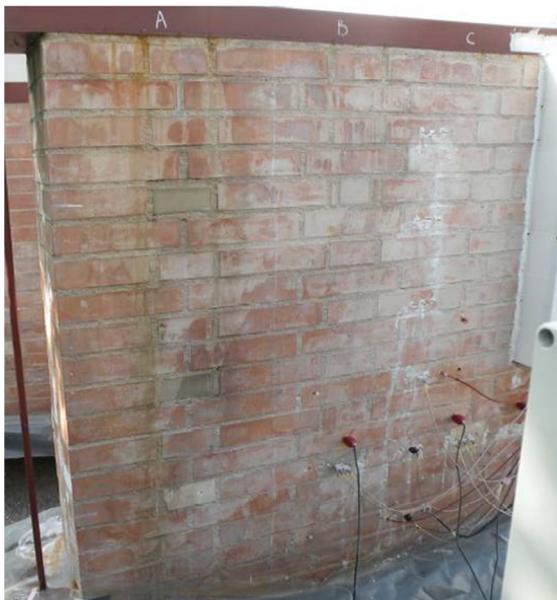
Figure 6.75: Wall PNDB, front side with monitoring sensors, 3rd May 2011

- a device for the measurement of environmental parameters (relative air humidity, air temperature and internal wall temperature),
- a device for the determination of the moisture content.
- a potential-measuring device for salt concentration survey,

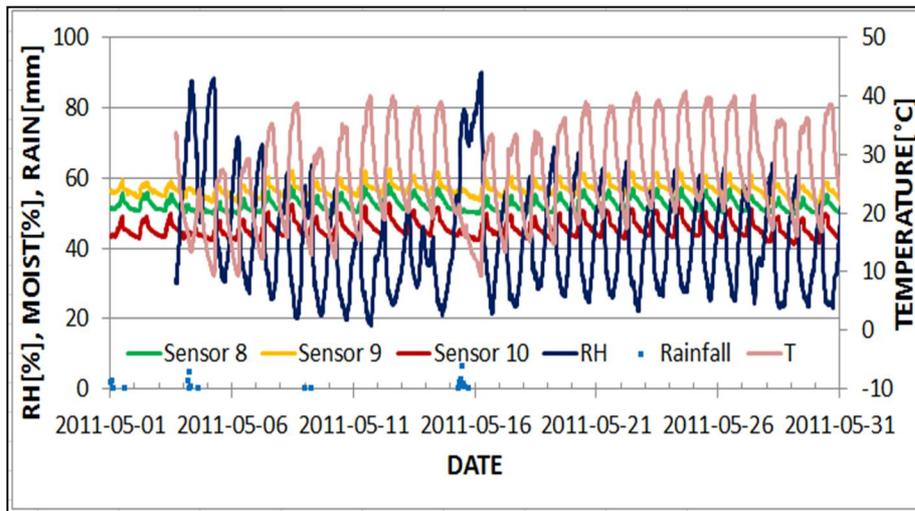
Figure 6.77: Wall PNDB, recorded values of air temperature, relative humidity and amount of rainfall together with values from 3 moisture sensors (May 2011)

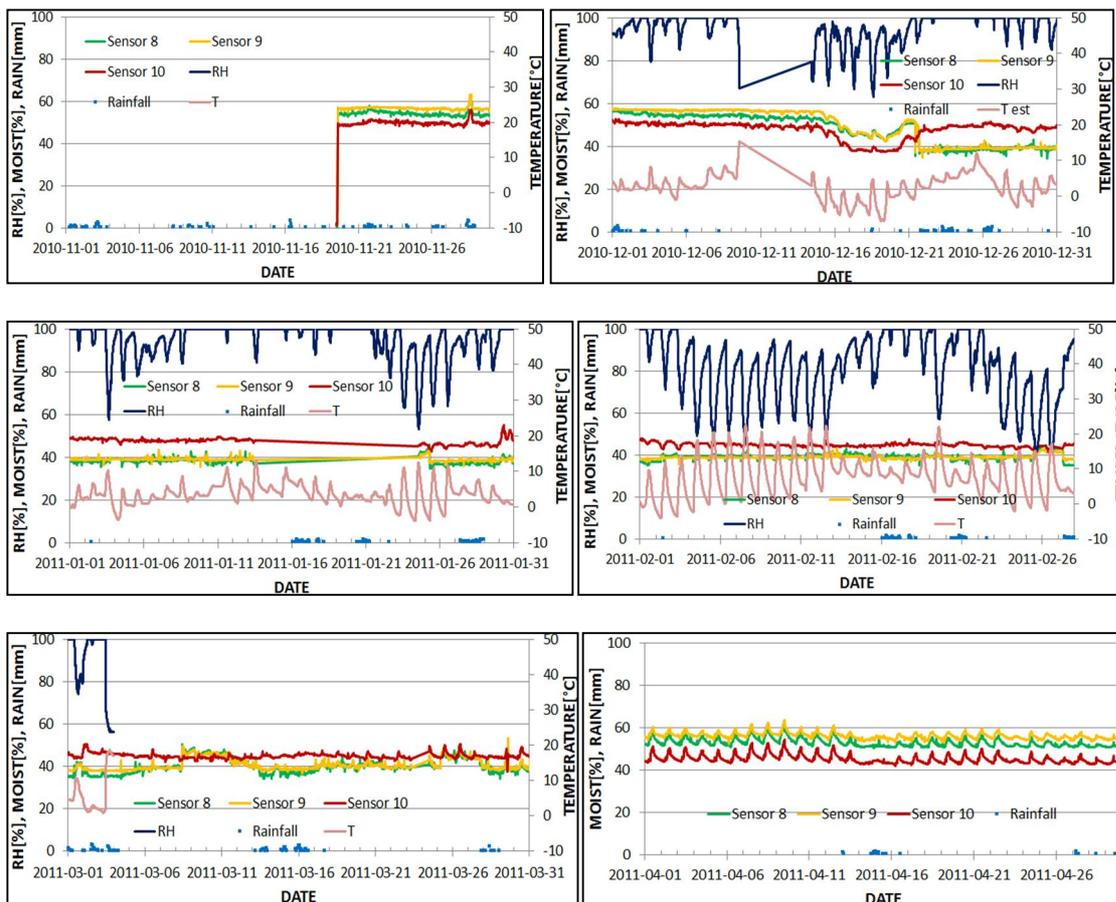
Figure 6.78: Wall PNDB, recorded values of air temperature, relative humidity and amount of rainfall together with values from 3 moisture sensors (November 2010 - April 2011)

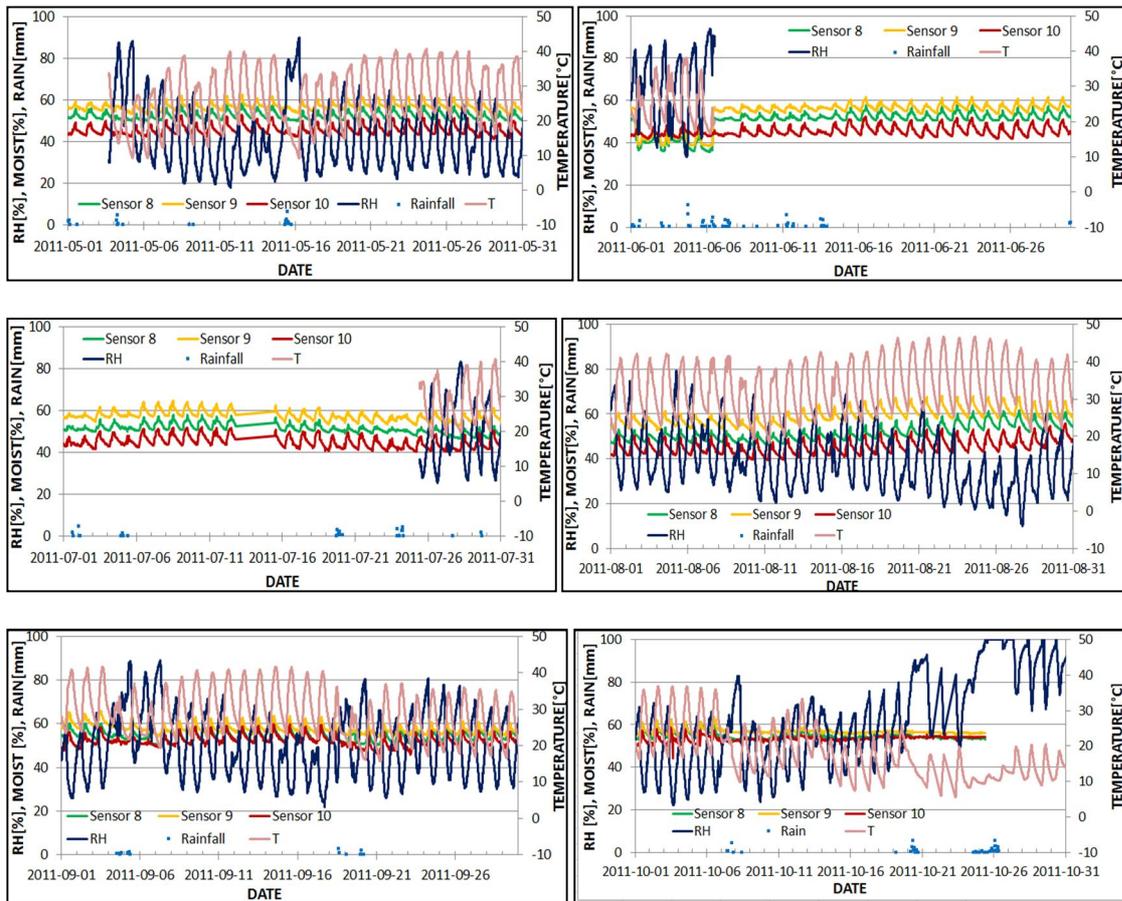
Figure 6.79: Wall PNDB, recorded values of air temperature, relative humidity and amount of rainfall together with values from 3 moisture sensors (May - October 2011)

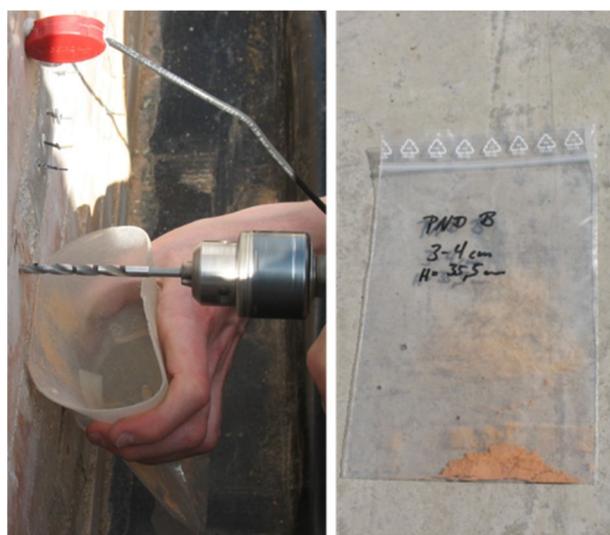
Figure 6.86: Salt analyses on mortar joints: Mortar dust sampled after 4 ageing summers (sept. 2013);

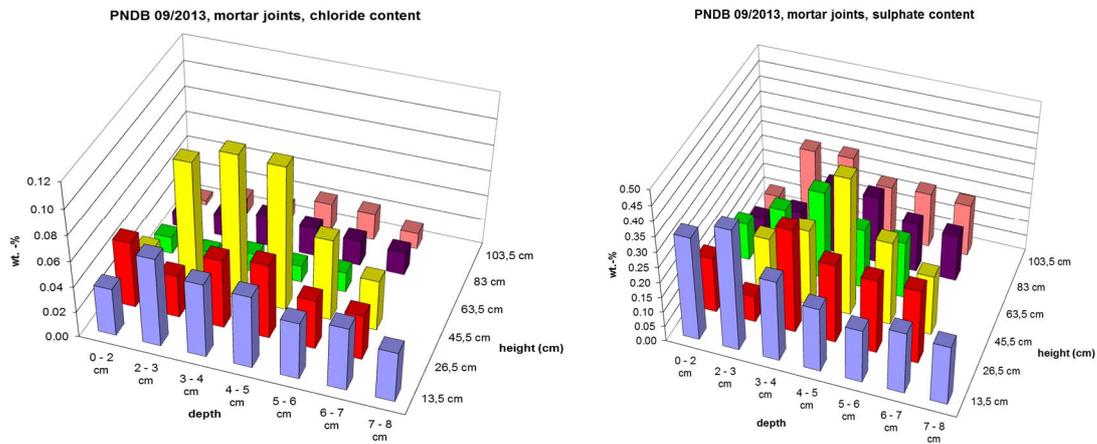
Figure 6.89: Full-scale wall PNDB, salt content on mortar joints at different heights from the wall base and different depth from the surface measured

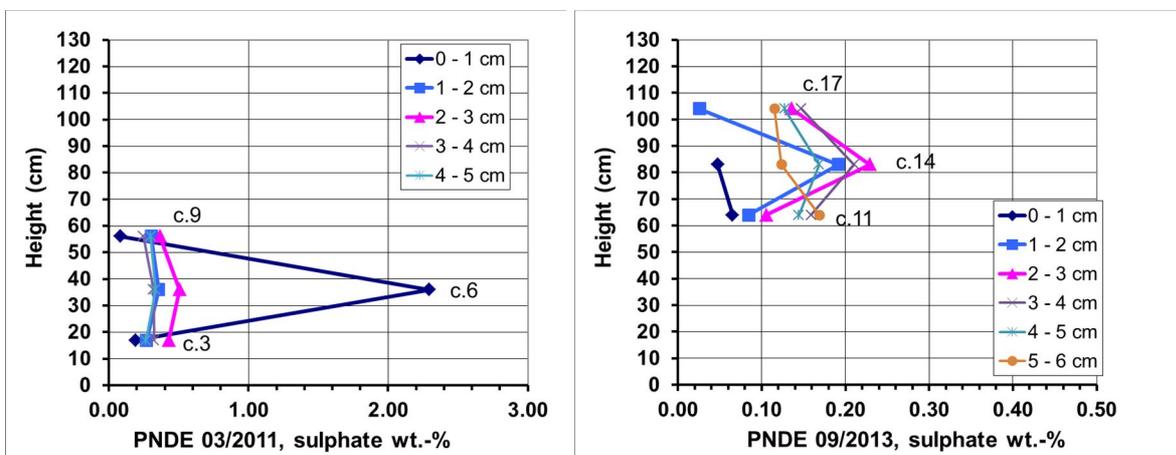
Figure 6.93: Comparison between sulphate content measured in March 2011 (after 1 ageing season) and in Sept. 2013 (after 4 ageing seasons)

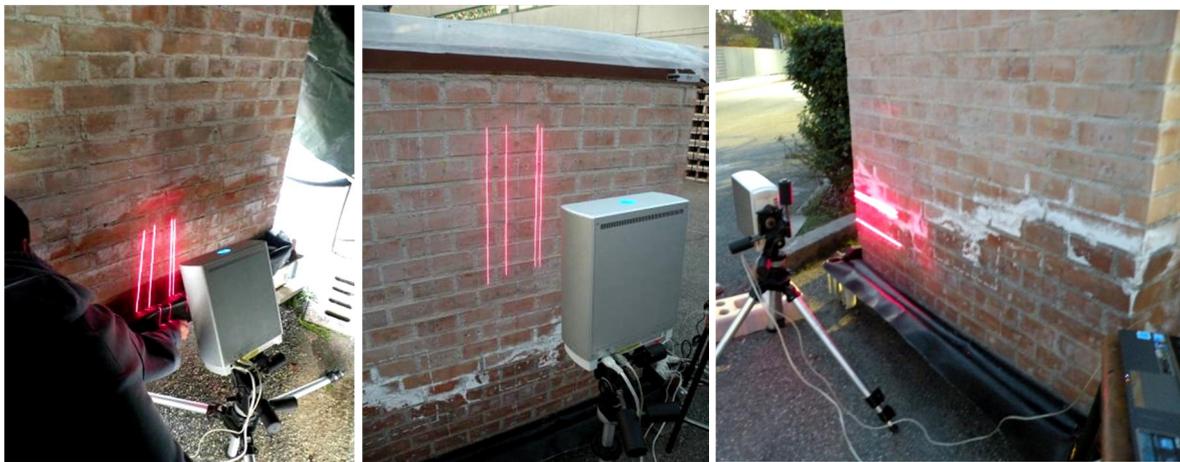
Figure 6.94: *example of Laser Scanner survey along: a) vertical alignments and b) horizontal alignment, Dark testing area below a plastic sheet*

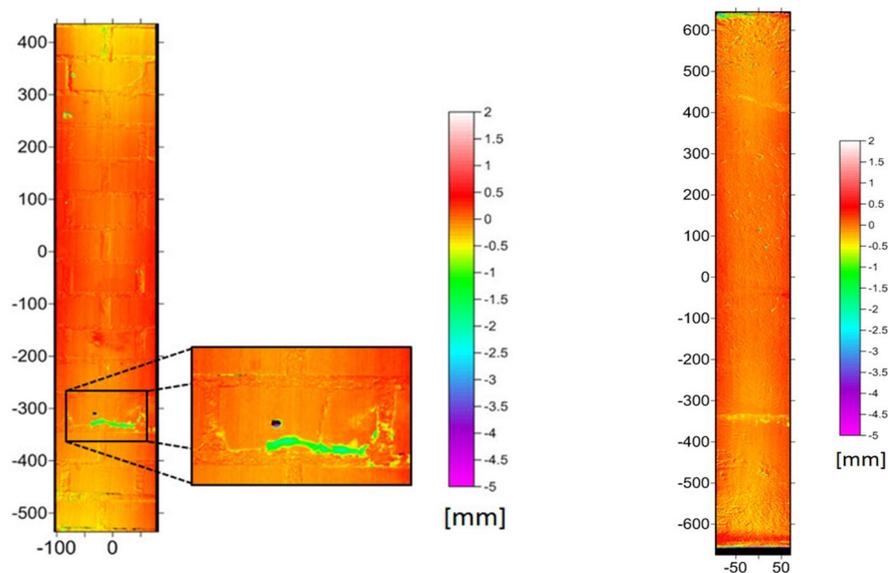
Figure 6.98: Difference displacement map (mm): 2011-2010: front side(left); rear side (right)

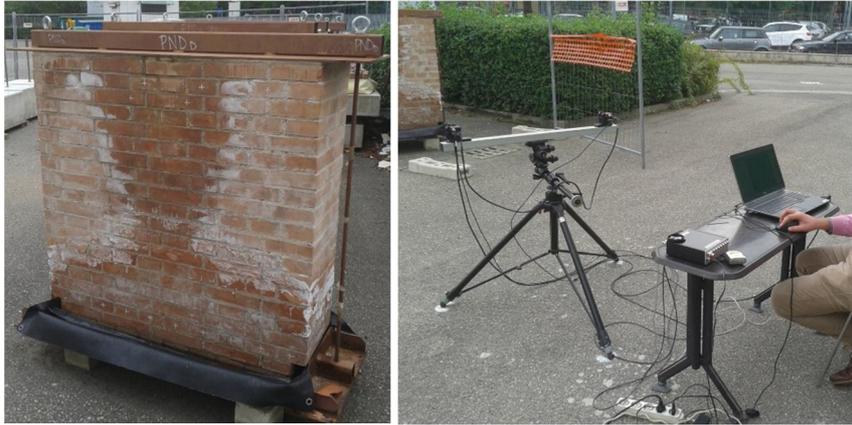
Figure 6.100: Wall PNDD, rear side, October 2013 and testing set-up

This proposed diagnostic methodology presents several innovative intrinsic aspects. Indeed, up to now, by the knowledge of the author, in the field of civil engineering, only indoors applications of the 3D DIC method have been studied, always to monitor specimens during the application of an external mechanical or thermal force which causes a stress-strain state in the investigated specimen' surface and without changing the relative positions between the DIC cameras and the investigated element. Moreover, the monitored surfaces were usually properly treated (i.e. by painting, coating, spray, etc.) prior to start the tests, in order to have at disposal a random pattern of dots, non-repetitive, isotropic and with high-contrast chromatic areas, which represents a pre-requisite of the DIC technique (5 -di LabExpFlood). Herein, however, it was chosen to use the same masonry texture with this purpose, after having tested its reliability during mechanical tests in smaller wall assemblies, as explained in the following chapters (§8 and 9 (8, 22)). The only precaution adopted was to mark some points in known positions with the aim of having at disposal "fixed" reference points to register the second period's images on the ones of the first period (white crosses in Figure 6.100 left).

The DIC cameras were positioned at a height from the ground of approx. 1 m and at about 4 m distance from rear side of wall PNDD with a relative distance between them of approx. 70 cm (Figure 6.100). After the adjustment of the exposure time, focus and aperture range of the lens of both cameras (§3.6.2), the calibration was carried out.

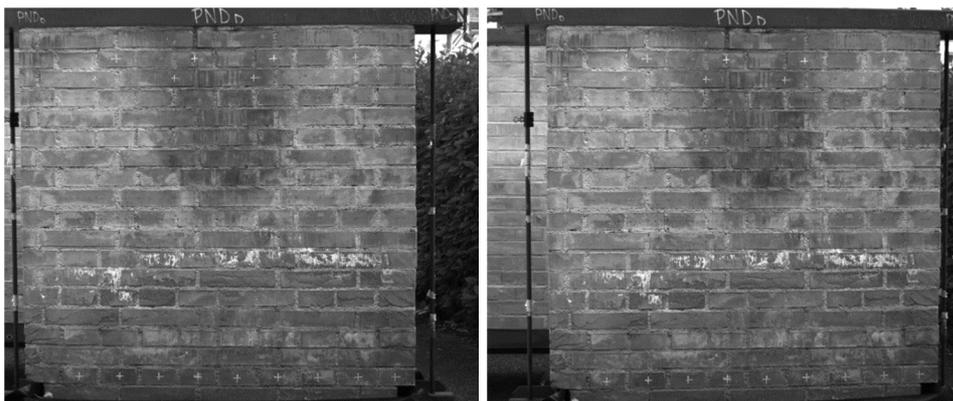
Figure 6.102: PNDD, rear side, July 2013, DIC images acquired at the same time instant by the left (a) and right (b) camera

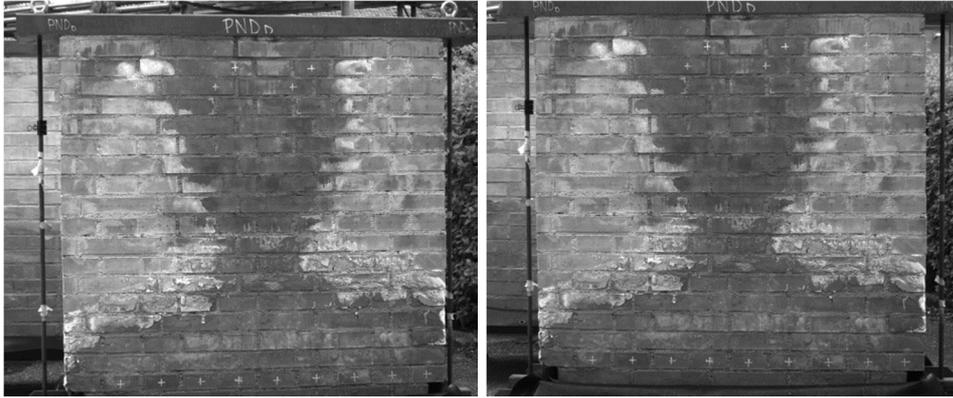
Figure 6.103: PNDD, rear side, end of October 2013, DIC images acquired at the same time instant by means of the left (a) and right (b) camera

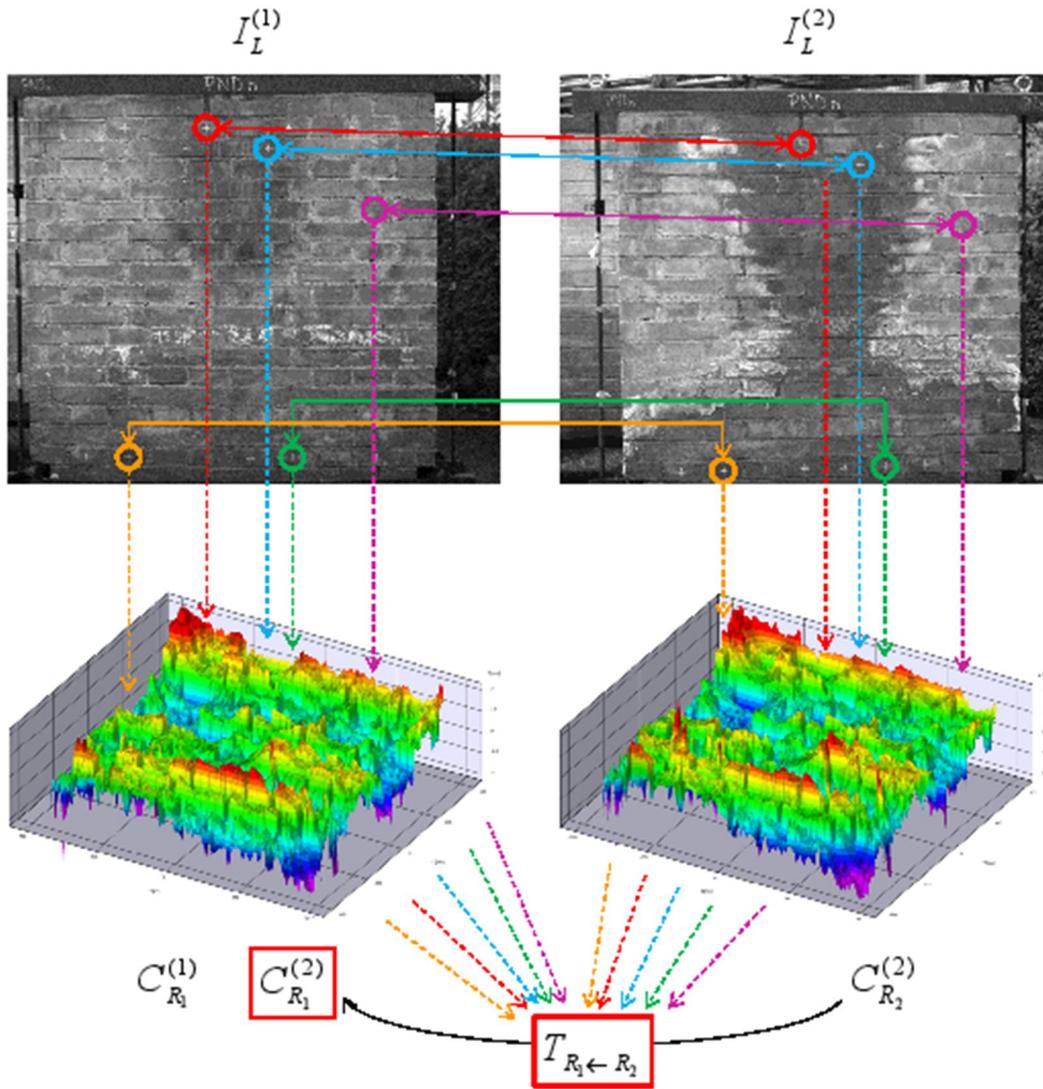
Figure 6.107: Registration procedure of the DIC images acquired in two different periods

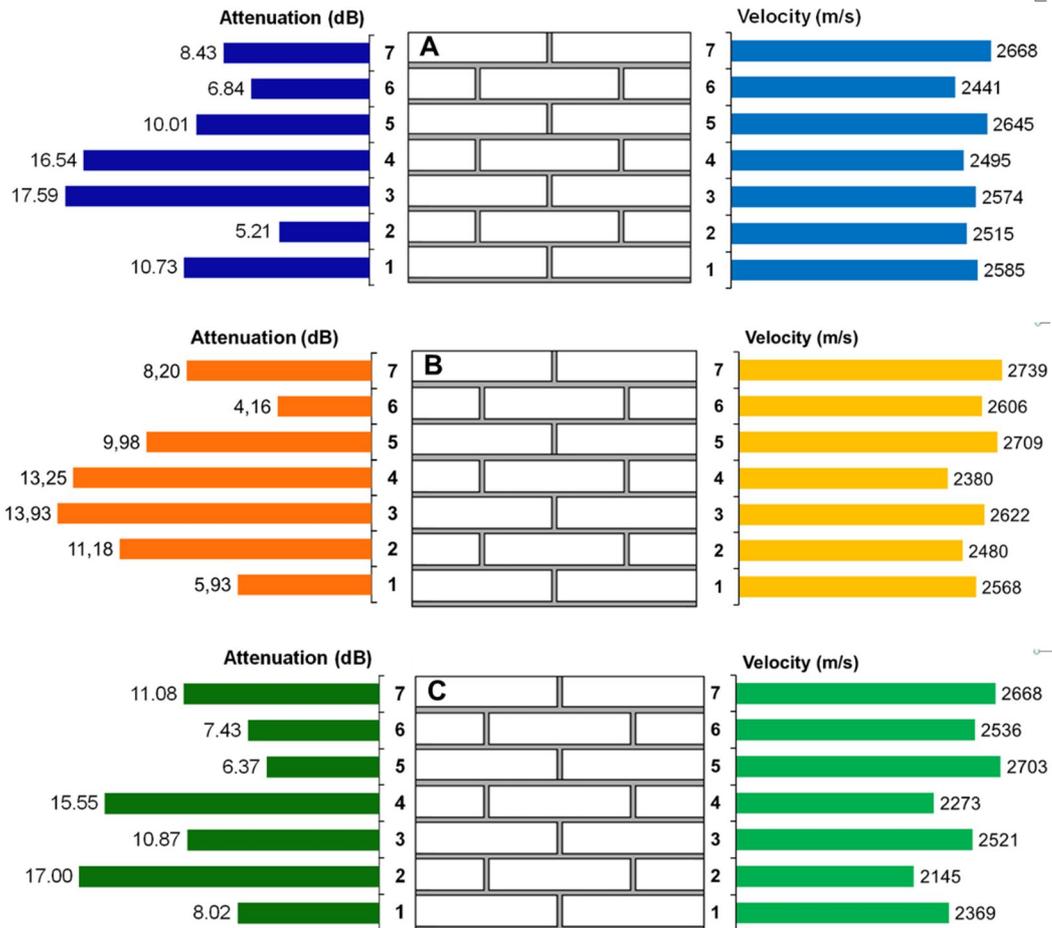
Figure 7.2: Small walls, as-built: values of sonic signal attenuation (left) and direct velocity (right) on each masonry course

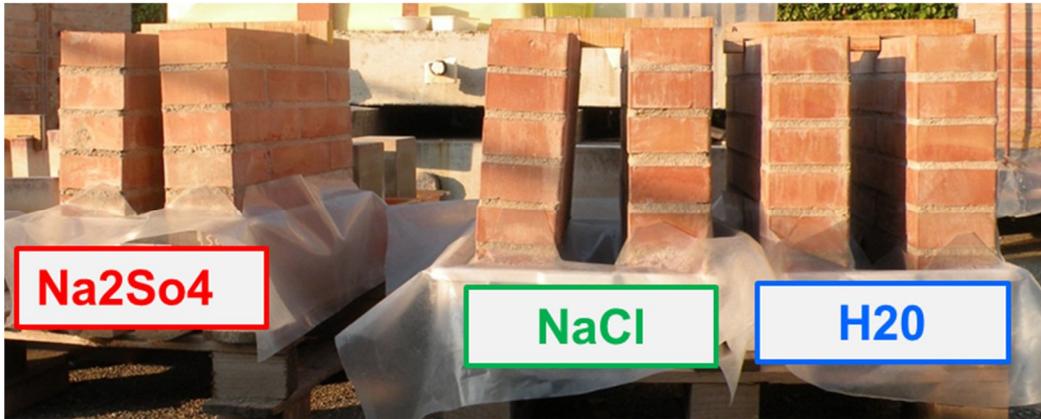
Figure 7.4: Arrangement of the small walls naturally aged

The tests were performed after 1 season of ageing in order to evaluate the effects of this initial environmental degradation. It is worth to remind that, in addition to outdoors exposure, these small walls were subjected to capillary rise from the base using water (VII and VIII), sodium

chloride solution (IX and X) or 0.05% -wt. sodium sulphate solution (XI and XII) (Figure 7.4).

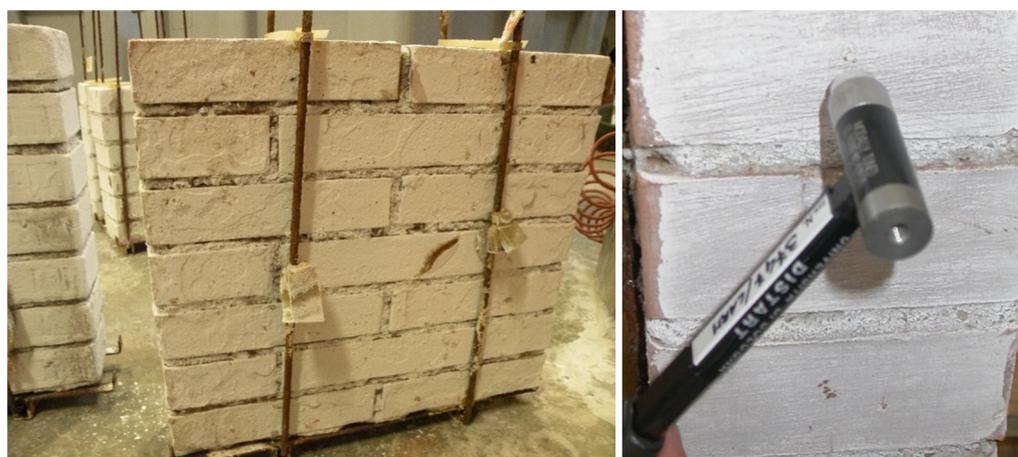
Figure 7.11: Small wall II at the end of artificial ageing treatment (38 cycles) (left) and detail of data acquisition (right)

The same procedure described before was used to perform sonic tests in direct transmission mode on the three small walls at the end of the artificial ageing treatments. In these cases, a rough cleaning of the surfaces before starting the tests was necessary as the surfaces were completely covered by salts (Figure 7.11).

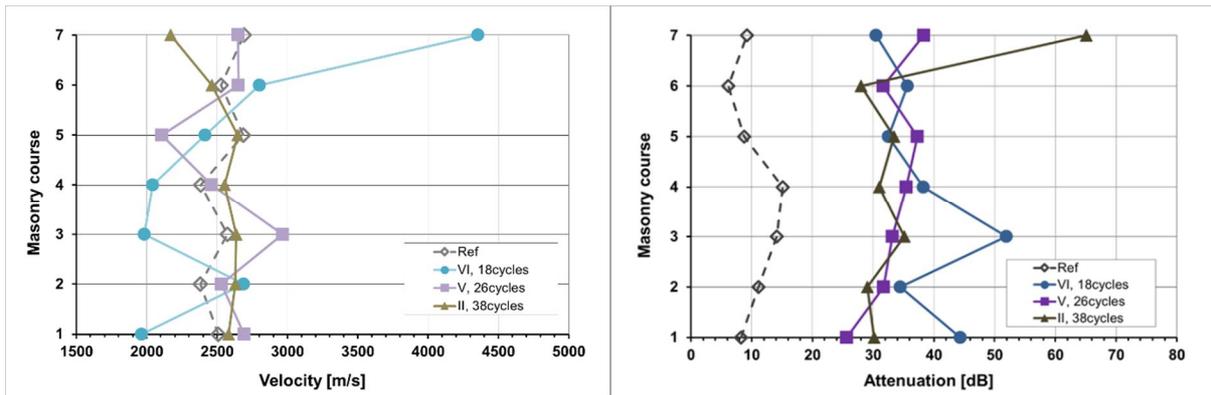
Figure 7.15: Average values of direct sonic velocity (left) and attenuation (right) measured for the three artificially aged small walls. In grey, the reference profiles.

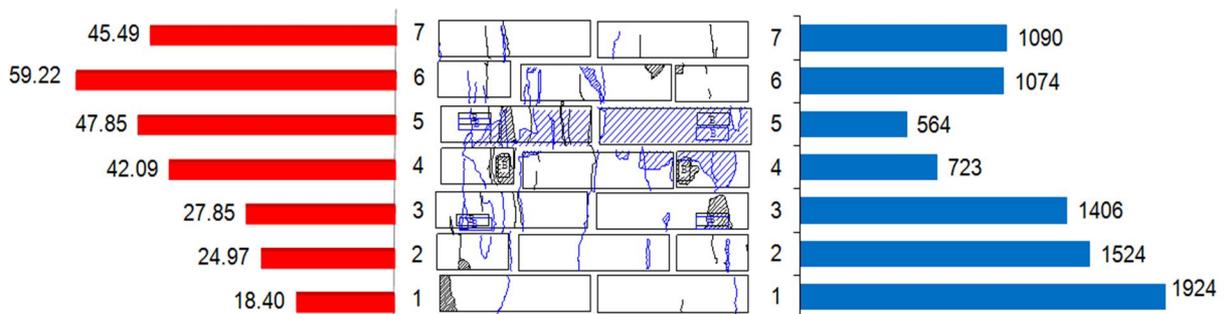
Figure 7.16: Small wall I, after mechanical compression test: values of sonic signal attenuation (left) and direct velocity (right) on each masonry course

For all the walls, the values of velocity and attenuation presented almost an opposite trend, by they gave complementary information. Indeed, while the lowest values of velocity are measured in correspondence of the greater cracks, greater attenuation were measured in presence of diffused cracks and exfoliations. Thus, a better knowledge on the health-state of masonry can be achieved by evaluating both parameters.

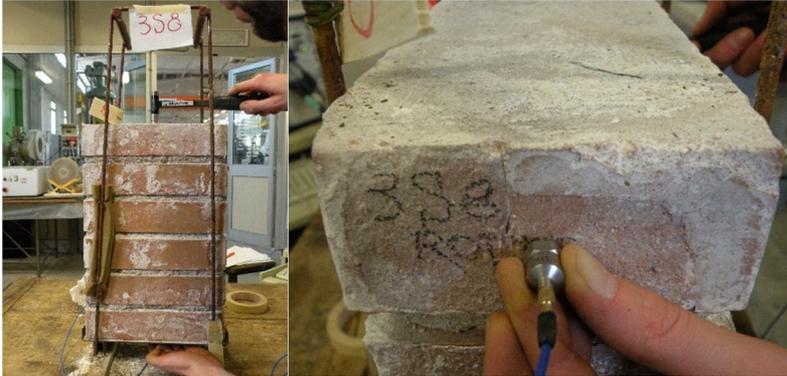
Figure 7.24: Data acquisition

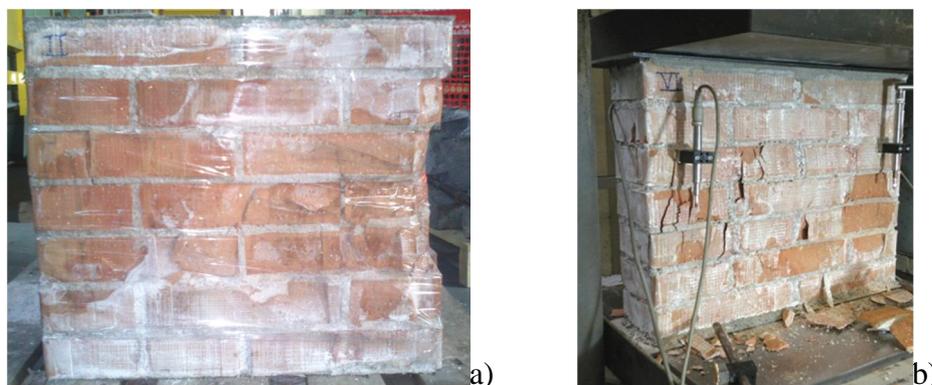
Figure 8.4: Visual observation and crack pattern survey of masonry wallet II (a) and VI (b)

During each compression test, a visual monitoring was also performed, paying serious attention to the subsequent opening of cracks, writing down the load level at which they occurred as well as their position and extension. At the end of the mechanical test, a visual observation was repeated to reproduce in drawings the resulting crack pattern to be used, for example, as comparison with the maps acquired via DIC (Figure 8.4).

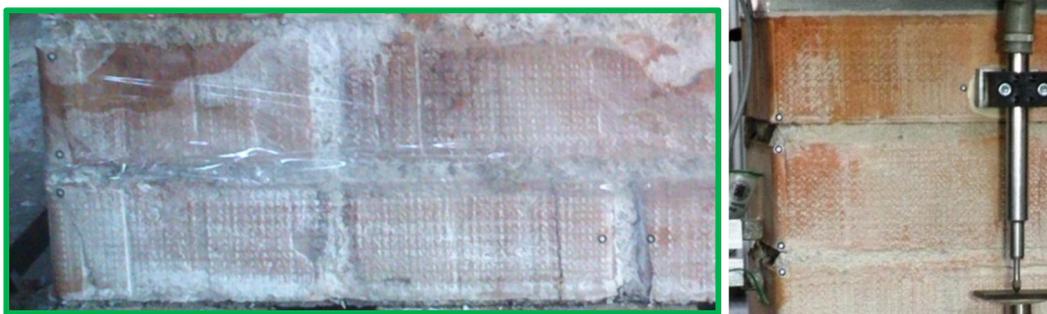
Figure 8.8: Position of the glued additional markers in two different wallets

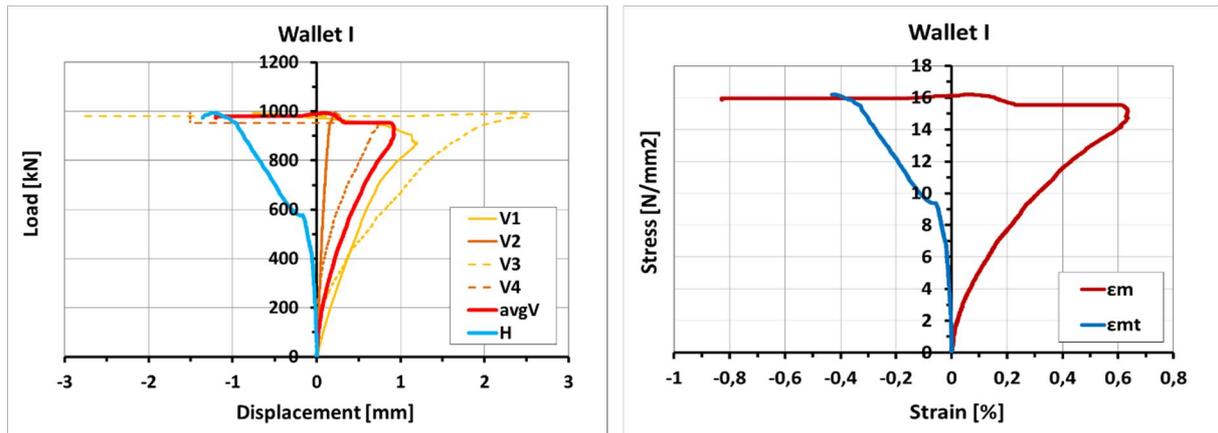
Figure 8.10: Wallet I, load-displacement and stress-strain graphs

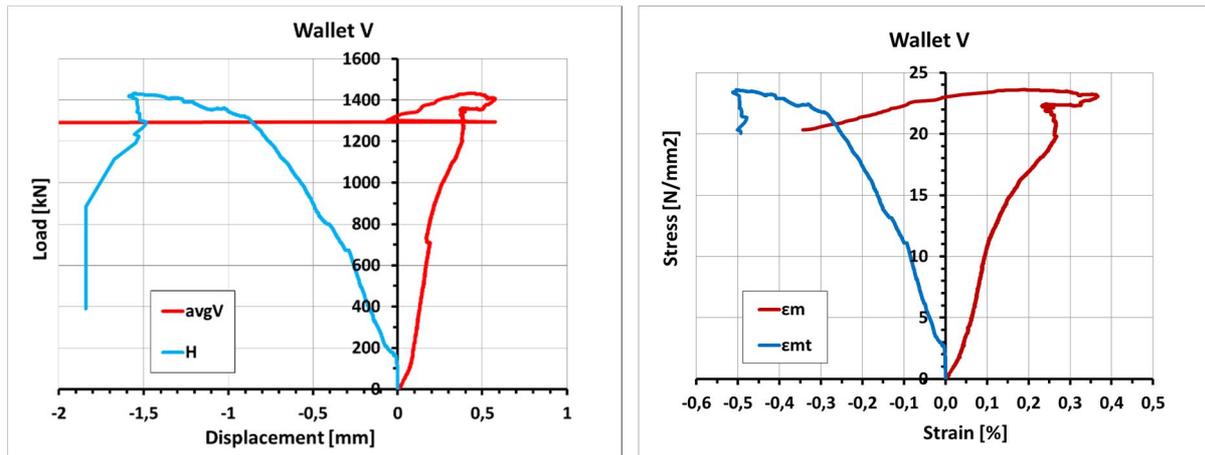
Figure 8.25: Wallet V, load-displacement and stress-strain graphs

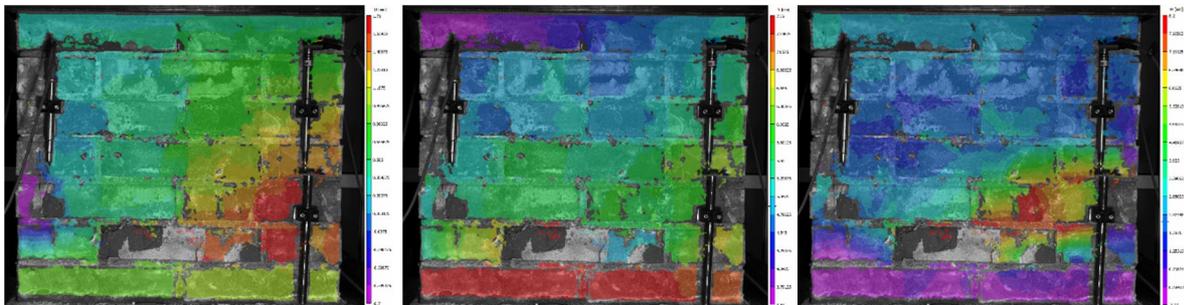
Figure 8.26: Wallet V, horizontal (left), vertical (centre) and out-of-plane displacements (right) at the peak load (1433 kN)

First of all, 3D maps of the displacements along the three main directions are visualized at the maximum load (Figure 8.26). These maps, that in this case are also more important as at this time instant two of the 4 vertical LVDTs were already fallen down, show localized points with high values of horizontal displacements (about 2mm) as well as of vertical displacements (approx. 6 mm).

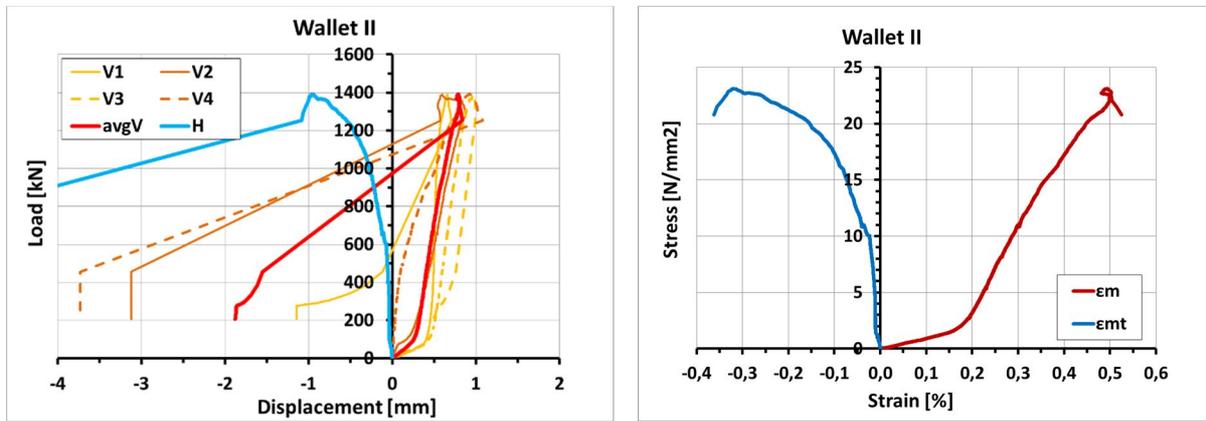
Figure 8.32: Wallet II, load-displacement and stress-strain graphs

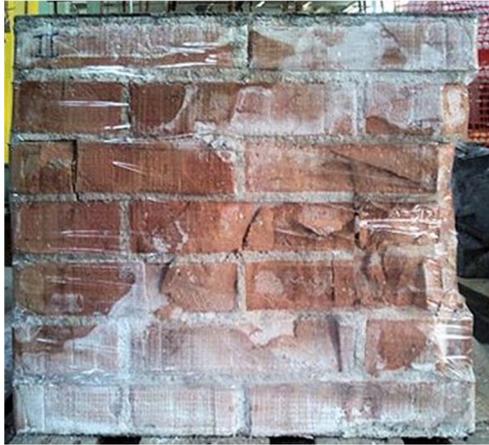
Figure 8.33: Wallet II: exfoliations and cracks visible at ...kN (left); crack pattern at the end of the mechanical test (right)

In the first part of the compression, until the 1st load pause, numerous audible assessment noises were detected; these slight movements were visible also in the load-displacement function as a parabolic branch. This portion of the curve was then followed, both for the horizontal and vertical displacements, by a linear branch until approx. 600 kN. At that point, the first visible crack occurred. It was a vertical crack, located in the middle section of the central brick of the 6^o masonry course. Actually, some exfoliations and delamination of the brick surfaces had already happened at lower levels of load, but they are much localized and they do not affect the global masonry behaviour nor the recorded data (Figure 8.33).

A second important crack appeared at about 1200 kN which corresponded to a change in the slope of the transversal displacements. After reaching the maximum load, we tried to record the descending branch but, again, it was not possible due to the fragile and explosive collapse of the wallet itself (Figure 8.33).

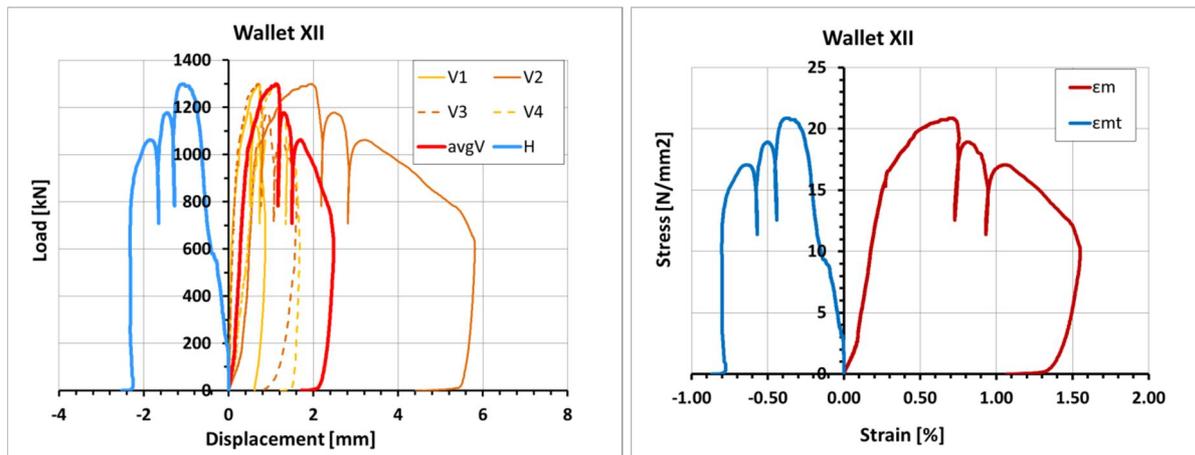
Figure 8.40: Wallet XII, load-displacement and stress-strain graphs

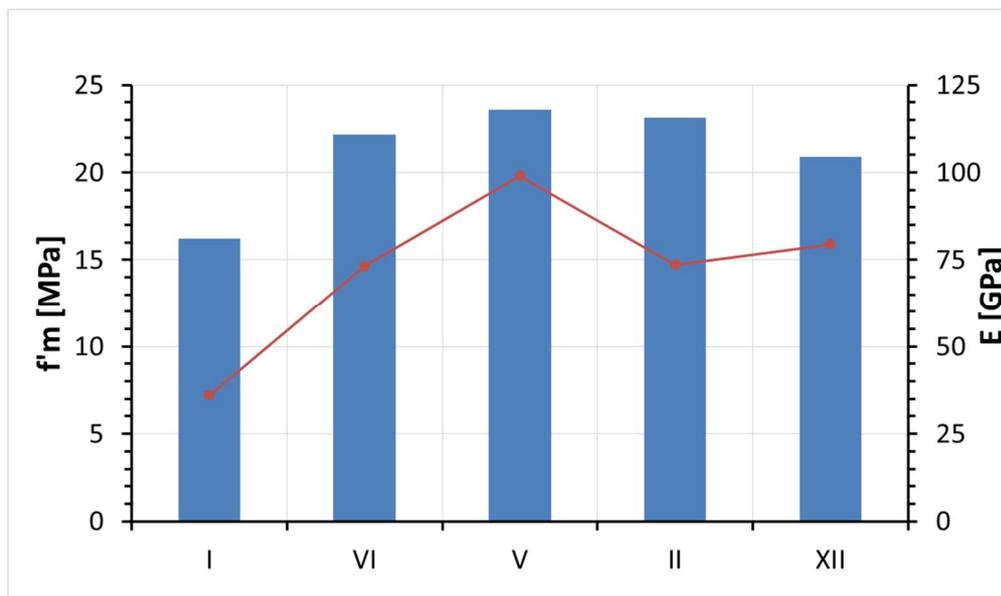
Figure 8.46: Compressive strength and modulus of elasticity for the 5 wallets

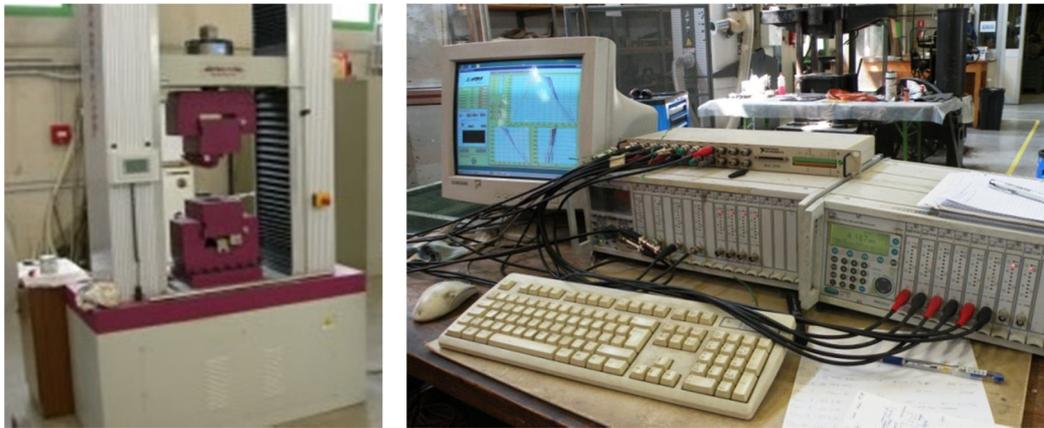
Figure 8: Load testing machine (left) and control unit (right)

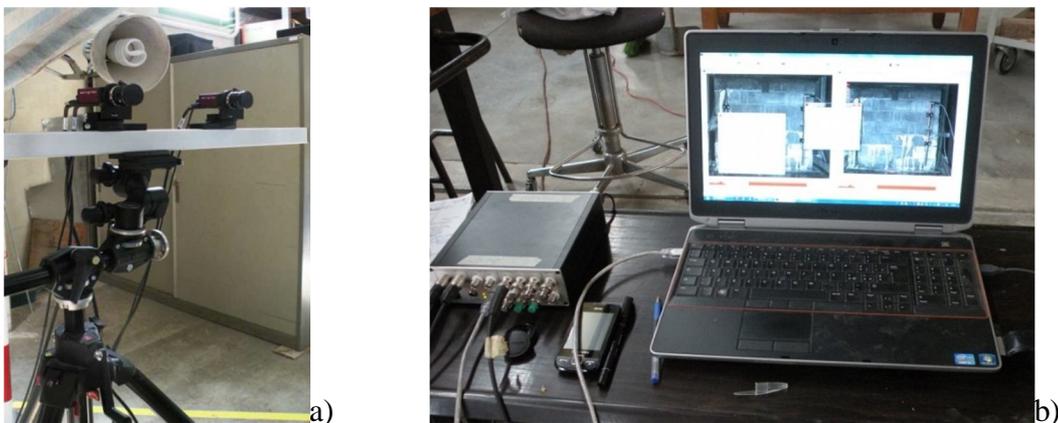
Figure 11: DIC testing equipment: a) digital cameras, b) laptop and data acquisition unit

Prior to start each mechanical test, the DIC equipment was prepared by choosing the better and fixed position of the cameras, adjusting the focus and the brightness, also installing a lamp to uniformly illuminated the investigated surface with white light and, if necessary, positioning a black panel behind the specimen to avoid sudden variations of light in the background of the images or recording the passage of laboratory staff as these conditions may worsened the quality of the acquired images. Then, the cameras were calibrated and finally three channels of the mechanical control unit (load and the two central LVDTs) were connected to DIC data acquisition unit, in order to link the two types of data recorded (§8.4.2).

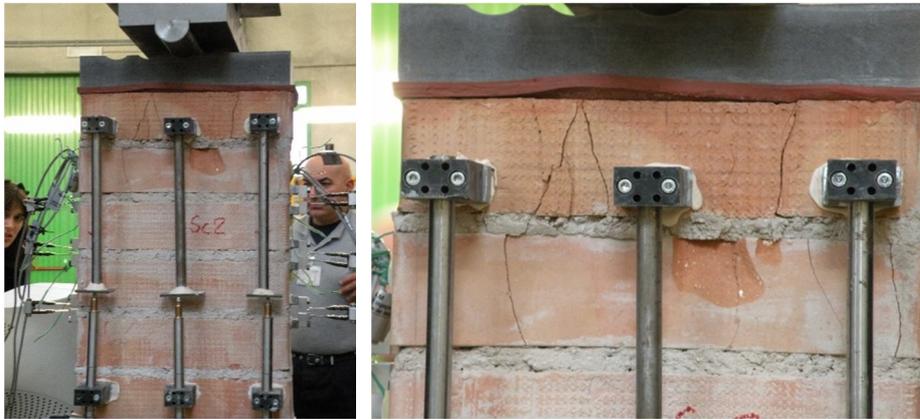
Figure 15: Six-brick column OS1, visible cracks on the rear side (left) and detail of the cracks on the fifth and sixth brick (right)

Visibly, no cracks appeared until approx. 400 kN. The first vertical cracks appeared in the rear side of the specimen, in the fifth brick from the bottom. Subsequent cracks, more evident, were detected on the sixth brick, again in the rear side and on the first brick of the front side (Figure 15). These denoted a certain rotational component, from the rear to the front side that intervenes during the test, probably caused by a no-proper load spreading i.e. due to the too deformable neoprene sheet positioned between the extreme brick's faces and the steel plates for the load distribution.

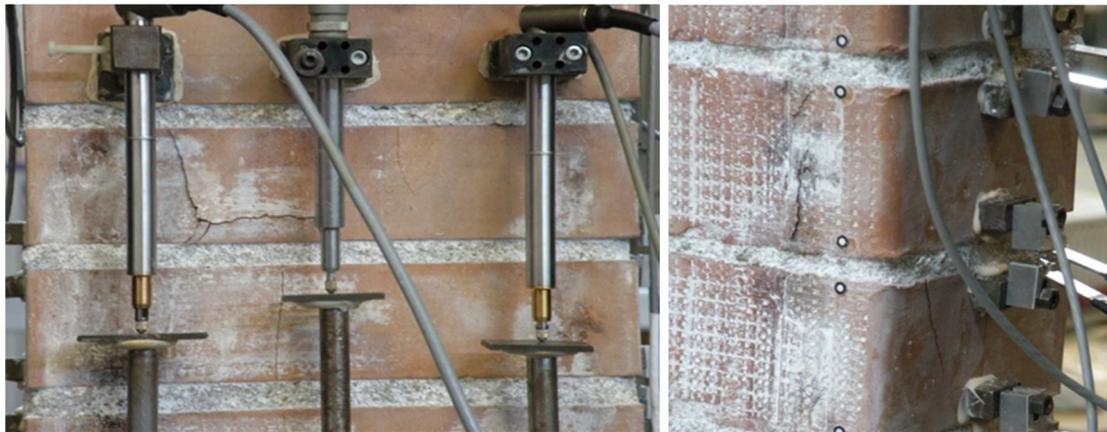
Figure 22: Six-brick column 4S1: details of the crack pattern appeared on the front (left) and rear side (right)

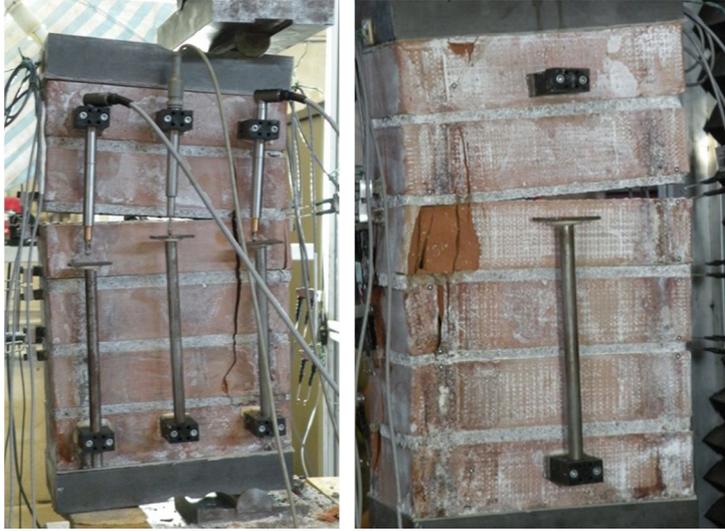
Figure 43: Six-brick column 4S3 ($e=80$ mm) at the end of the compression test: front (left) and rear side (right). Vertical cracks below the load application point are very evident as well as the mortar joints opening (with detachment from the brick faces) on the opposite side

The collapse type of this six-brick column appeared also visually evident. In the first two load cycles no cracks appeared while, at about 150 kN, vertical cracks below the load application point were visible both on the front and rear side of the specimen. These cracks were accompanied by the progressive opening of the mortar joints far away from the load application point, which caused, at the end of the test, the detachment of the mortar/brick interfaces in correspondence of the 4th mortar joint (Figure 43).
