Alma Mater Studiorum – Università di Bologna

DOTTORATO DI RICERCA IN
INGEGNERIA DEI MATERIALI

EXPERIMENTAL ASSESSMENT OF ENVIRONMENTAL DECAY EFFECTS
IN MASONRY
VIA NON DESTRUCTIVE DIAGNOSTIC TECHNIQUES
AND
MECHANICAL TESTS

Esame finale anno __2014__

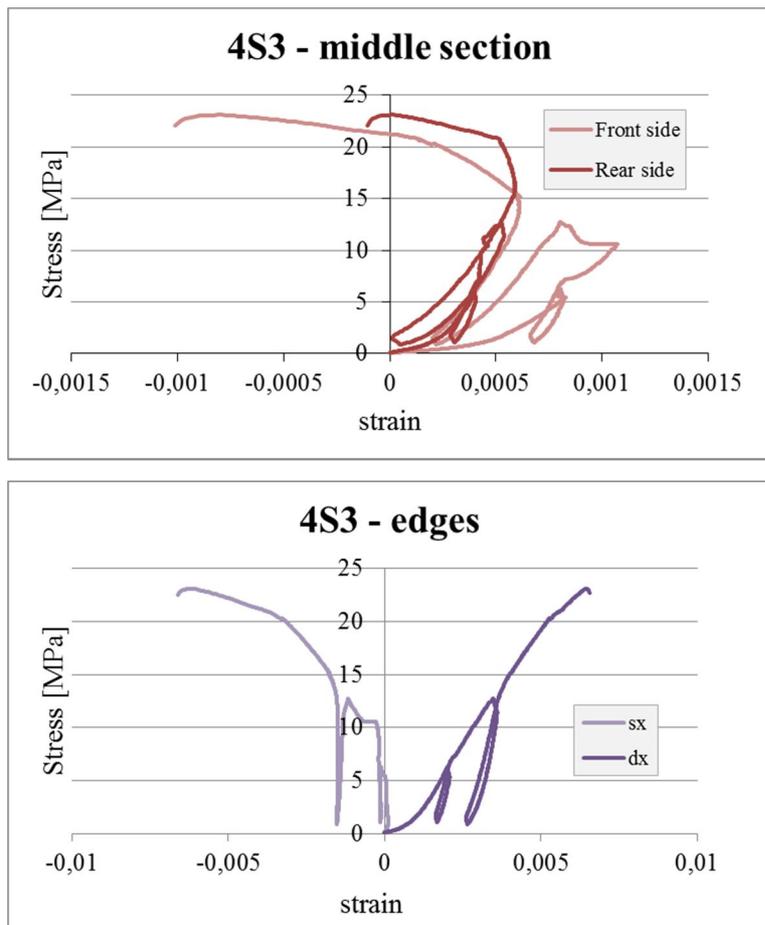
Figure 44: Six-brick column 4S3, resulting stress-strain graphs

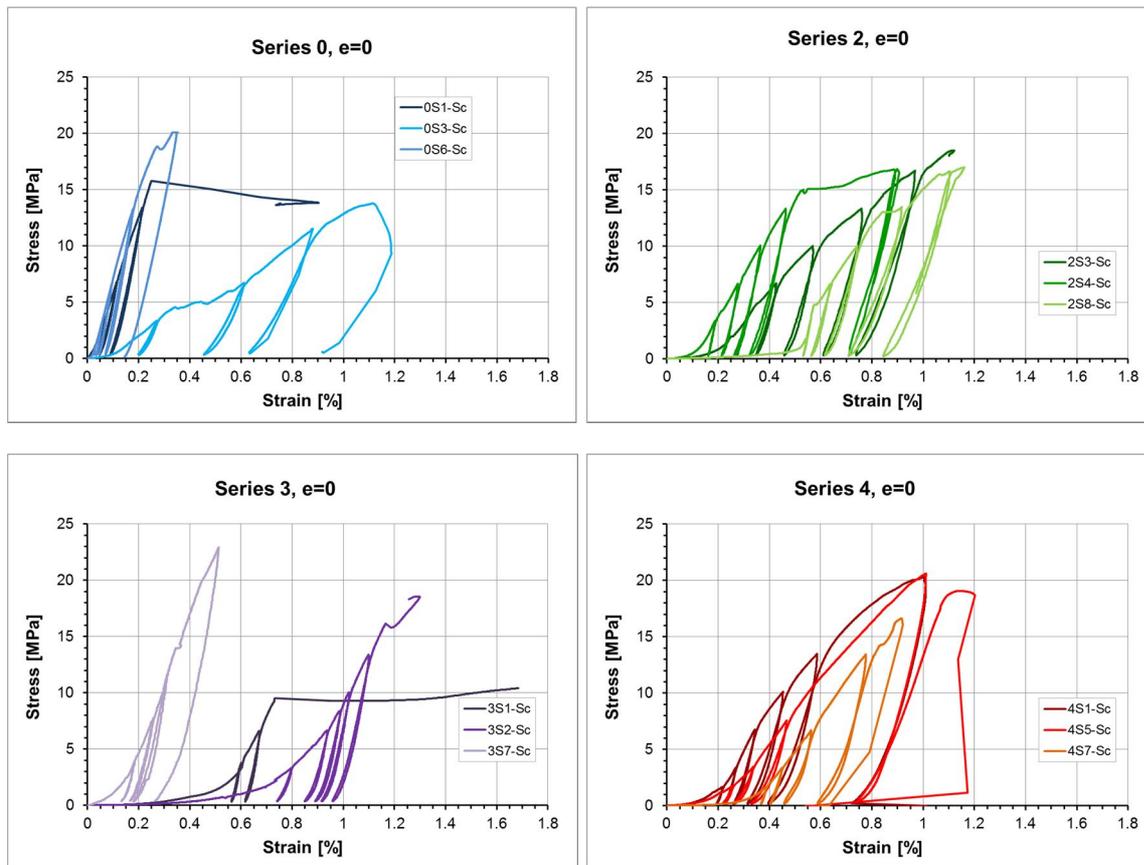
Figure 51: Stress-strain graphs obtained from the concentric load tests for the four series of six-brick columns

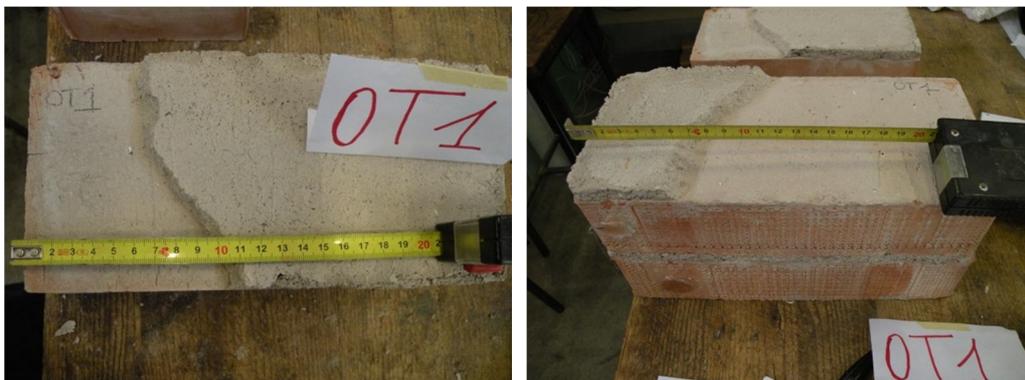
Figure 64: Triplet OS1, type of rupture: view of both faces

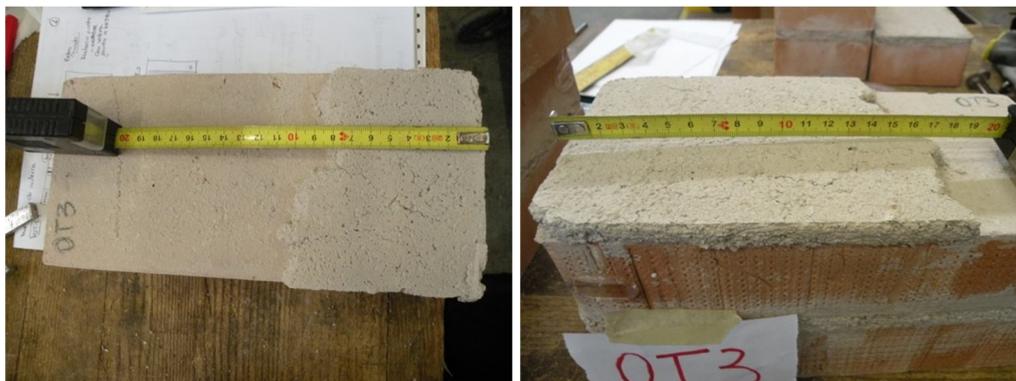
Figure 67: Triplet OT3, type of rupture

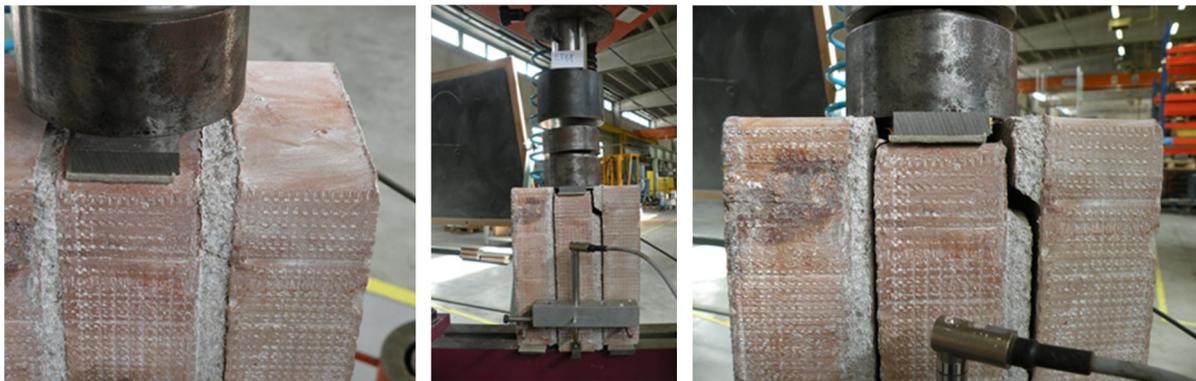
Figure 69: Triplet 2T11, first crack (left), general view of the rupture (centre) and detail of the cracks (right)

The rupture of triplets 2T10 and 2T11b (Figure 68, Figure 70) occurred in the same way, with the complete, smooth detachment of one mortar joint from the corresponding brick surface. Instead the collapse of specimen 2T11 occurred with the delamination of both mortar joints; also in this case, the surfaces of the brick remained completely clean with the exception of a little edge (Figure 69).

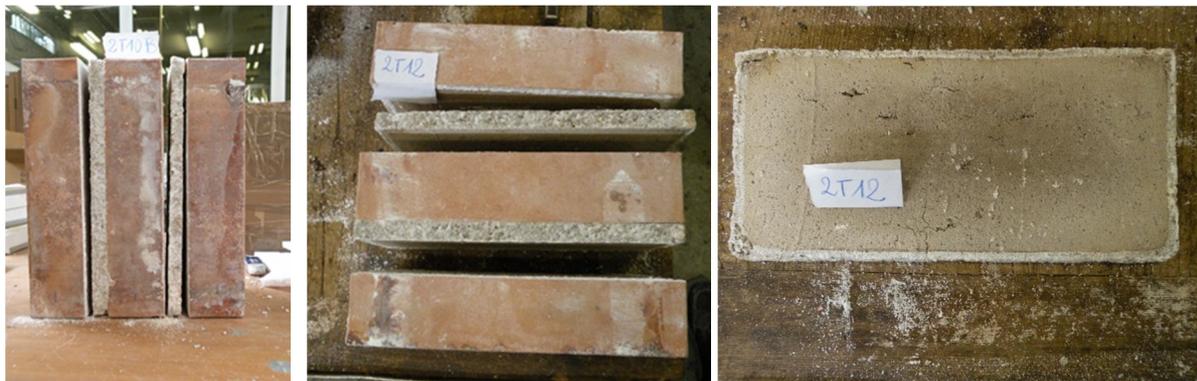
Figure 71: Triplet 2T10b and 2T12, at the end of the ageing cycles

As the rupture of the triplets 2T10, 2T12 and 2T12b occurred during their preparation, some photos of their actual state were taken. In all the 3 cases, both lime joints resulted completely detached from the corresponding brick and the surfaces of the two construction materials were clean as if they weren't attached at all. This was probably due to a scarce initial adherence worsened by the presence of salt crystals at the interfaces (**Figure 71, Figure 72**).

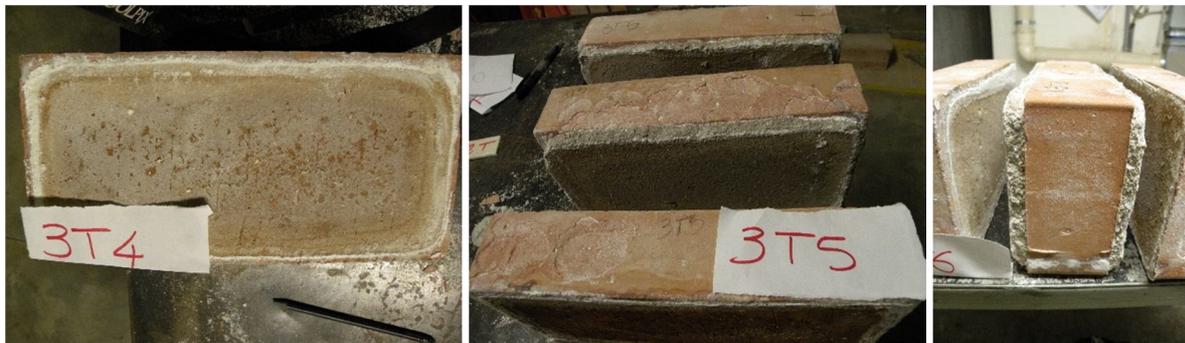
Figure 73: State of triplets 3T4, 3T5 and 3T6: one or both mortar joints were completely detached. The brick surfaces appeared clean and smooth with the exception of a thin layer of salt crystals near the external border.

At the end of the accelerated ageing treatment, 4 of the 6 triplets belonging to series 3, were still apparently intact. Thus, it was decided to prepare them for the mechanical shear test. Unfortunately, the three triplets (3T1, 3T4 and 3T5), broken during their rotation prior to be positioned under the testing machine from the horizontal configuration (direction parallel to the mortar joints) to the vertical one. From the photos taken, it appeared evident that the detachments of both lime joints from the brick surface was caused by the presence of salt depositions (Figure 73).

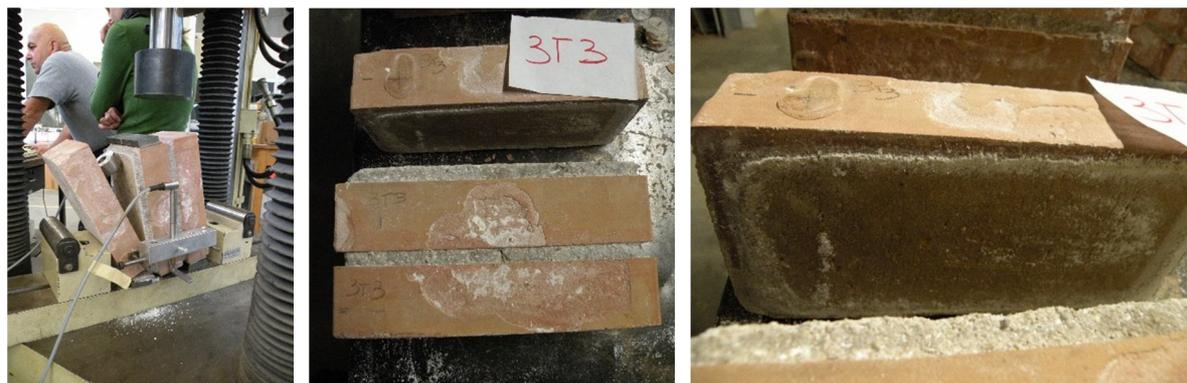
Figure 74: Triplet 3T3, at the end of the mechanical test. Under the load plates (left) and details of the rupture (centre and right)

Therefore, only one specimen, 3T3, was really tested. Anyhow, in this case, the collapse occurred at a very low load level (120 N) which results in an almost null shear strength (Table 27). The rupture occurred at one mortar/brick interface, type a, as in the previous cases, but the brick surface appeared somehow “dirt”, with a slight layer of salts, more accentuated near the external borders (Figure 74).
