**Alma Mater Studiorum – Università di Bologna**

**DOTTORATO DI RICERCA IN  
INGEGNERIA CIVILE, AMBIENTALE E DEI MATERIALI**

**SEISMIC VULNERABILITY ASSESSMENT AND FRAGILITY  
ANALYSIS OF INDUSTRIAL RC PRECAST STRUCTURES**

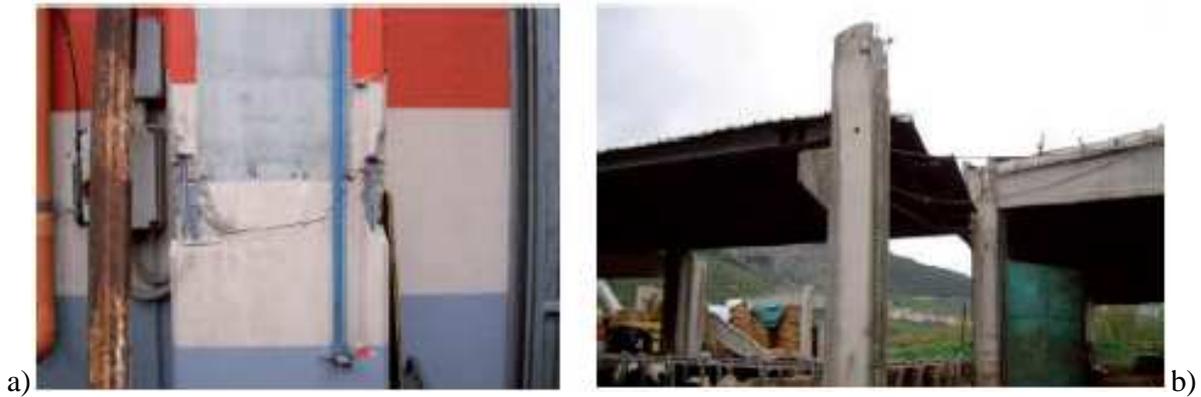
Figure 1. Damages from l'Aquila earthquakes (2009): a) Plastic hinge formation in the column, b) un-seating of the beam

Faggiano et al. [2009] [18] illustrate how structural elements of industrial precast buildings responded to the L'Aquila earthquake in compliance with the provisions of the code they were designed with: none of the columns failed, in some cases plastic hinges developed due to the intensity of the seismic action (Figure 1 a). Many buildings presented damage to the beam column joint, but just in one case the beam fell down for loss of support (Figure 1 b). In this case the resistance of the connection did not rely only on friction, as we could often observe in Emilia, but failure instead occurred due to spoiling of the concrete covering the steel reinforcement in the joint (Cassotto C., Ph.D Thesis [2015]). The same mechanism affected the roof-beam connection (Figure 2 a). The most severe and common damage was related to the curtain wall system, especially masonry walls, but also the anchoring systems of the precast panels proved to be inefficient (Figure 2b).

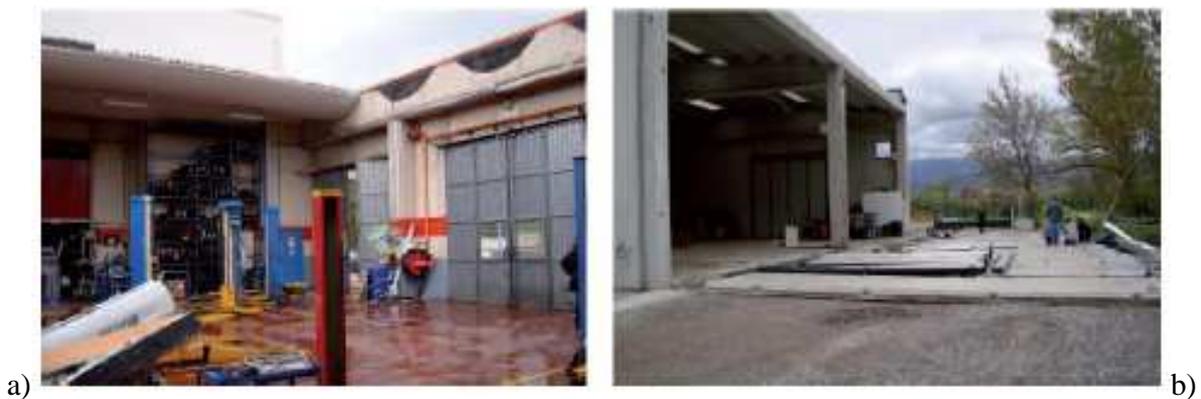
Figure 2. Damages from l'Aquila earthquakes (2009): collapse of the roof element, failure of curtain wall

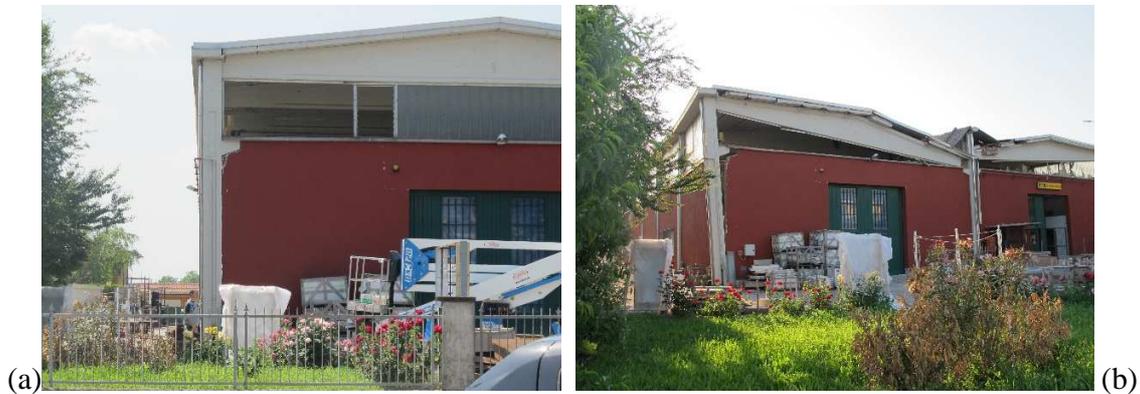
Figure 10. Industrial building in San Giacomo Roncole (Mirandola, MO): (a) the building after May 20<sup>th</sup> earthquake, and (b) after May 29<sup>th</sup> earthquake

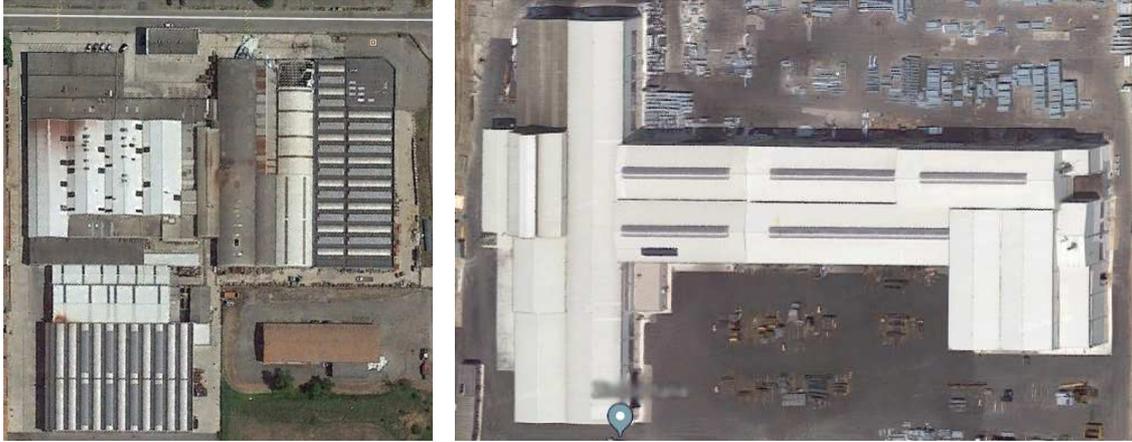
Figure 14. Example of two built-up area located in San Felice sul Panaro (Mo)

The industrial clusters, in the Emilia region, are sometimes characterized by building with irregular plan shape, example L shape or, very often, by buildings grew in phases during the years, as the sum of different buildings strictly connected without any seismic joint (Figure 14). Often this build up area is made of buildings with different structural typologies. In these complex situations, the database allows the subdivision of the built-up area in different “zone” to take into account all the building details. In these cases, it would have been wrong to consider the build-up area simply as the sum of different buildings, since, in that way, it would not have been taken into account the structural interaction between them; interaction that can completely change the seismic answer.

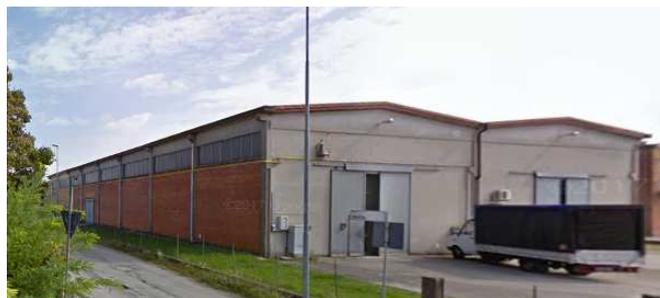
Figure 24. Type 1 Building with double slope precast beams simply-supported at the top of the columns and masonry cladding panels.

The roof can be made of precast elements with hollow-clay-blocks or, in recent construction, TT or hollow-core concrete elements. Columns are usually quite slender, with square cross-sections with 30-40 cm side. No beam-column connection devices are present. The beam height can be up to 2 m in the centre, and typically have either no or little restraints against out-of-plane movements, with the exception of the presence of an upper pocket support on the top of the columns. These buildings have normally a single storey, eventually with an intermediate floor in a limited portion of the building on one side, where offices are located. Often, the presence of that intermediate floor on one side of the building caused an irregularity in the structural behaviour of the building, with negative effects during ground-motions. It's worth noticing that often there are no beam to link the main frame in transverse direction.

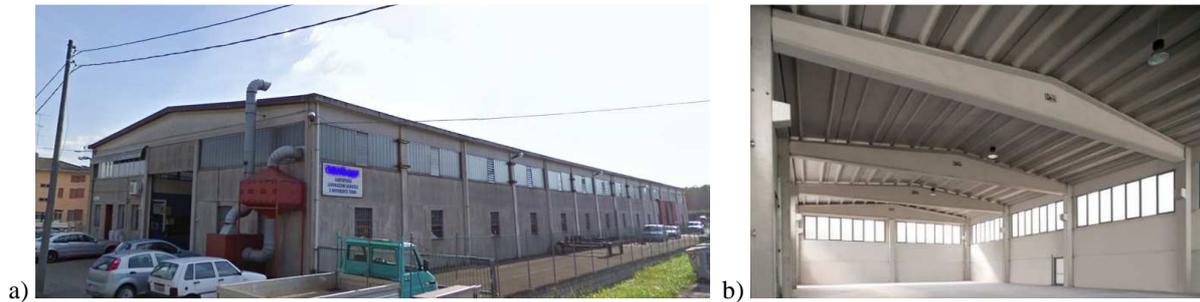
Figure 25. a) Buildings type 0 with double slope precast beams simply-supported at the top of the columns and horizontal precast cladding panels placed between the columns, b) a typical roof of building types 0 characterized by TT elements.

Type 0 - Buildings with double slope precast beams simply-supported at the top of the columns with horizontal precast cladding panels placed between the columns (Figure 25). A typical technology adopted in the 70's and in the 80's. From the structural point of view, this typology is very similar to the previous except for the presence of precast cladding panels.

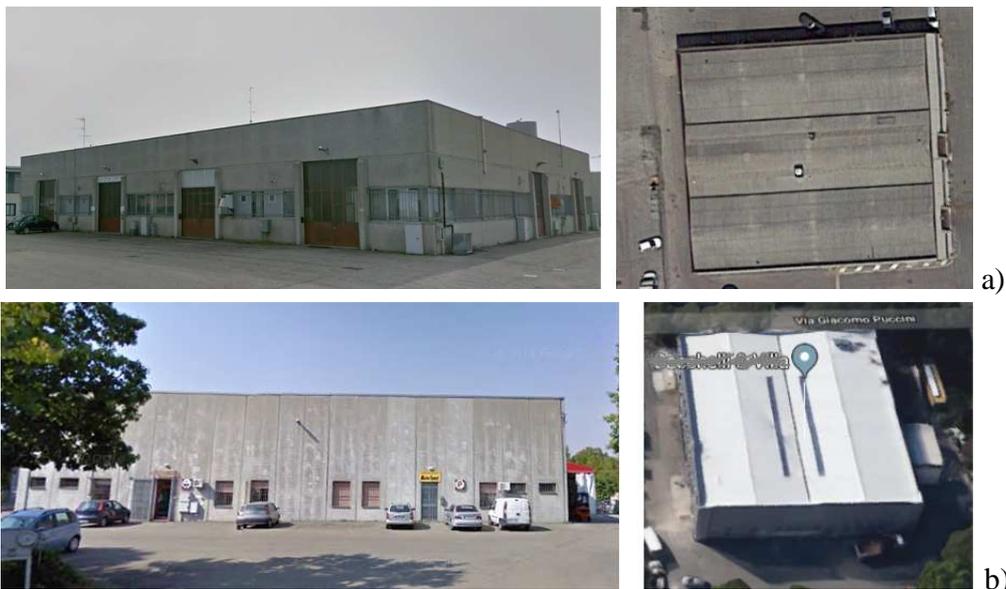
Figure 26. Type 2: buildings with double slope precast beams simply-supported at the top of the columns with external precast heavy cladding panels fixed externally to the columns a) horizontal panels or b) vertical panels.

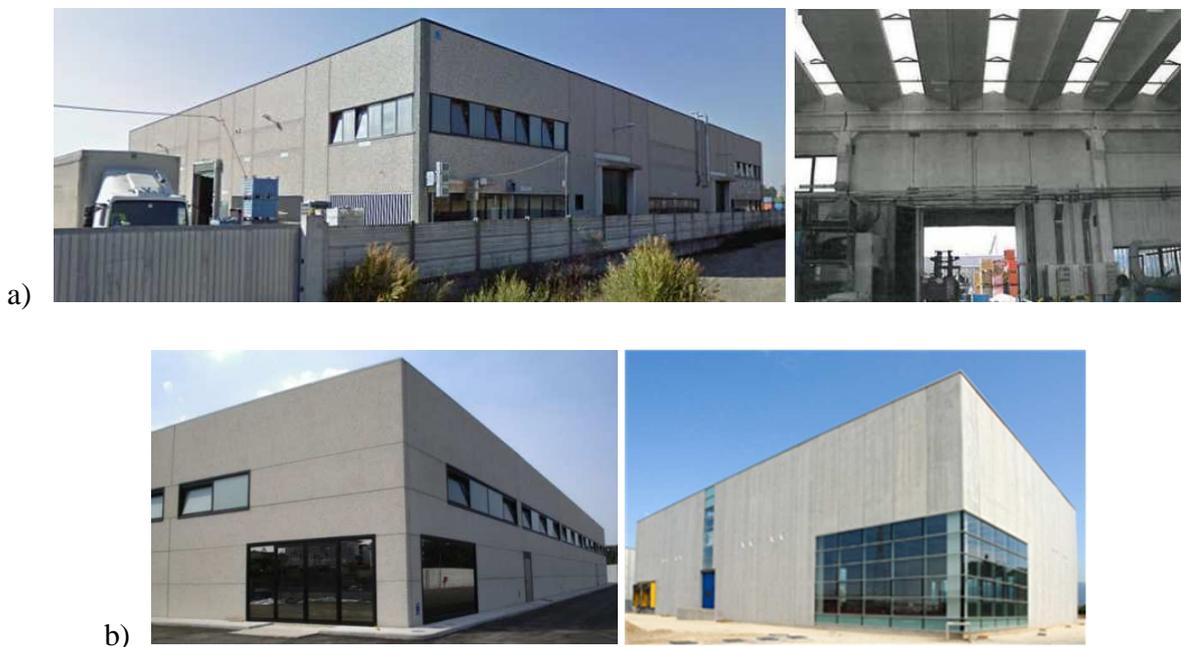
Figure 27. Type 3 - Buildings with long span planar roof: a) example of external and internal view; b) types of cladding panels: horizontal and vertical.

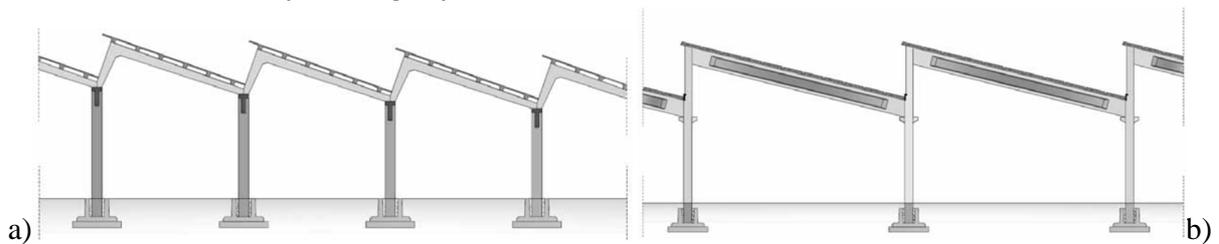
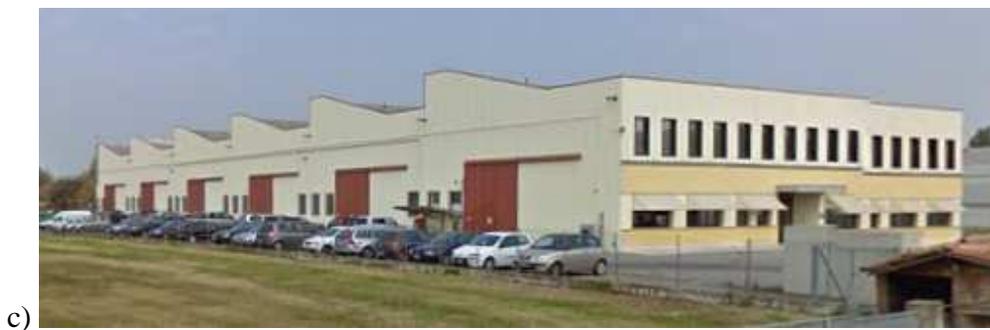
Figure 28. Shed roof: a) beams "knee" b) oblique beams c) picture of a building catalog as type 4.

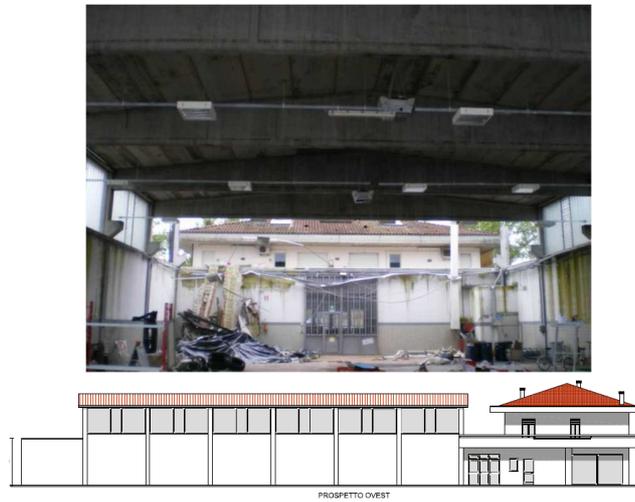
Figure 30. Type 5 due to the presence of a cast in place portion of the building. Due to this irregularity a portion of the building totally collapsed.

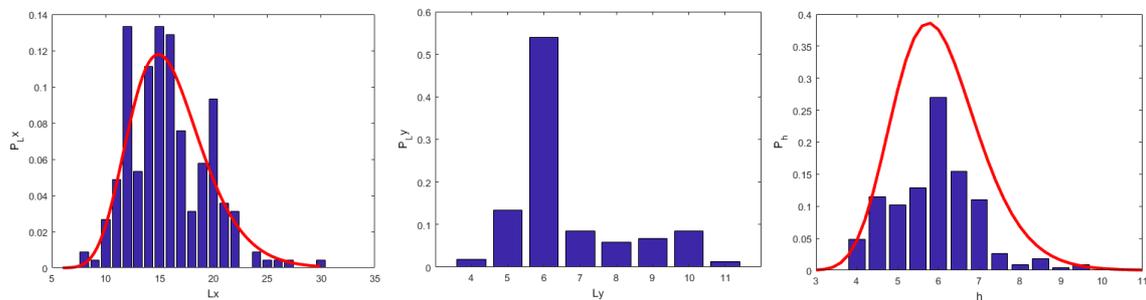
Figure 36. Type 0/1: probability distributions of the length of the main beam, of frame spacing and column height.

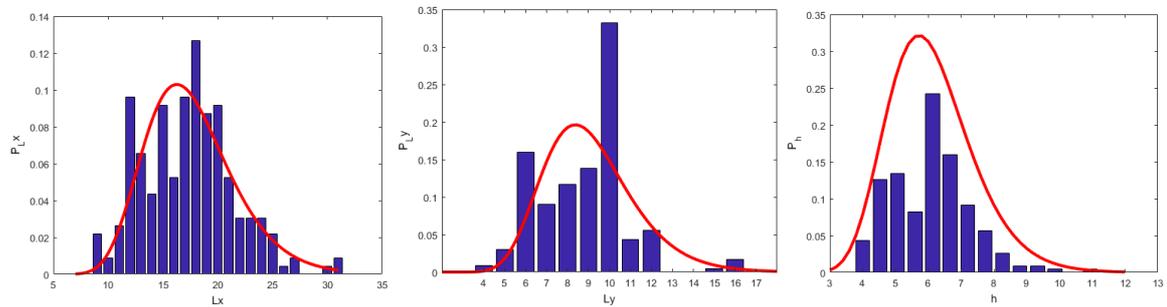
Figure 37. Type 2: probability distributions of the length of the main beam,of frame spacing and column height.

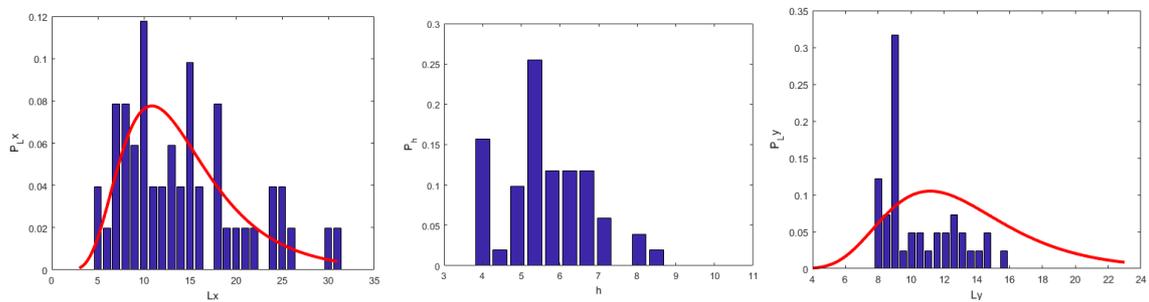
Figure 38. Type 3: probability distributions of the length of the main beam,of frame spacing and column height.

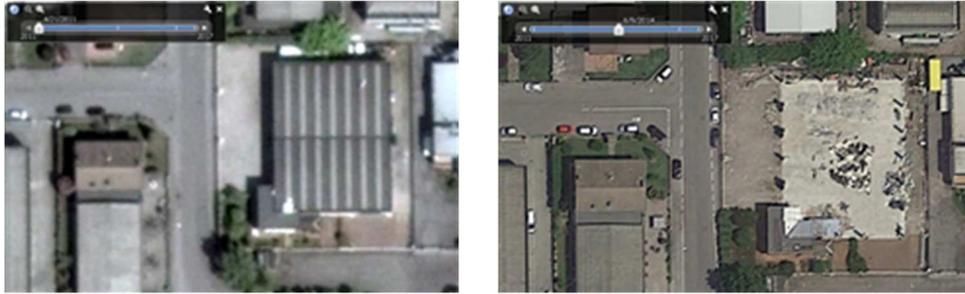
Figure 39. Google Earth images of a building located in Medolla (MO): a) before the seismic events 2011 b) after the seismic event 2014.

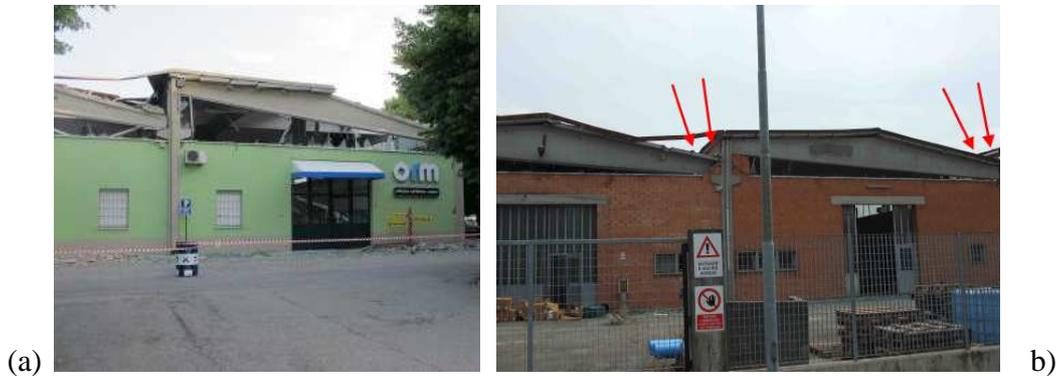
Figure 40. Roof collapses in precast buildings: two examples of partial collapse due to interaction with masonry curtain walls.

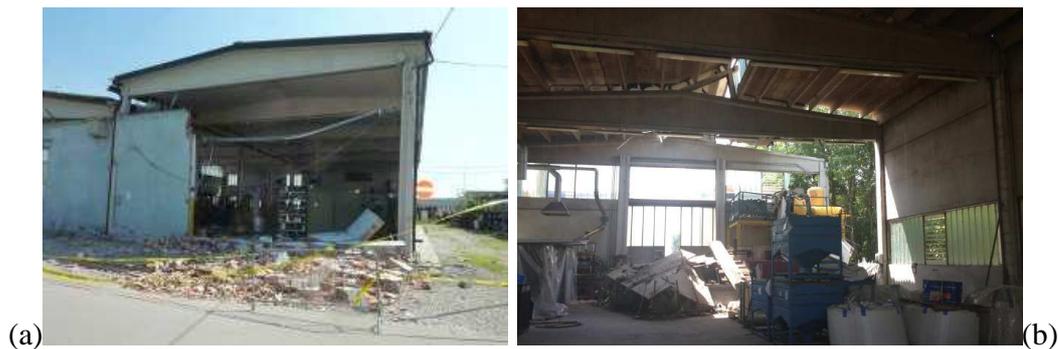
Figure 41. Collapse of (a) a masonry curtain wall not restrained by the RC structure

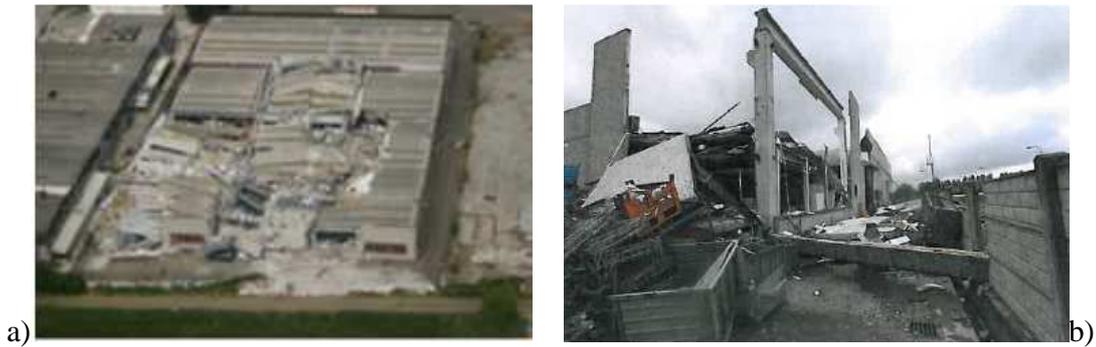
Figure 42. Roof collapses in precast buildings: (b) extended collapse in a modern prefabricated building

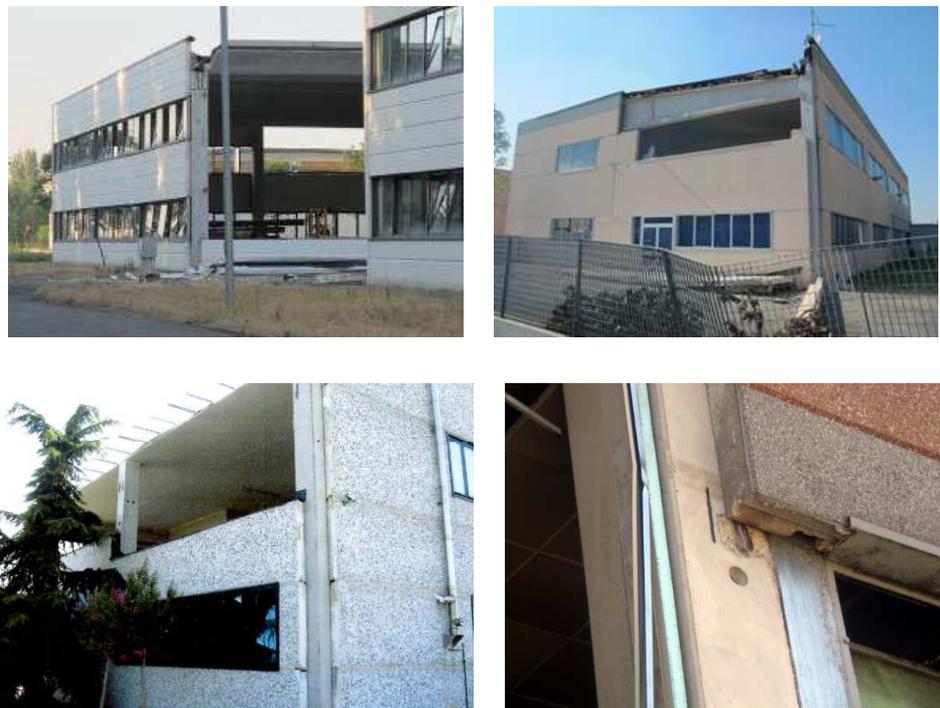
Figure 43. Collapse RC cladding panels due to failure of the steel channel profiles supporting them.

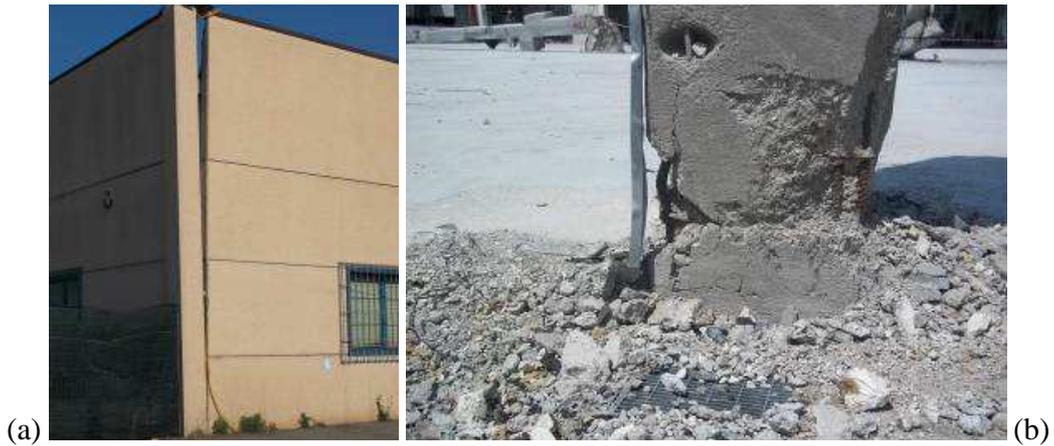
Figure 44. Damages in precast RC columns: (a) rotation of external columns; and (b) large base rotation due to formation of a plastic hinge with yielding and buckling of longitudinal steel bars

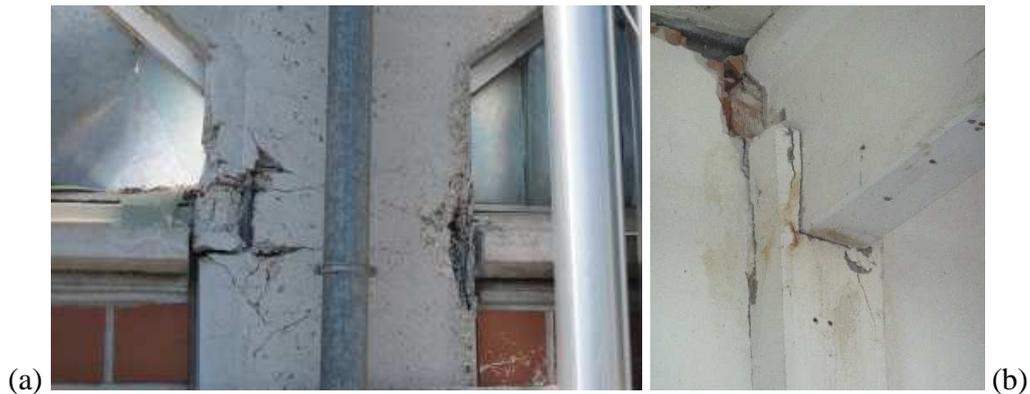
Figure 45. Local damages in precast RC columns: (a) failure mechanism due to interaction with masonry infills; and (b) damage of the upper fork of a column due to flexural-torsional displacements of the precast beam

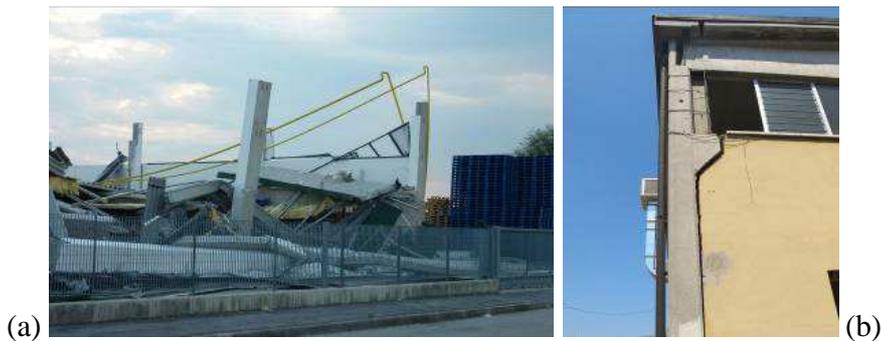
Figure 46. Damages in precast RC columns: (a) extended building collapse caused by large column rotation due to foundation settlement; and (b) column rotation due to settlement at the foundation level, counteracted by the presence of an industrial concrete pavement

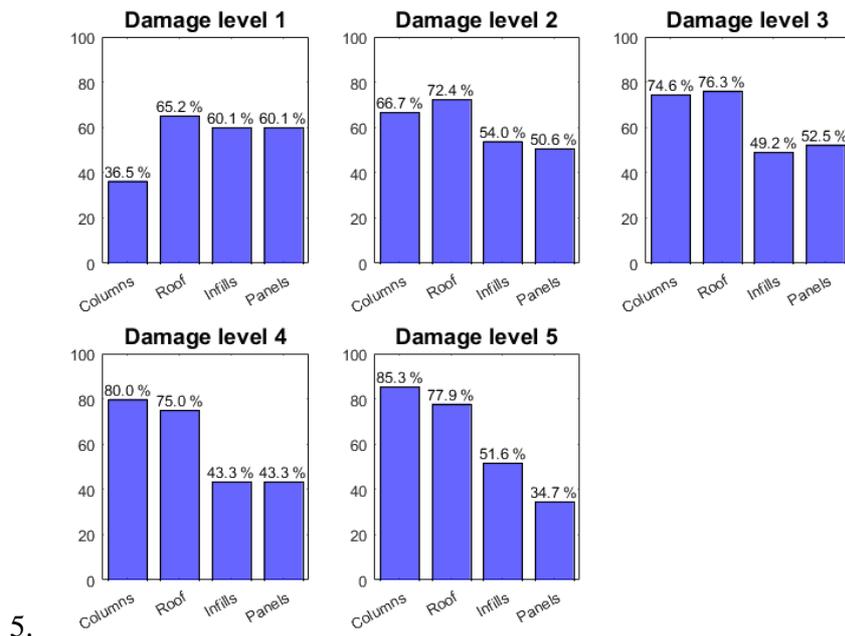
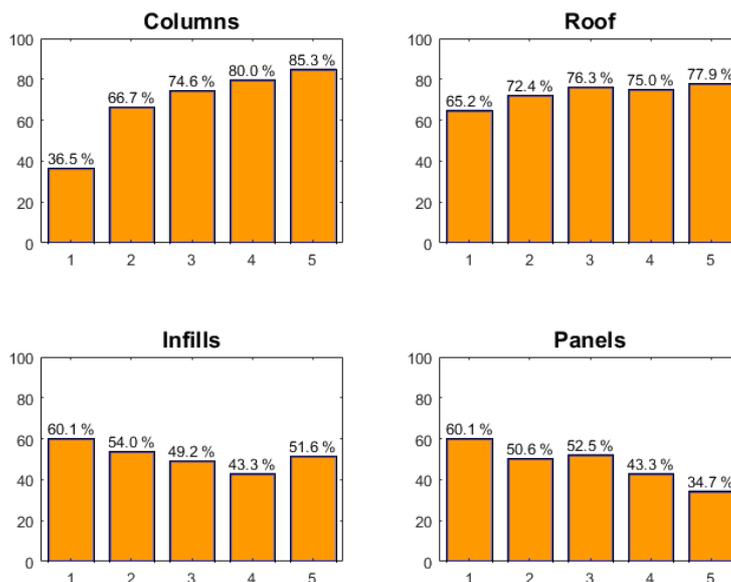
Figure 47: Damage of the main components of the precast structures among the different damage levels.

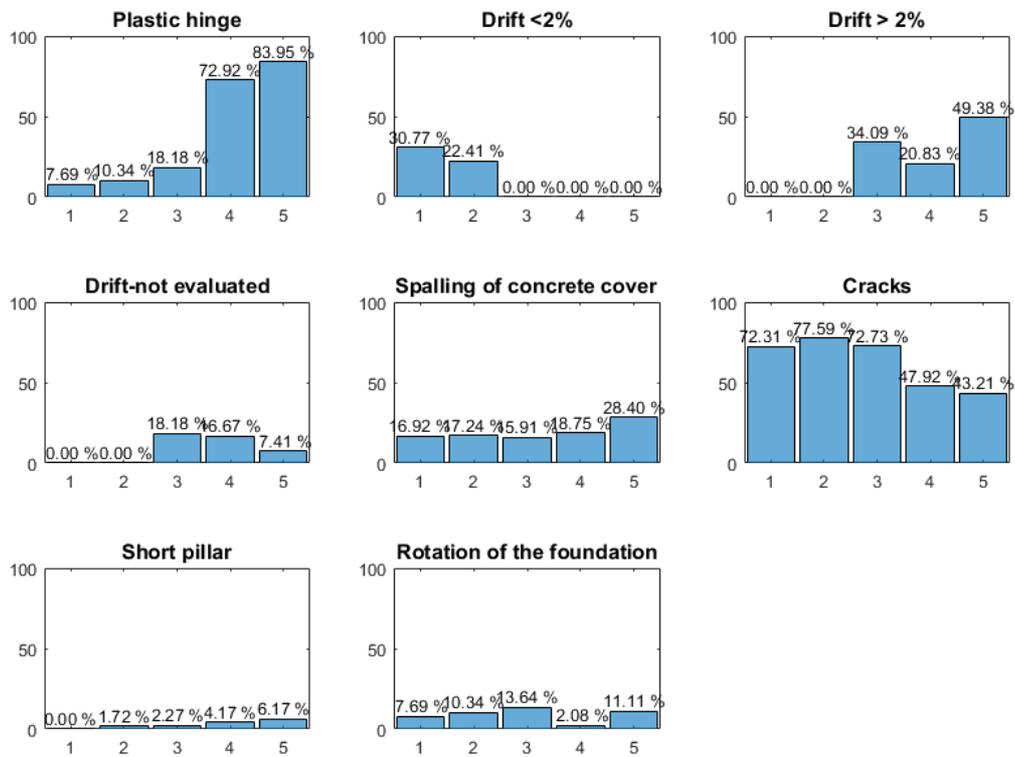
Figure 48. distribution of different types of column damage among the 5 damage levels.

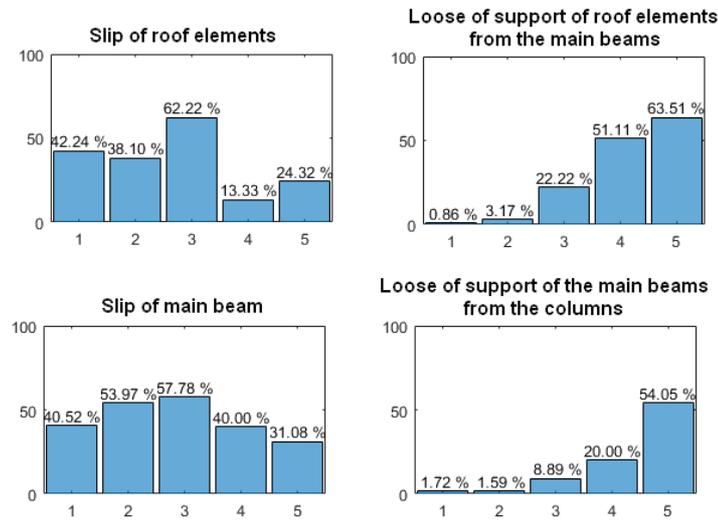
Figure 49. distribution of different types of roof damages among the 5 damage levels.

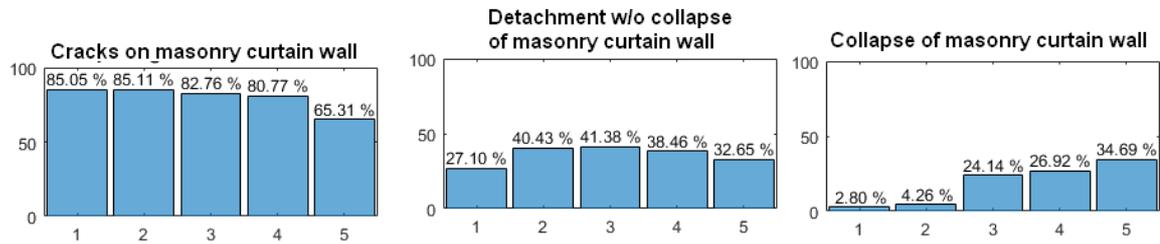
Figure 50. distribution of different types damages on masonry curtain wall among the 5 damage levels.

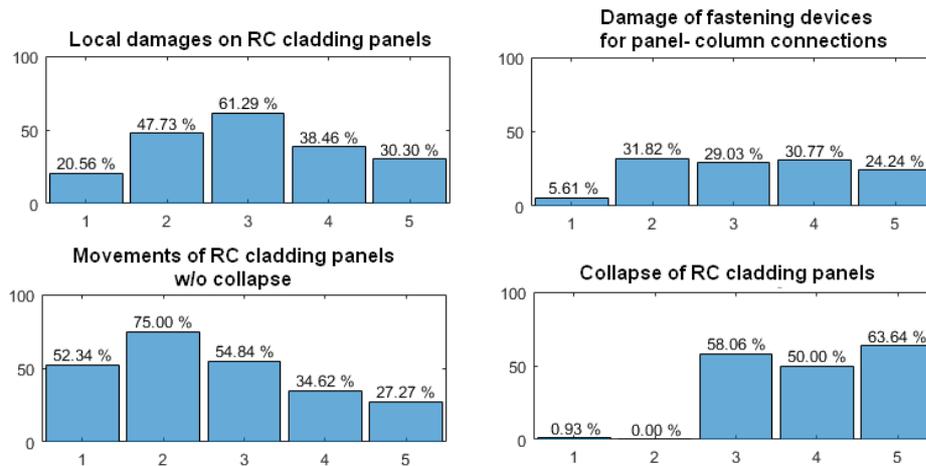
Figure 51. distribution of different types damages on RC cladding panels among the 5 damage levels.

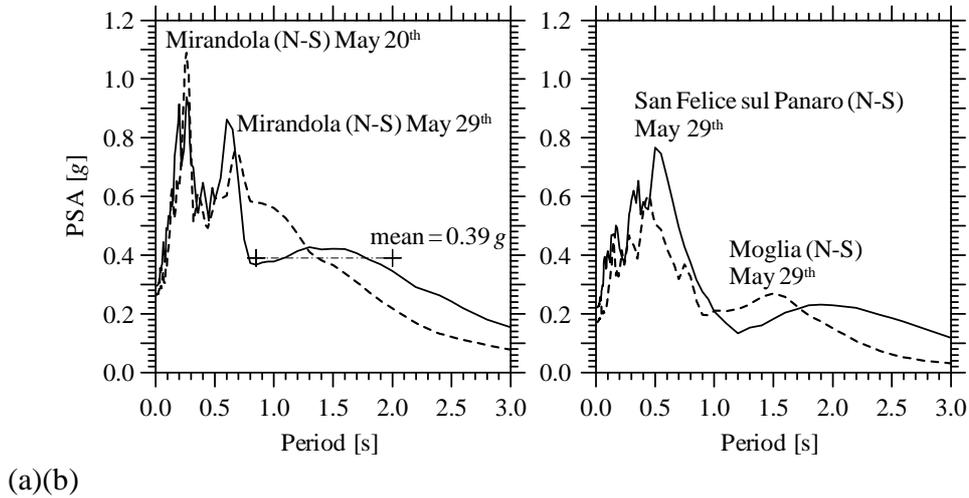
Figure 52. Horizontal PSA versus period for (a) the seismic station at Mirandola (first and second mainshocks), and (b) those at San Felice sul Panaro and Moglia (second mainshock)

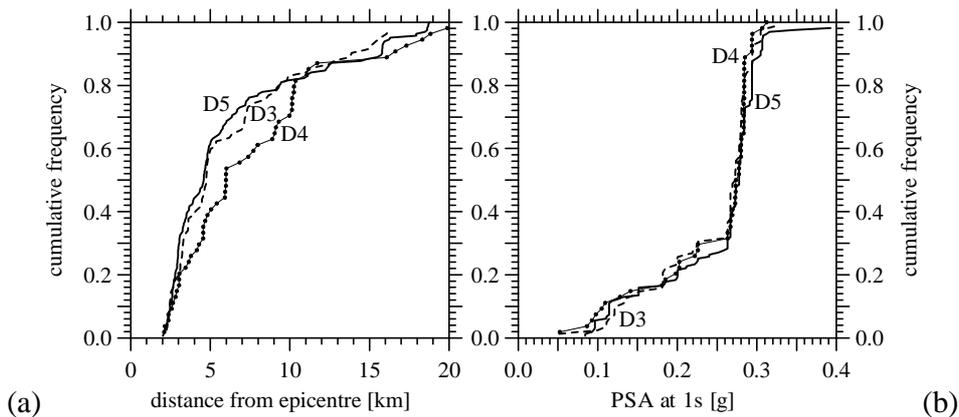
Figure 54. Cumulative frequencies of buildings belonging to damage levels D3 (dashed lines), D4 (line with symbols) and D5 (solid line) versus (a) distance from the nearest epicentre, and (b) corresponding PSA at 1 s

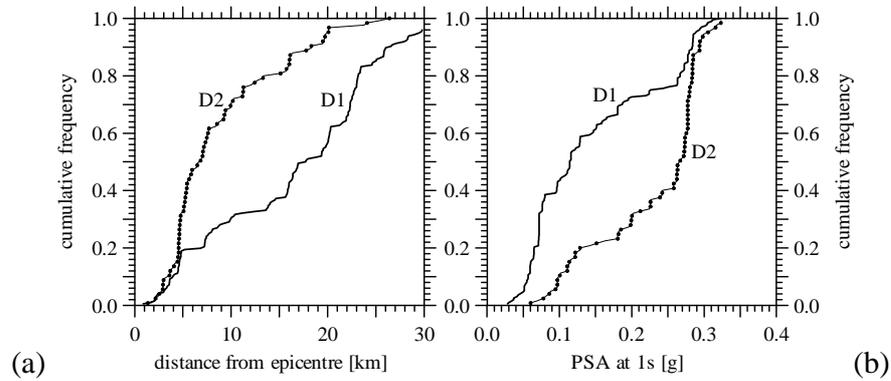
Figure 56. Cumulative frequencies of buildings belonging to damage levels D1 and D2 versus (a) distance from the nearest epicentre, and (b) corresponding PSA at 1 s

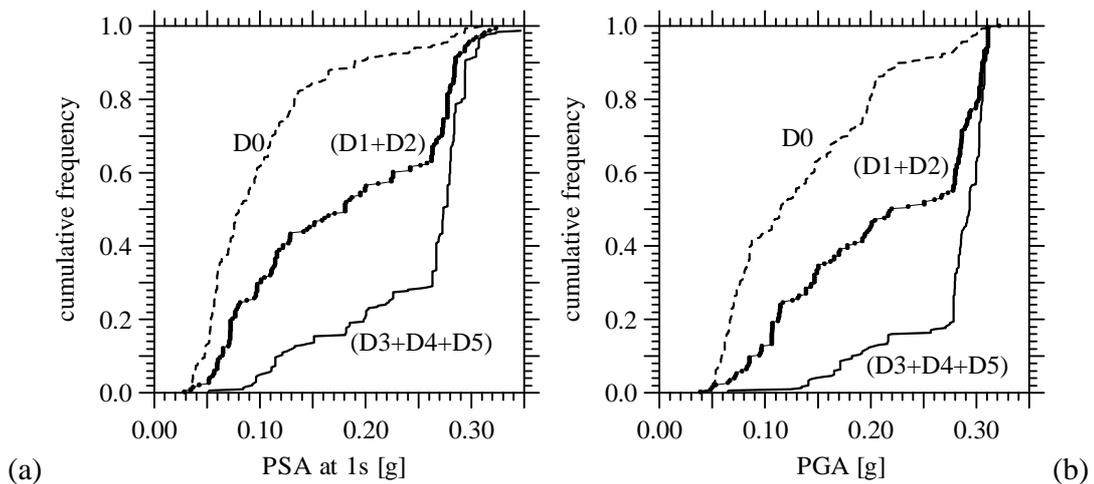
Figure 60. Cumulative frequencies of the three classes of damage levels versus (a) PSA at 1 s corresponding to the nearest epicentre, and (b) maximum experienced PGA

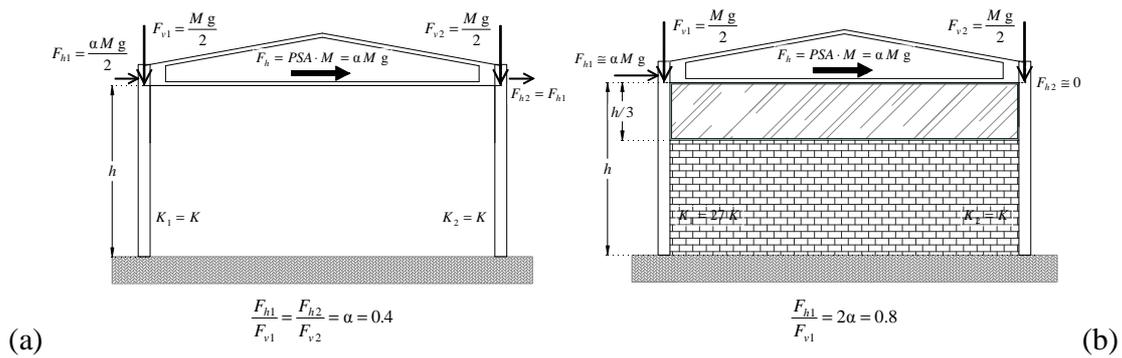
Figure 61. Single-storey single-bay precast frame (a) without masonry infill and (b) with an infill wall provided with a strip window between precast beam and wall

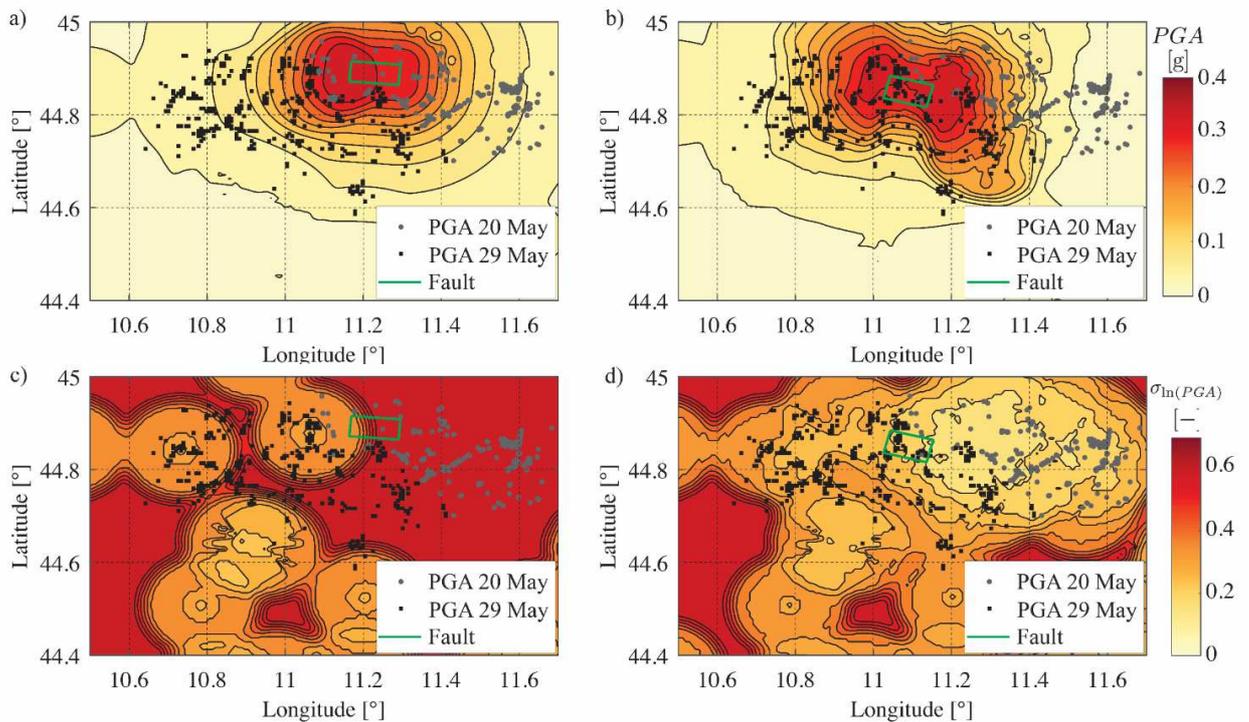
Figure 62. Shakemaps for (a-b) the median value of the horizontal PGA, and (c-d) for its logarithmic standard deviation (SD), for (a, c) the 20 May and (b, d) 29 May earthquakes. Grey dots and black squares indicate the locations of the buildings in database associated to the PGA of 20 May and 29 May, respectively.

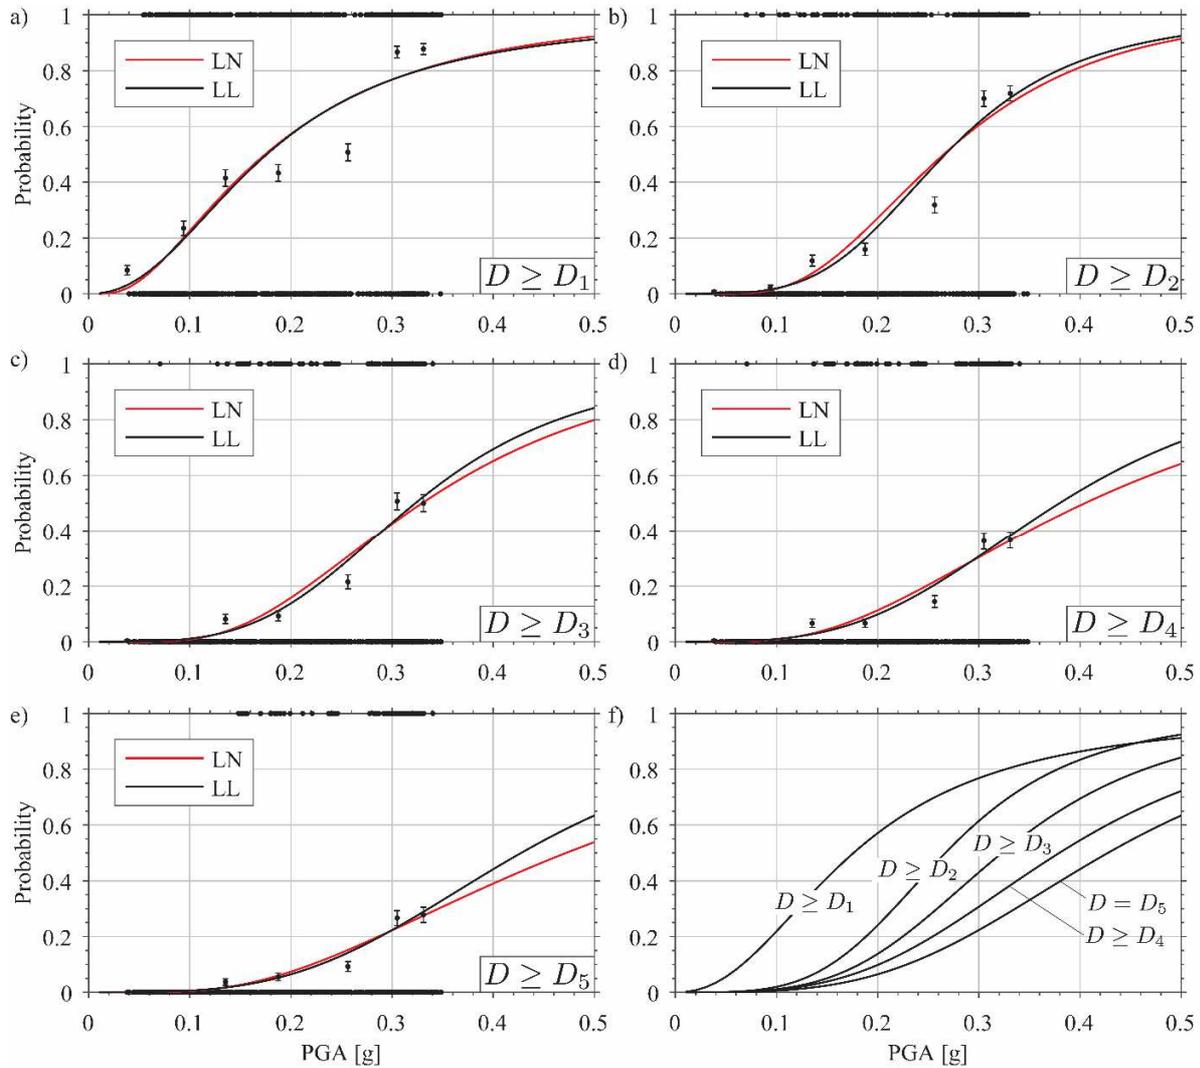
Figure 64. (a-e) comparison among failure probabilities for damage levels  $D_1$  to  $D_5$ , point-estimates from damage matrices (black circles), lognormal (LN) and log-logit (LL) parametric fragility curves obtained by maximum likelihood estimation; (f) LL parametric fragility curves for the various damage levels.

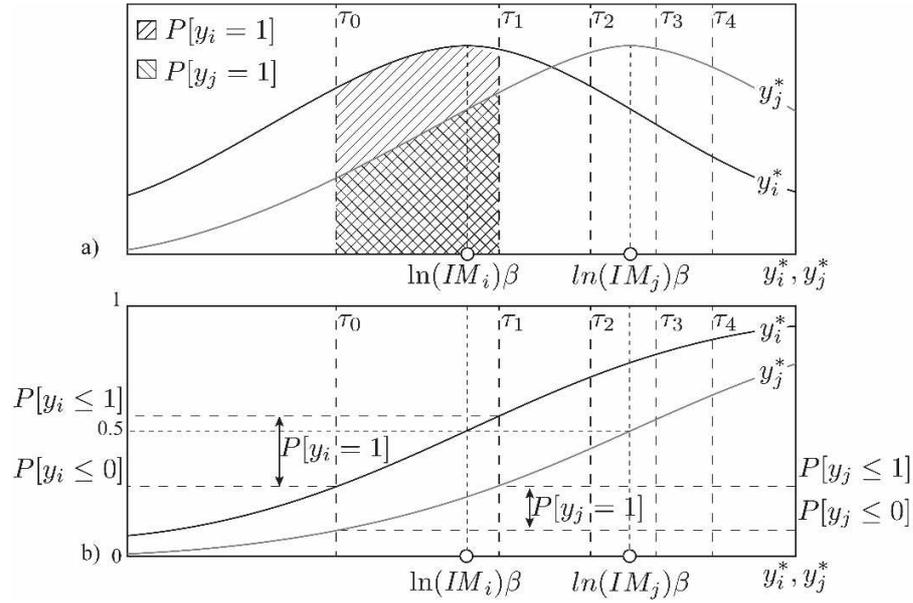
Figure 65. (a) PDF and (b) CDF for  $y_i^* | IM_i, \beta$  and  $y_j^* | IM_j, \beta$ , with  $IM_j > IM_i$  and  $\beta > 0$ . The boundaries of the intervals used to map the continuum latent variables  $y_i^*$  and  $y_j^*$  to the ordinal damage variables  $y_i$  and  $y_j$  are indicated by dashed lines. The areas corresponding to the probability of observing damage  $D_i = D_1$  (i.e.  $y_i = 1$ ) and  $D_j = D_1$  (i.e.  $y_j = 1$ ) are hatched in (a).

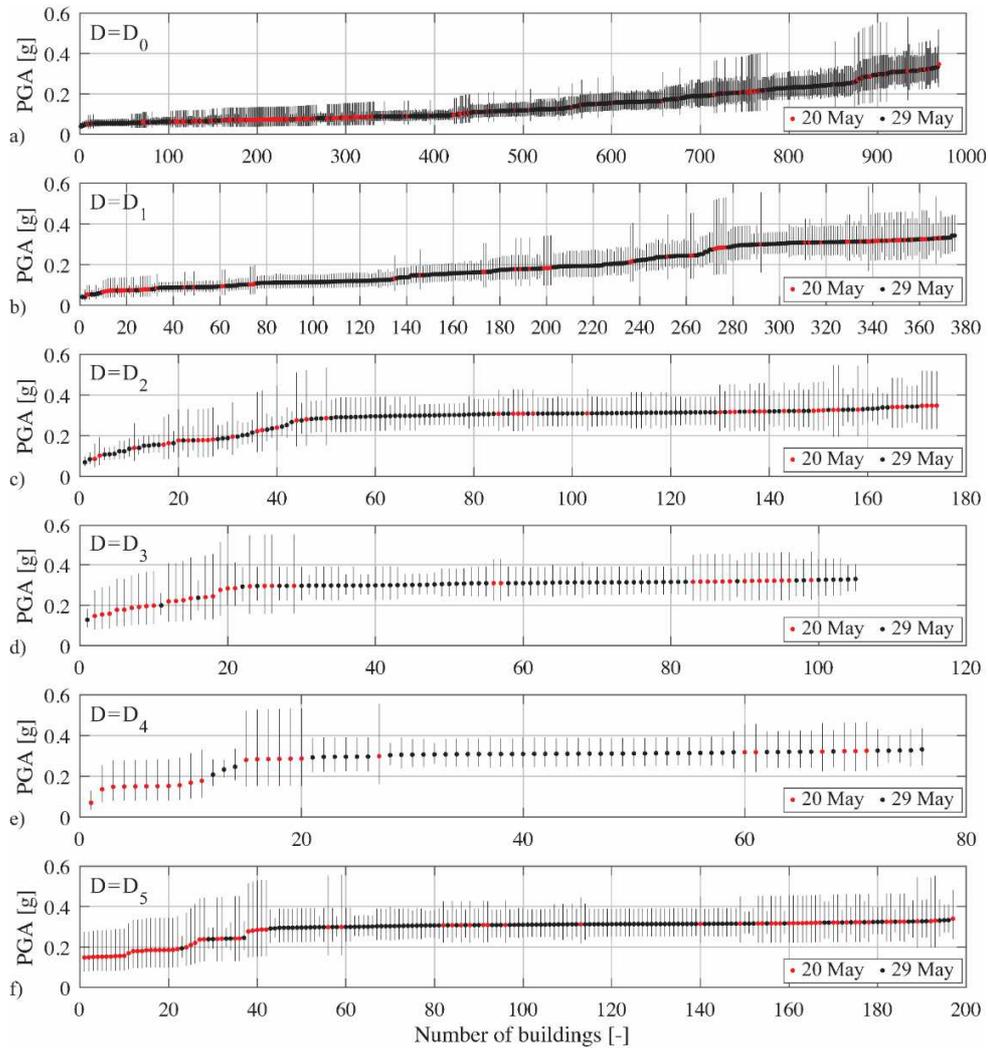
Figure 66. Dataset used for the ordinal regression. Figures a) to f) correspond to damage levels  $D_0$  to  $D_5$ , respectively. Each point represents the median PGA value assigned to a building, colours indicate the earthquake that produced the ground-motion (20 May and 29 May). Vertical bars represent  $\pm$  standard deviation intervals on the logarithm of PGA, centred on the median PGA value.

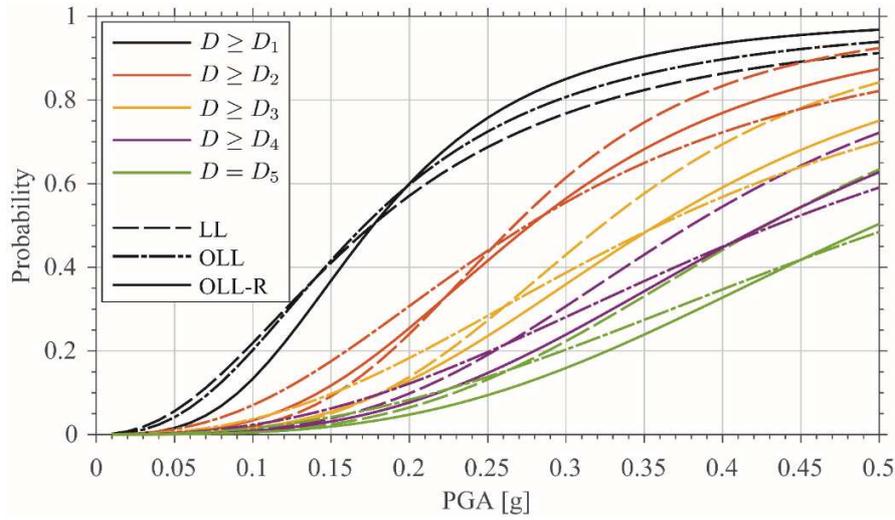
Figure 67. Comparison of fragility curves obtained from the log-logit models (LL), the ordinal log-logistic model (OLL) and the ordinal log-logistic model taking ground-motion uncertainty into account (OLL-R).

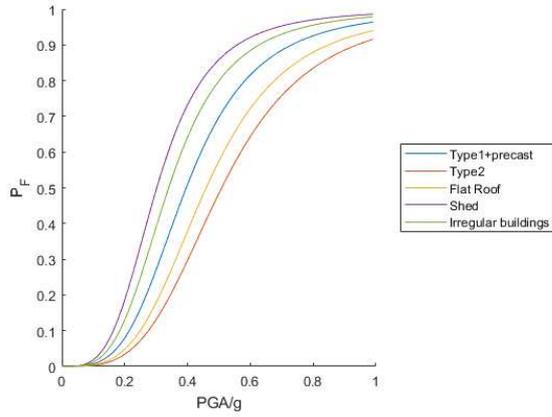
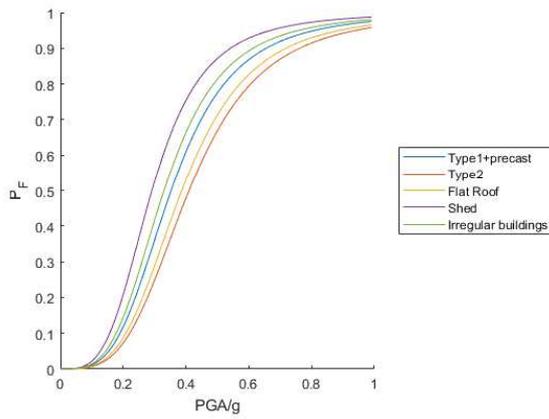
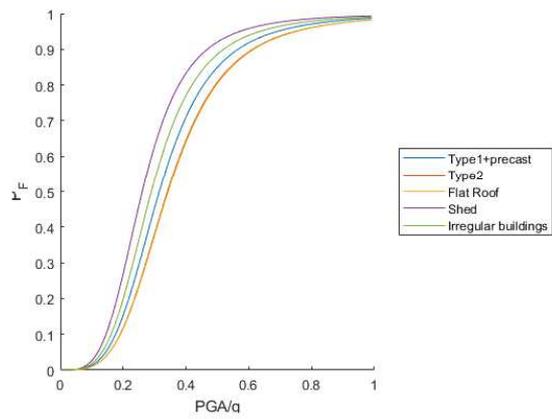
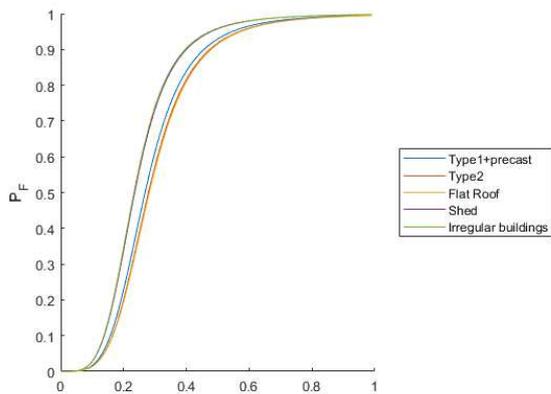
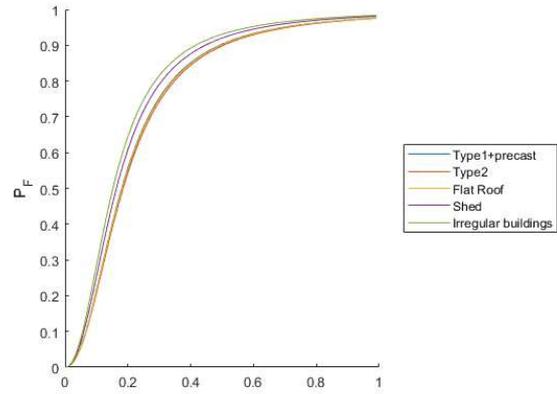
Figure 68. Comparison of the fragility curves for each building class, for each damage level, considering no ordinal models.
