**DOTTORATO DI RICERCA IN  
INGEGNERIA CIVILE, CHIMICA, AMBIENTALE E DEI MATERIALI**

**INFRASTRUCTURE MAINTAINANCE  
AND COUNTERMEASURES PLANNING  
IN COMPLEX GEOLOGICAL  
AND GEOMORPHOLOGICAL SETTINGS**

PRESENTATA DA GIACOMO TEDESCO

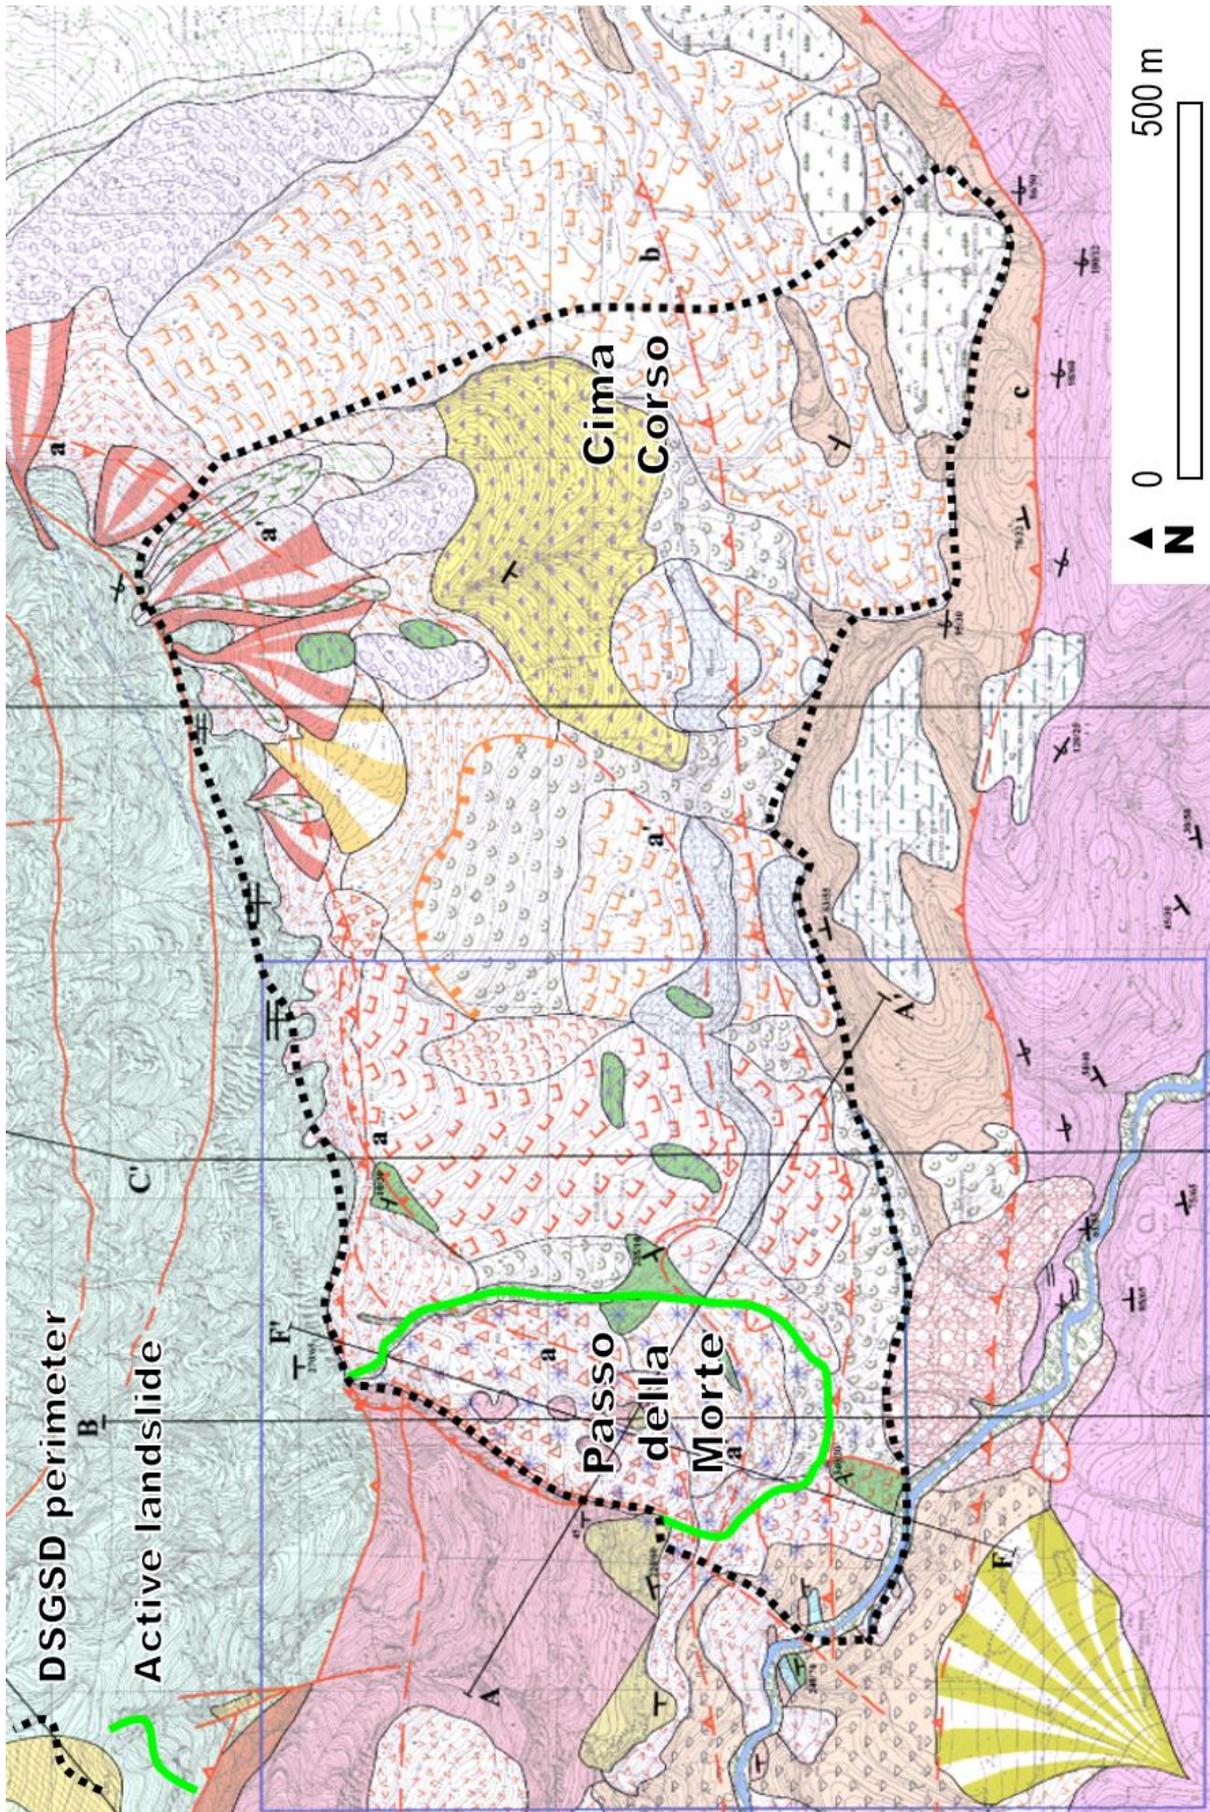
Figure 2-5 Simplified geological-geomorphological map (modified after Marcato 2007)

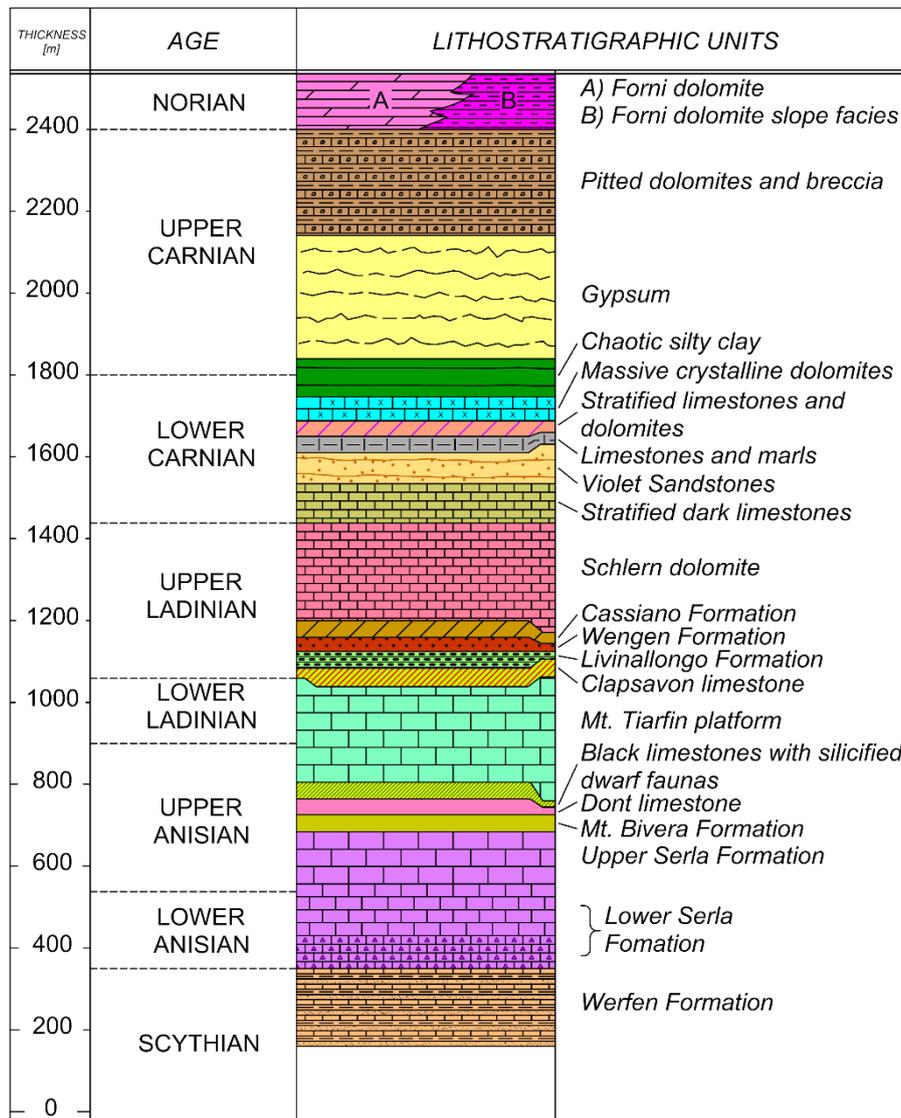
Figure 2-7 Stratigraphic column (modified after Marcato 2007)

Pisa published a series of stratigraphic sections of the Bivera area [9]. Starting from those profiles, Marcato [2] sketched the stratigraphic column representative of the Passo della Morte area. In his doctorate thesis, Marcato named the former Pisa units using the current terminology. Moreover, he modified the thickness of the Schlern dolomite bed in 300 meters.

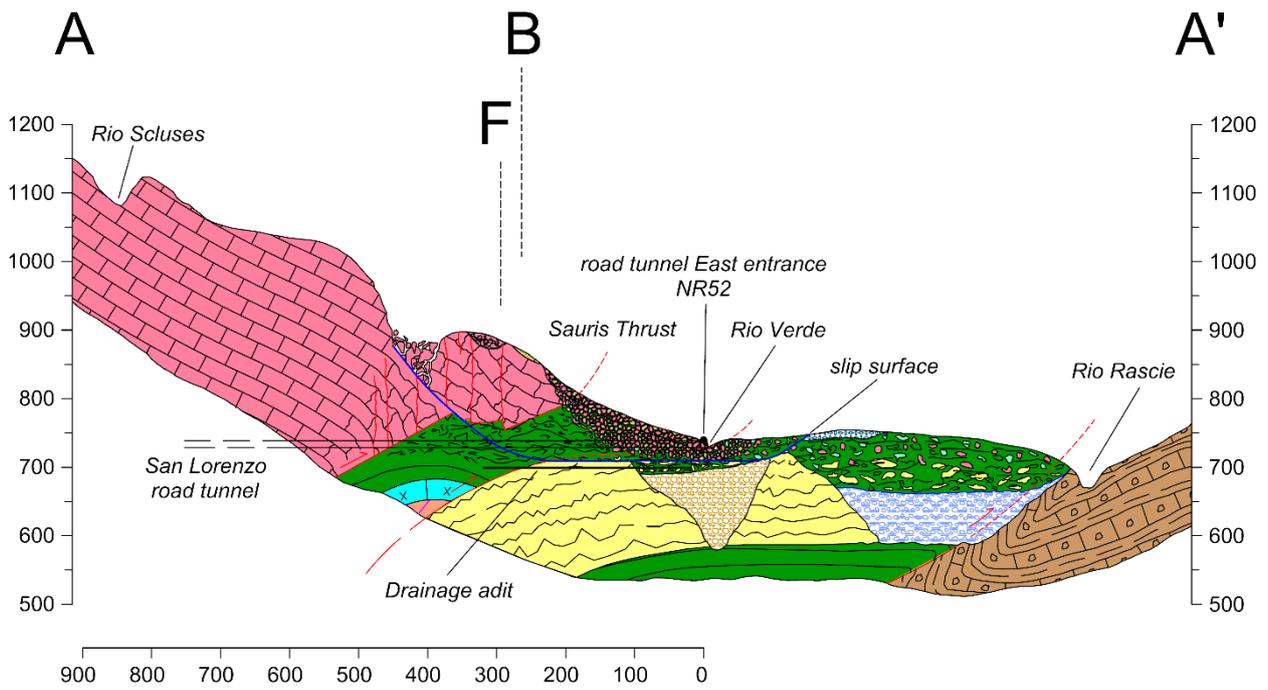
Figure 2-9 Geological section AA' (modified after Marcato 2013)

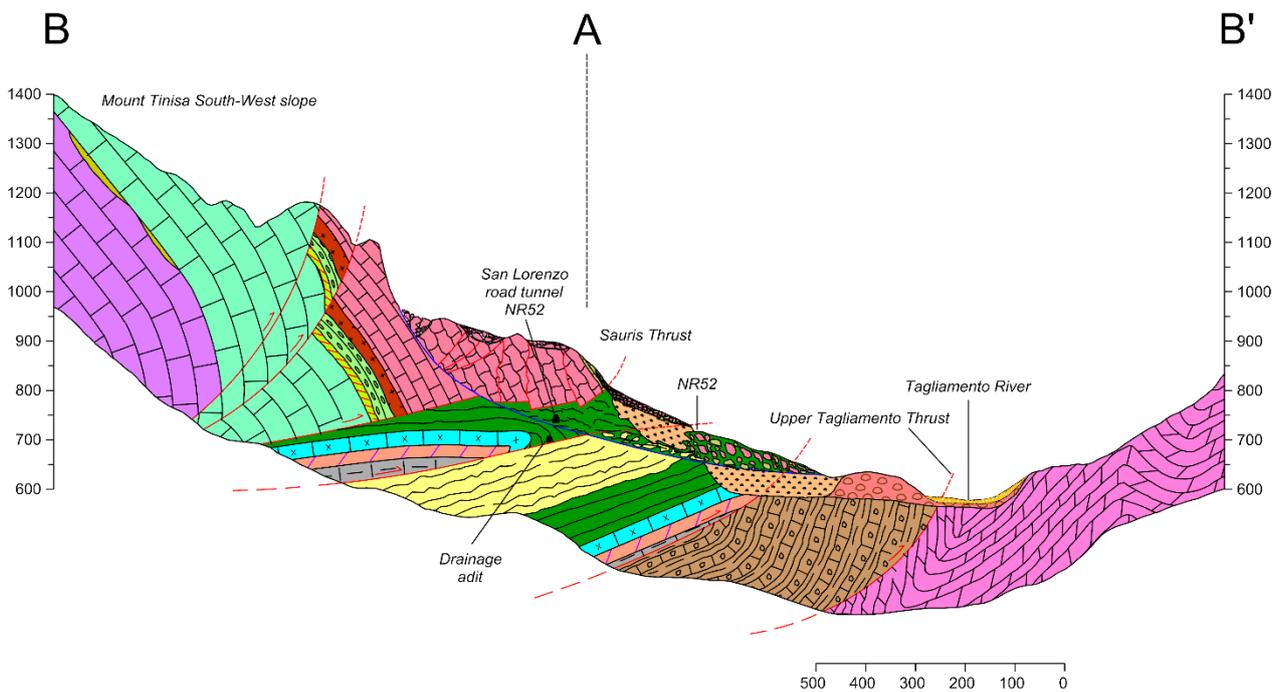
Figure 2-10 Geological section BB' (modified after Marcato 2013)

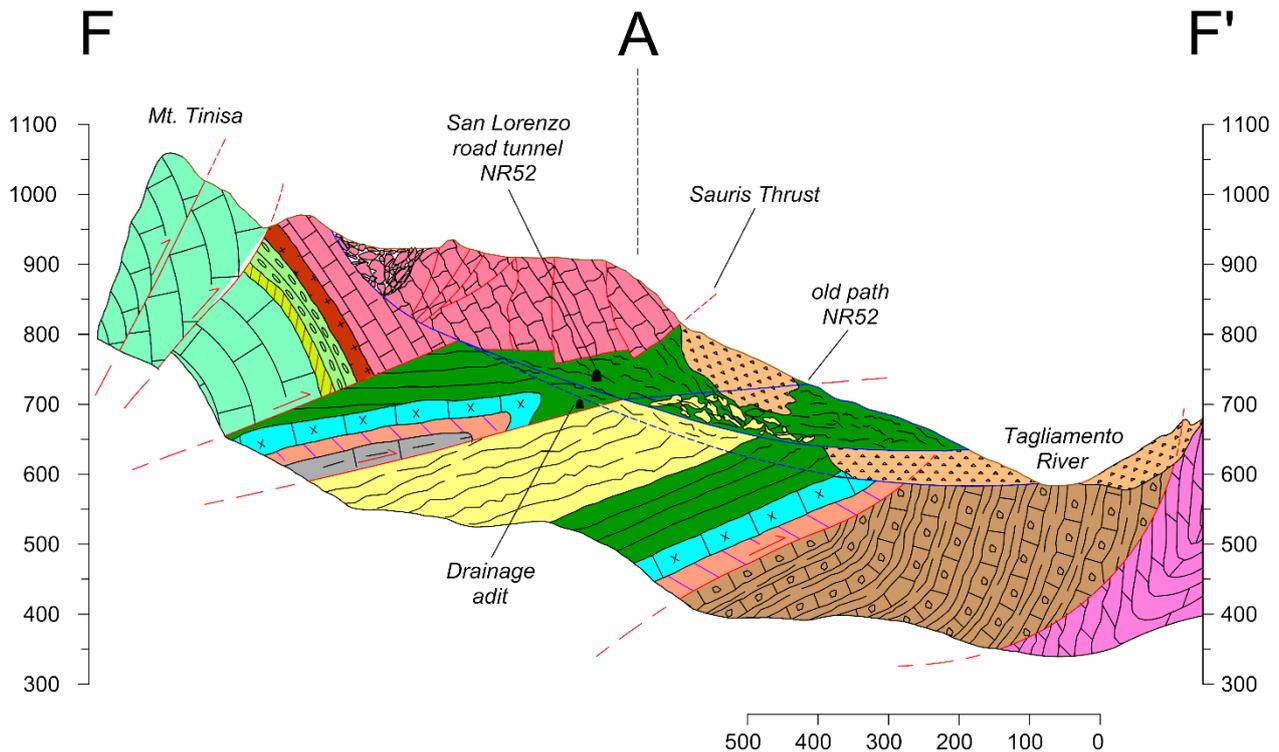
Figure 2-11 Geological section FF' (modified after Marcato 2013)

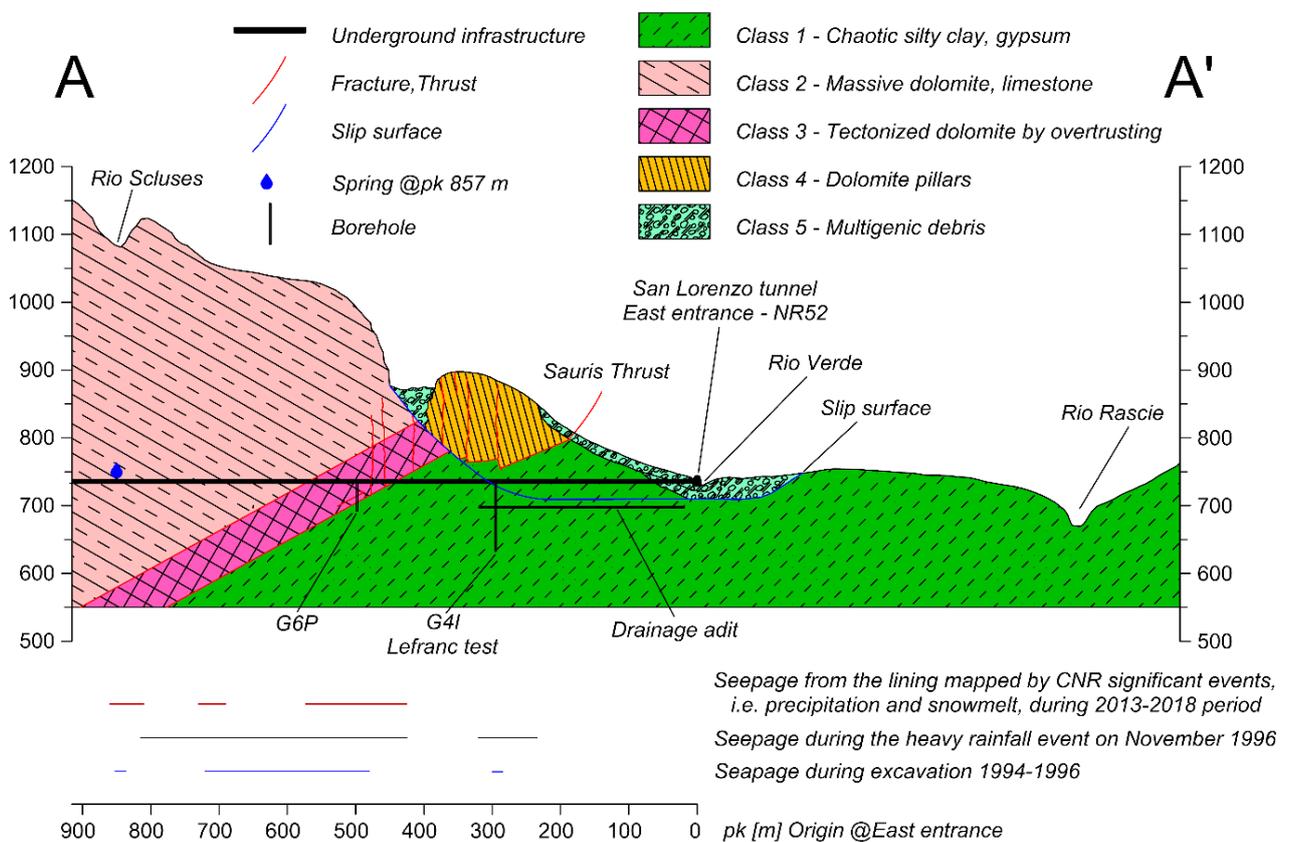
Figure 2-15 Hydro-geological section AA'

In Figure 2-15 the hydro-geological section is presented (modified after Borgatti et alii [21])

The groundwater flow in the Passo della Morte area is defined by a main flow from North to South, which means from Mount Tinisa to Tagliamento River. The regional thrust, before mentioned as Sauris line, represents the contact between the fractured limestone and dolomite units with the almost impermeable clay-rich formation. This lithological boundary outcrops on the South slope of the Mt. Tinisa around an elevation of 700 m a.s.l.

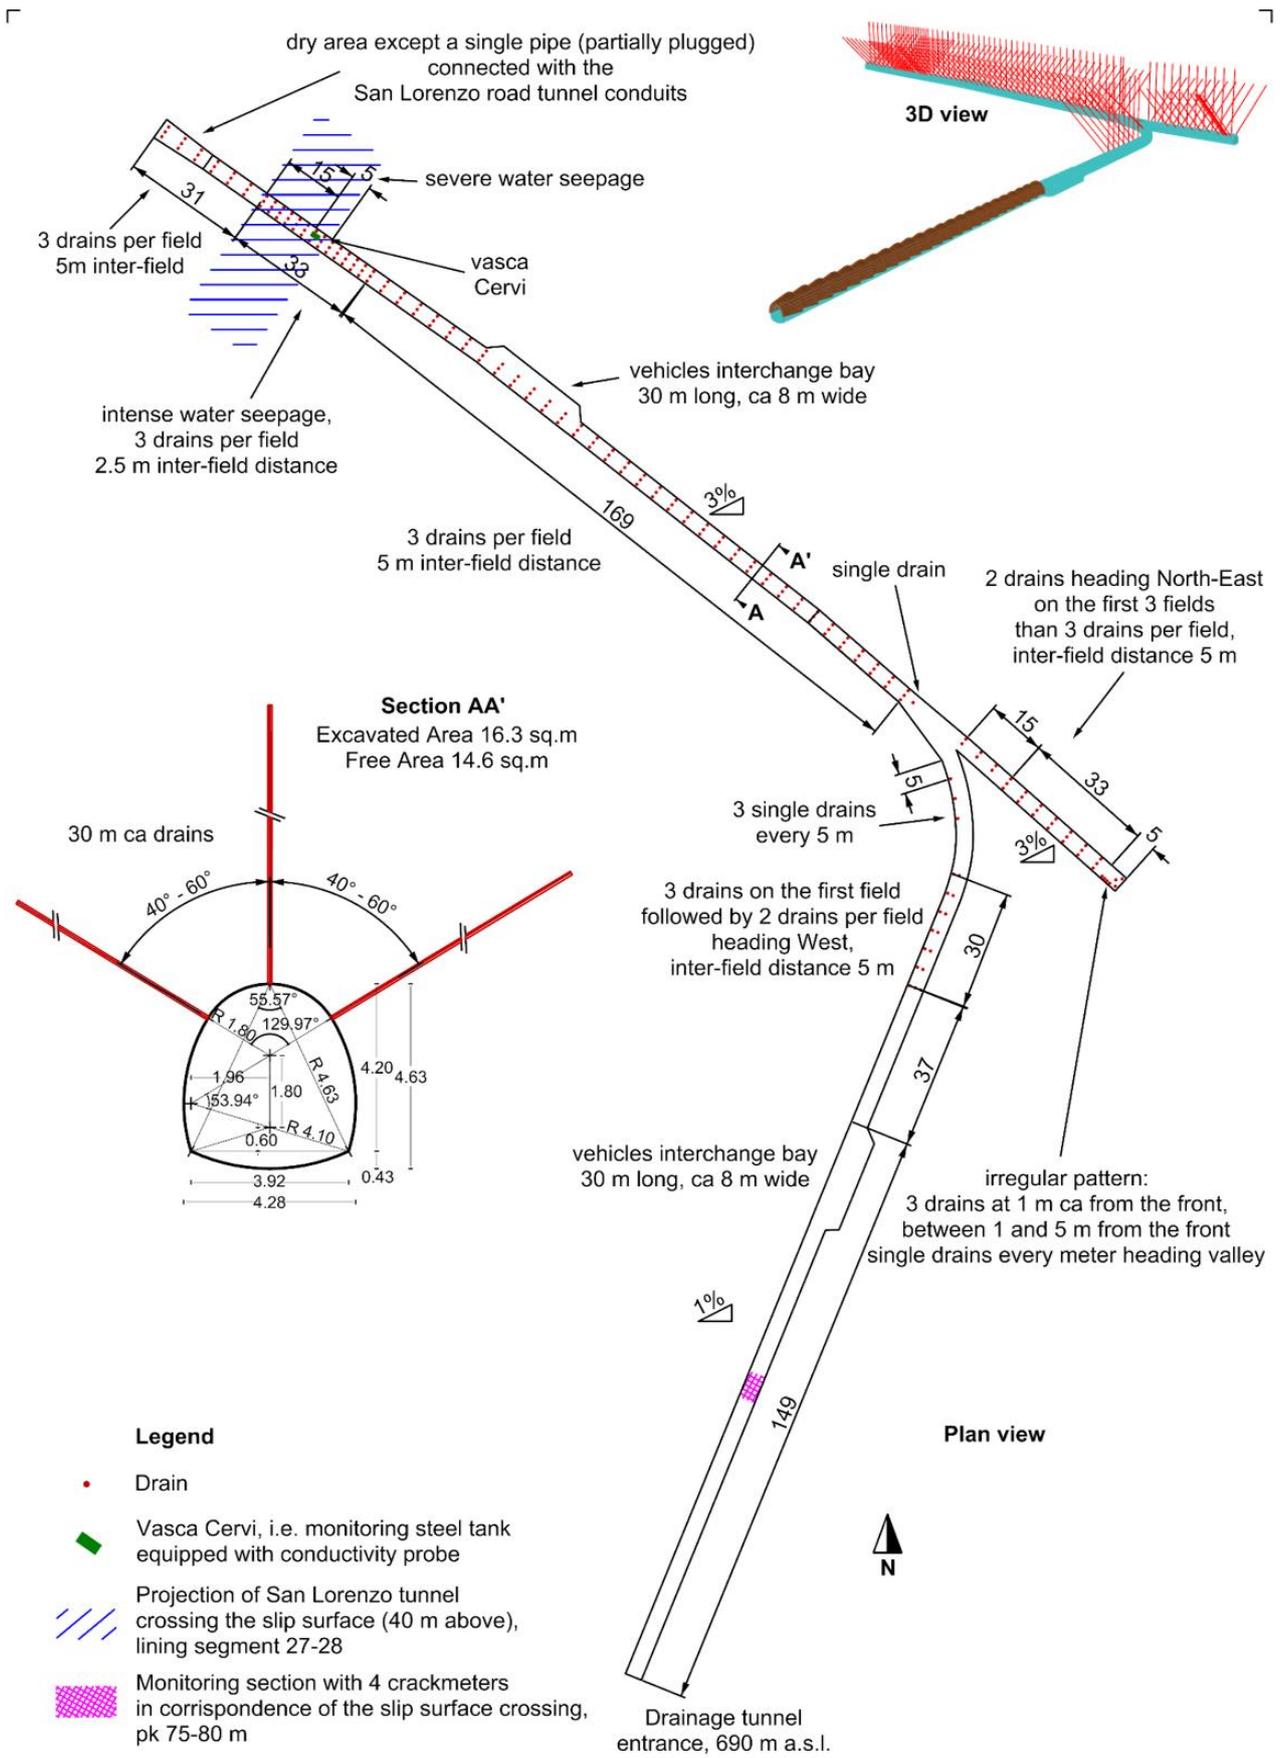
Figure 2-20 Drains pattern into the drainage tunnel

the drainage capacity, and the number was increased as water seepage become more intense, i.e. where the slip surface of Passo della Morte landslide intersect the road tunnel (Figure 2-20).

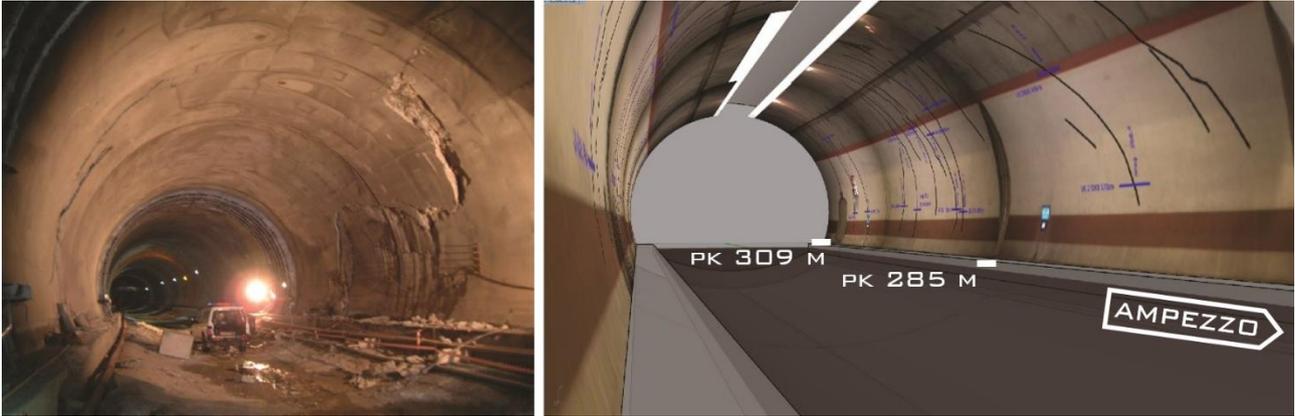
*Figure 2-21 On the left: damage on concrete lining at pk 300 (segments from 26 to 29) after the heavy rainfall event on late 1996. On the right: a 3D reconstruction of the crack in the final lining at segment 27-29 (2012 photos)*

In Figure 2-21 the tunnel-landslide intersection is shown, those pics present the damages on the tunnel lining few months after construction and the cracks in the new concrete lining.

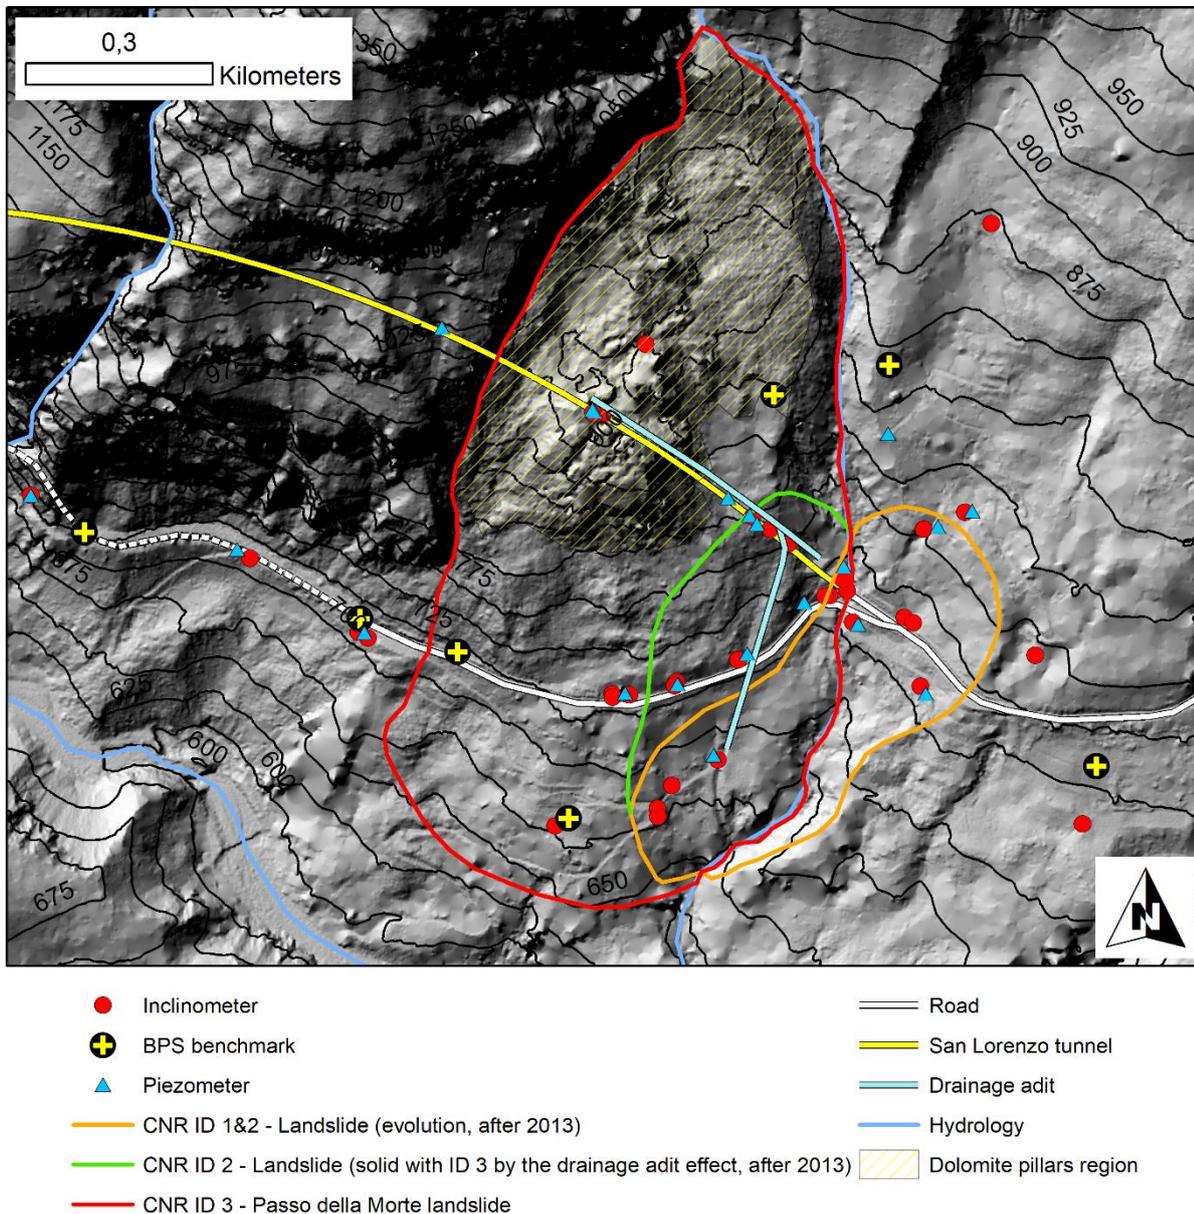
Figure 3-1 Instrumentation installed since 1999

In the Figure 3-1, the instruments installed at Passo della Morte since 1999.

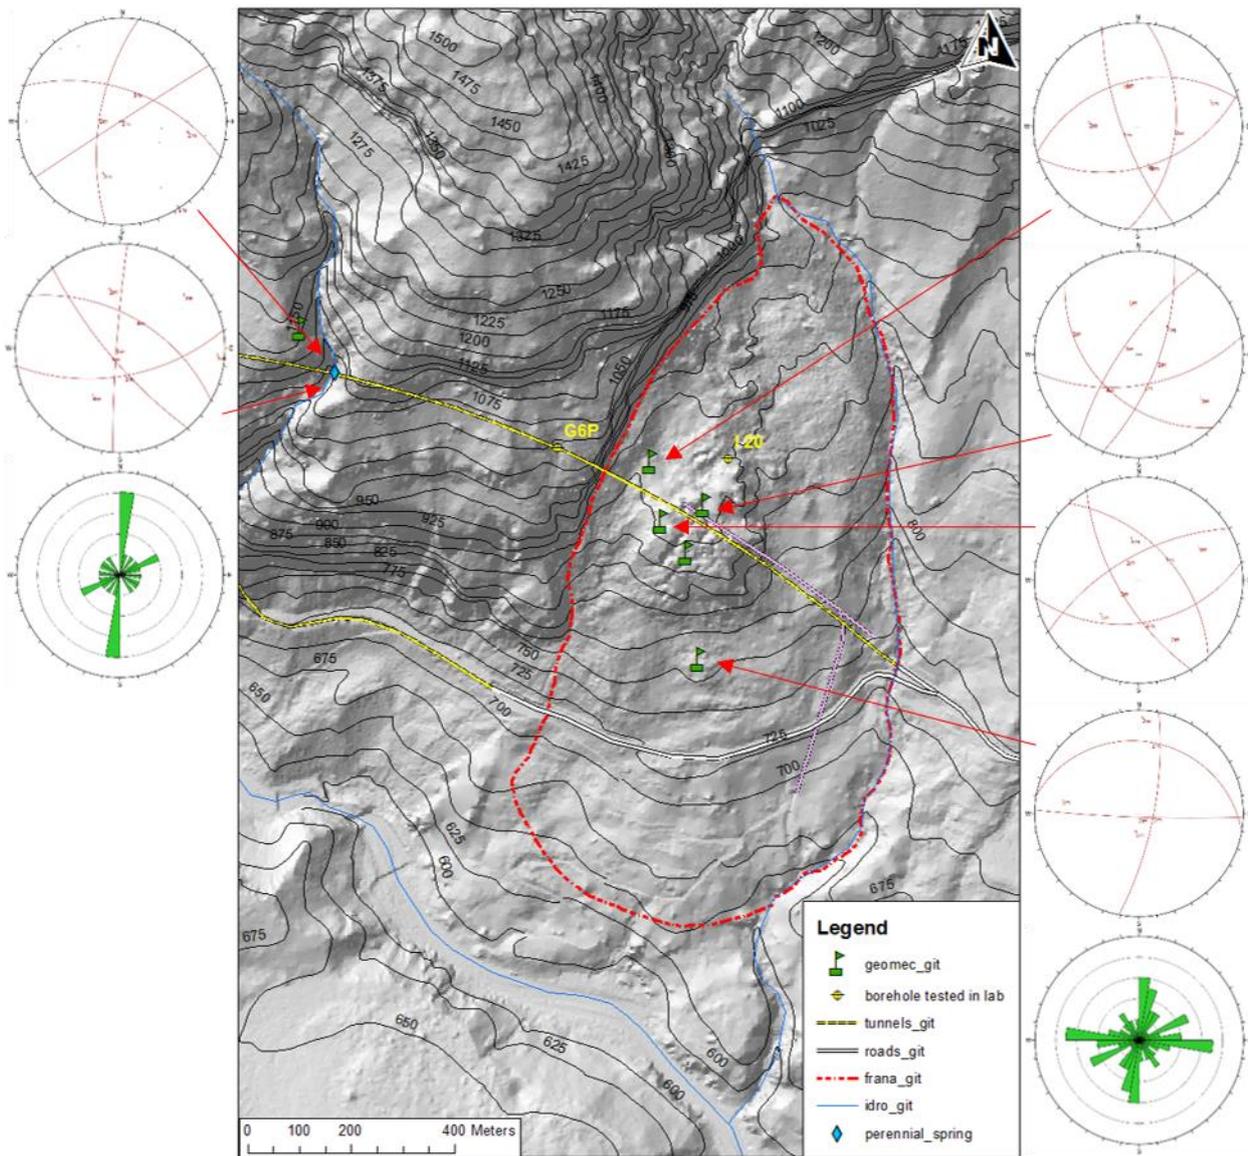
Figure 3-2 Discontinuities mapped in the landslide area (2016 field survey)

The discontinuities play a key role in the definition of the rock mass behavior both from the mechanical and from the hydrogeological points of view. During fall 2016, a series of field surveys were carried out to map the fractures in the dolomite pillars area. In Figure 3-2 the stereo-net (equiangular projections) for each survey spots and two Rosette plots are shown, on the right for the central part of the landslide and close to the Col Pimin vertical wall on the left. Those datasets clearly show that the dolomite pillars area present three joint sets as well as a bedding plane. Nevertheless, each pillar or boulder is randomly tilted and rotated following the downslope movement of the Passo della Morte landslide.

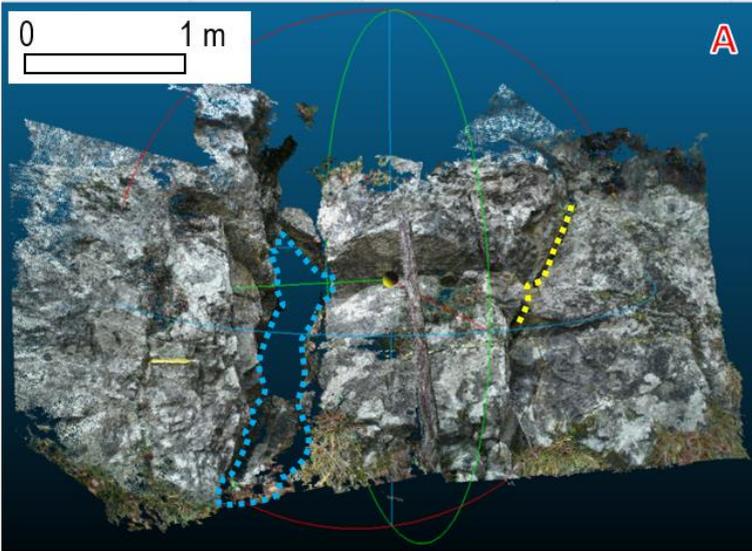
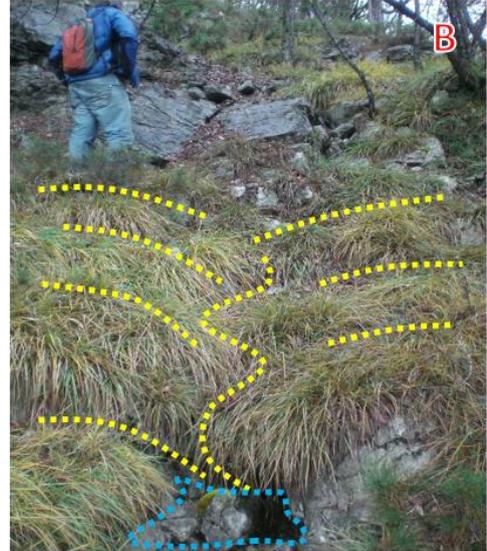
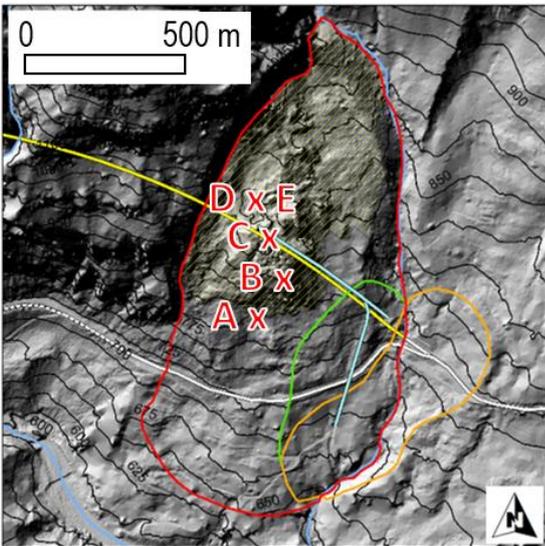
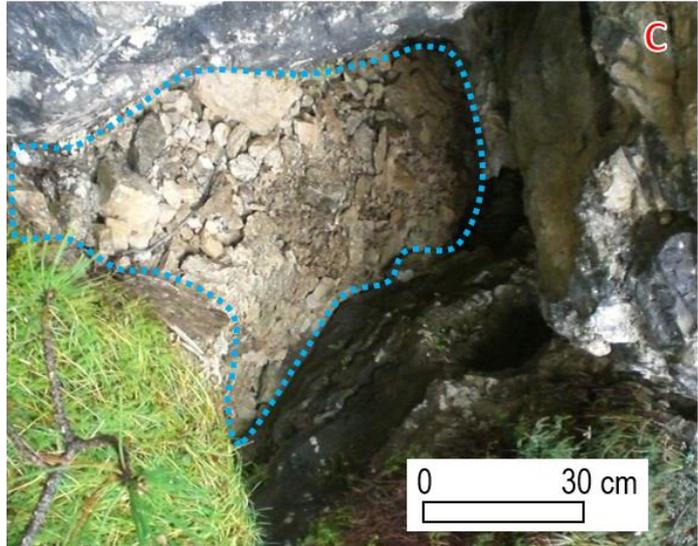
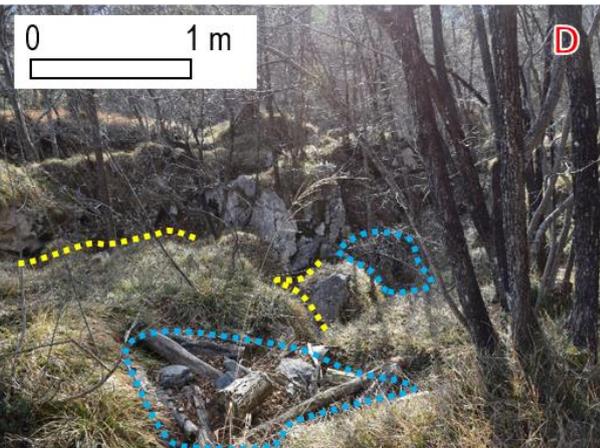
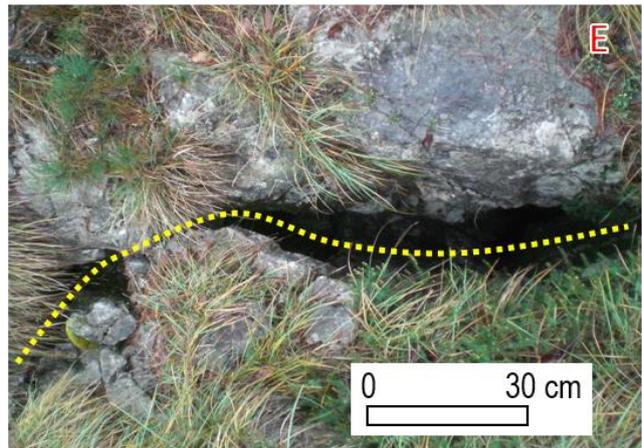
Figure 3-3 Survey of the dolomite pillars area. From the top: photogrammetric survey on left (A), open fractures on right (B), pics localization (middle-left), sinkholes (C), severely fractured area in the I20 neighborhoods (D), open fracture (E)

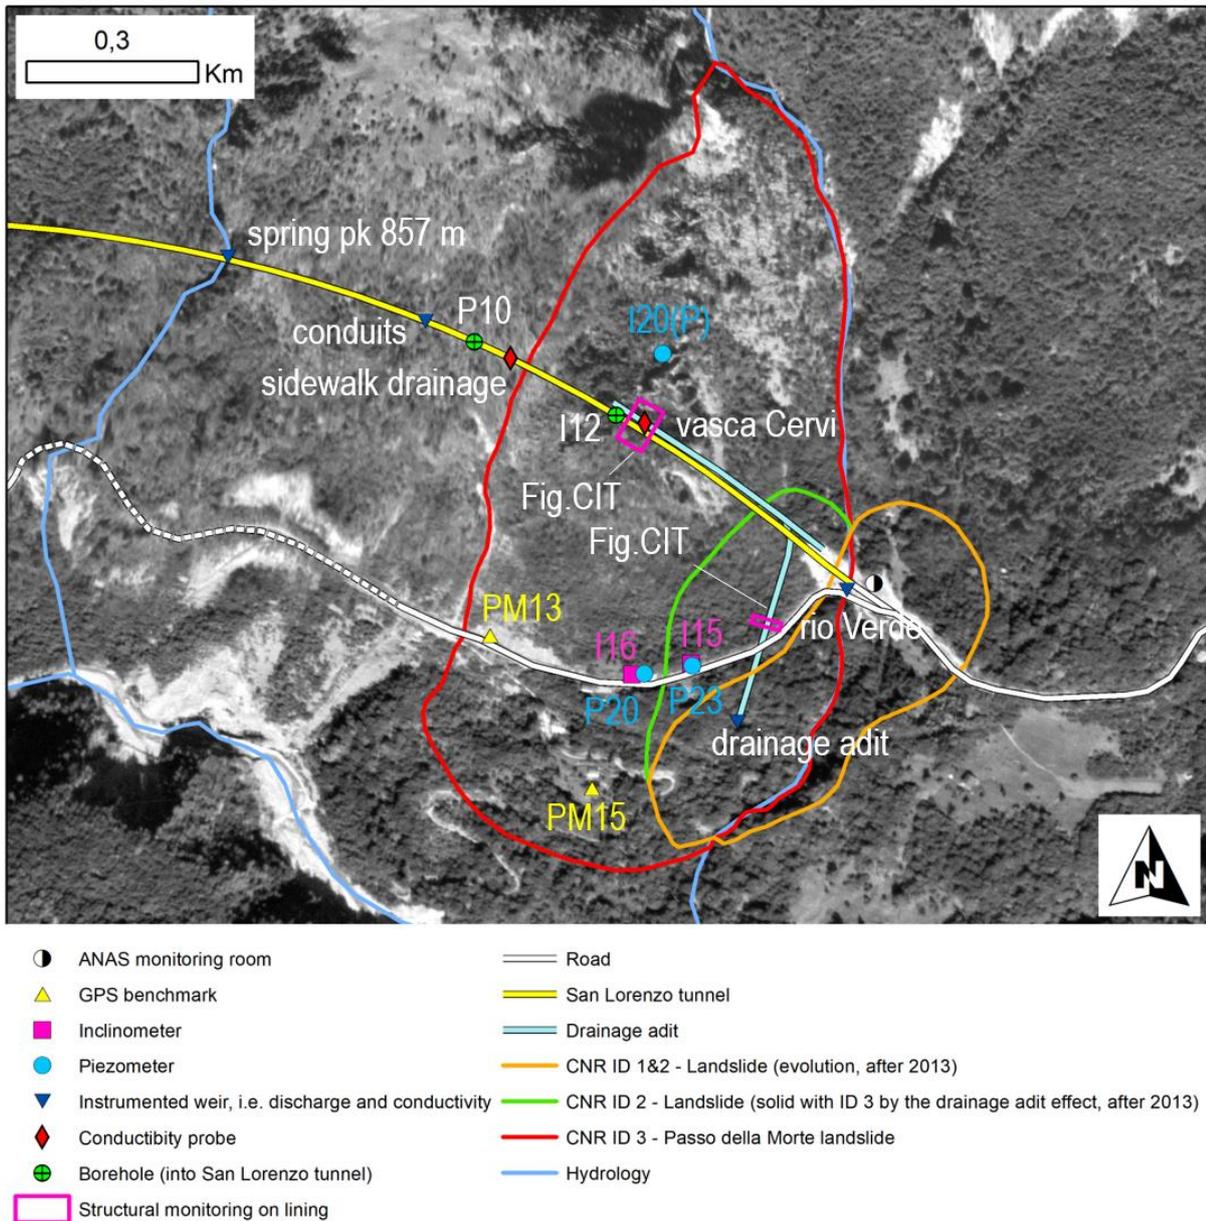
Figure 3-4 Monitoring network directly used in the current study

On January 2017, a piezometer has been installed in the I-20 borehole (previous denomination AM-14) to monitor the water table variation in the dolomite pillars region, i.e. the upper part of the landslide (Figure 3-4).

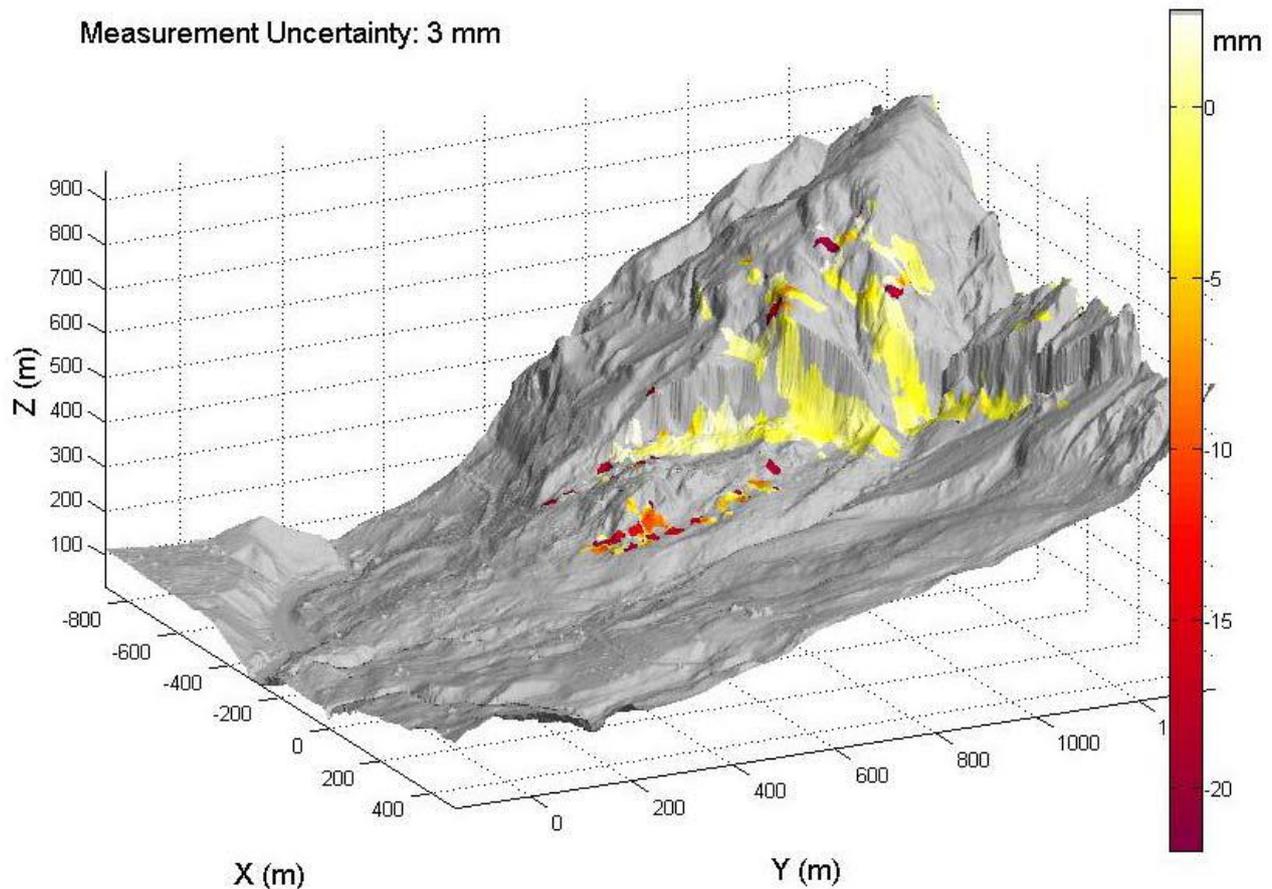
Figure 3-6 GB-InSAR displacements (campaign 2004-2005) [2]

The Passo della Morte landslide superficial displacements have been monitored by SAR both Ground and Satellite based. Ground Based radar (GBInSAR) was set up in Stavolo Mezzan. The acquisitions were done during two periods on December 2004 and July 2005. The radar was pointed on Col Cimin vertical walls and landslide 3 dolomite pillars area.

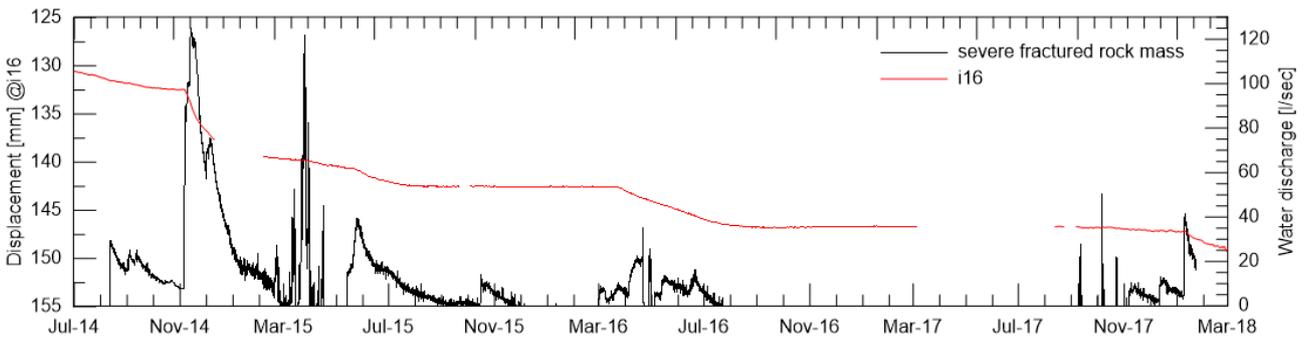
Figure 3-8 Correlation between slip surface deformation and severe fractured rock mass water discharge

Thanks to the continuous data set, in-place inclinometers allow landslide movement at the slip surface to be correlated with severe precipitation events and/or seasonal snow-cover melting [31]. Matching the I16 displacement trend with the P20 (Figure 3-4) groundwater table level (Figure 3-7) and the groundwater discharge from fractured dolomite (Figure 3-8)

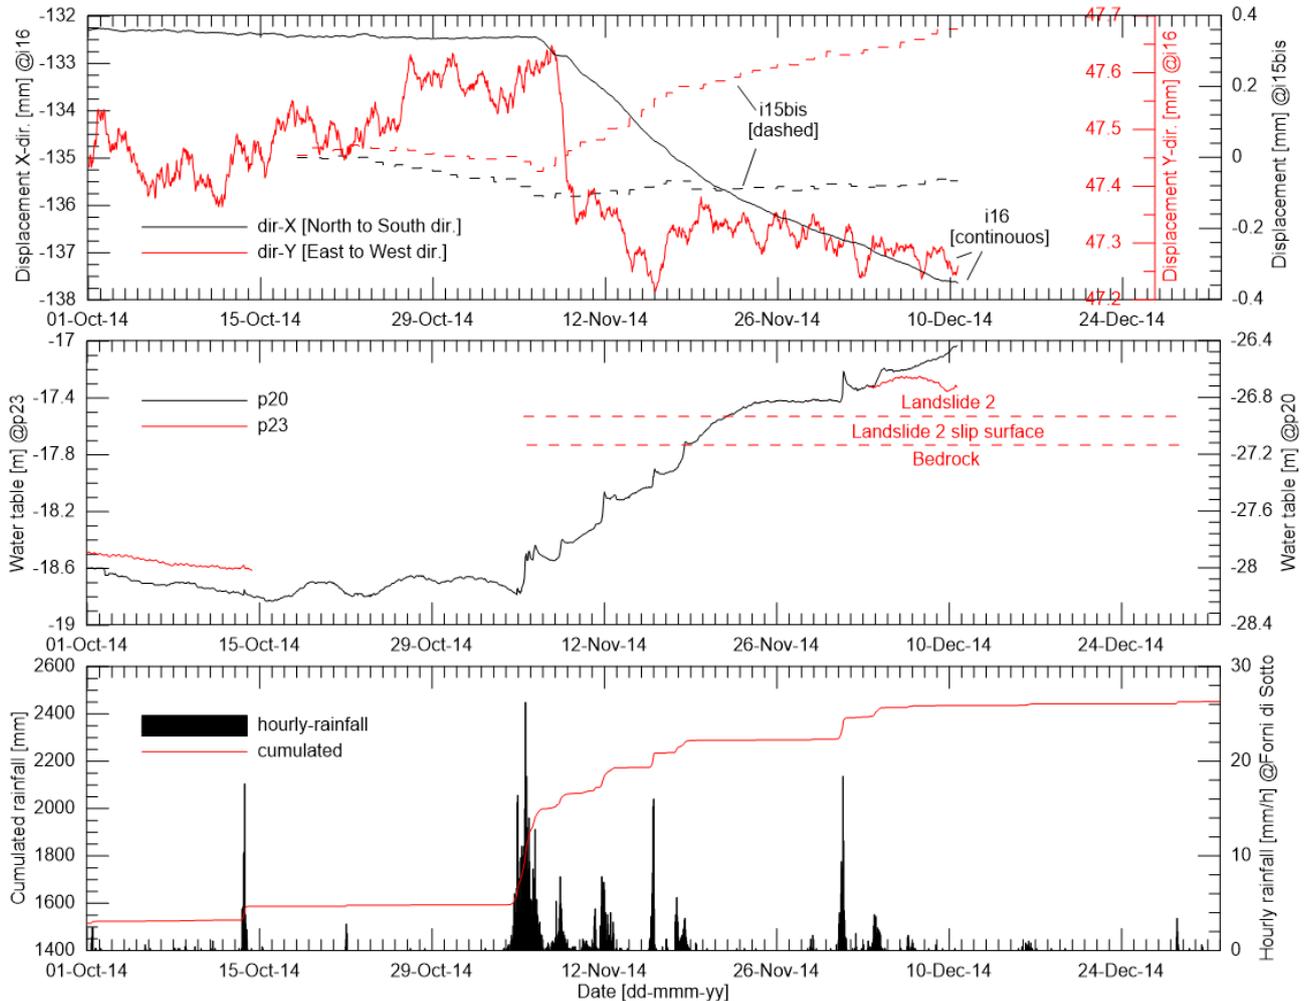
Figure 3-9 P20 and P23 water tables rising after the heavy rainfall on November 2014 and slope movement activations (I-16 on landslide 3, I-15 on landslide 2)

During the extreme event (650 mm in 12 days ca) on November 2014, the water table rising measured at P20 can be associated with the landslide body deformation thanks to the presence of the inclinometer I16 (Figure 3-7). In that figure, a similar behavior is shown by I15 recorded displacement.

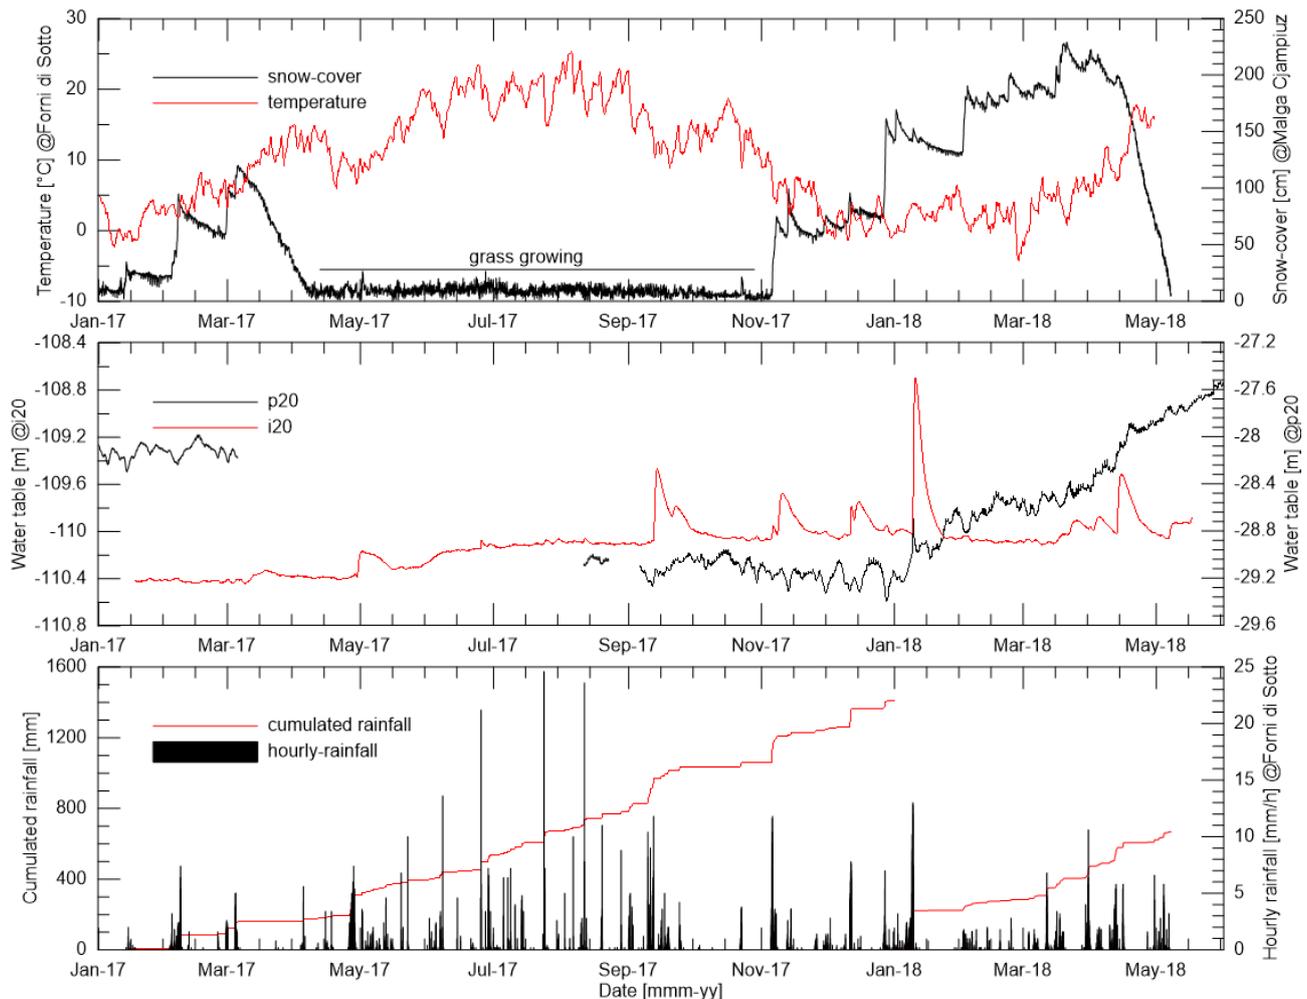
Figure 3-10 I-20 and P-20 water tables (2017-2018)

Analyzing the available 16 months dataset (Figure 3-10) it can be noticed that the water table in the dolomite pillars area is almost constant. The I20 groundwater table risings, up to 1.6 m, occurred during the most important annual infiltration events, either rainfall or snowmelt. Those peaks are generally flattened in less than 2 weeks. The I20 borehole stratigraphy report suggests that groundwater table level is localized in the coarse debris at the lower limit of the dolomite unit, around a meter above the clay-rich units. A comparison between P20 and I20 highlights the impulsive response with a higher activation threshold for the I20 signal.
