**DOTTORATO DI RICERCA IN  
INGEGNERIA CIVILE, CHIMICA, AMBIENTALE E DEI MATERIALI**

**INFRASTRUCTURE MAINTAINANCE  
AND COUNTERMEASURES PLANNING  
IN COMPLEX GEOLOGICAL  
AND GEOMORPHOLOGICAL SETTINGS**

PRESENTATA DA GIACOMO TEDESCO

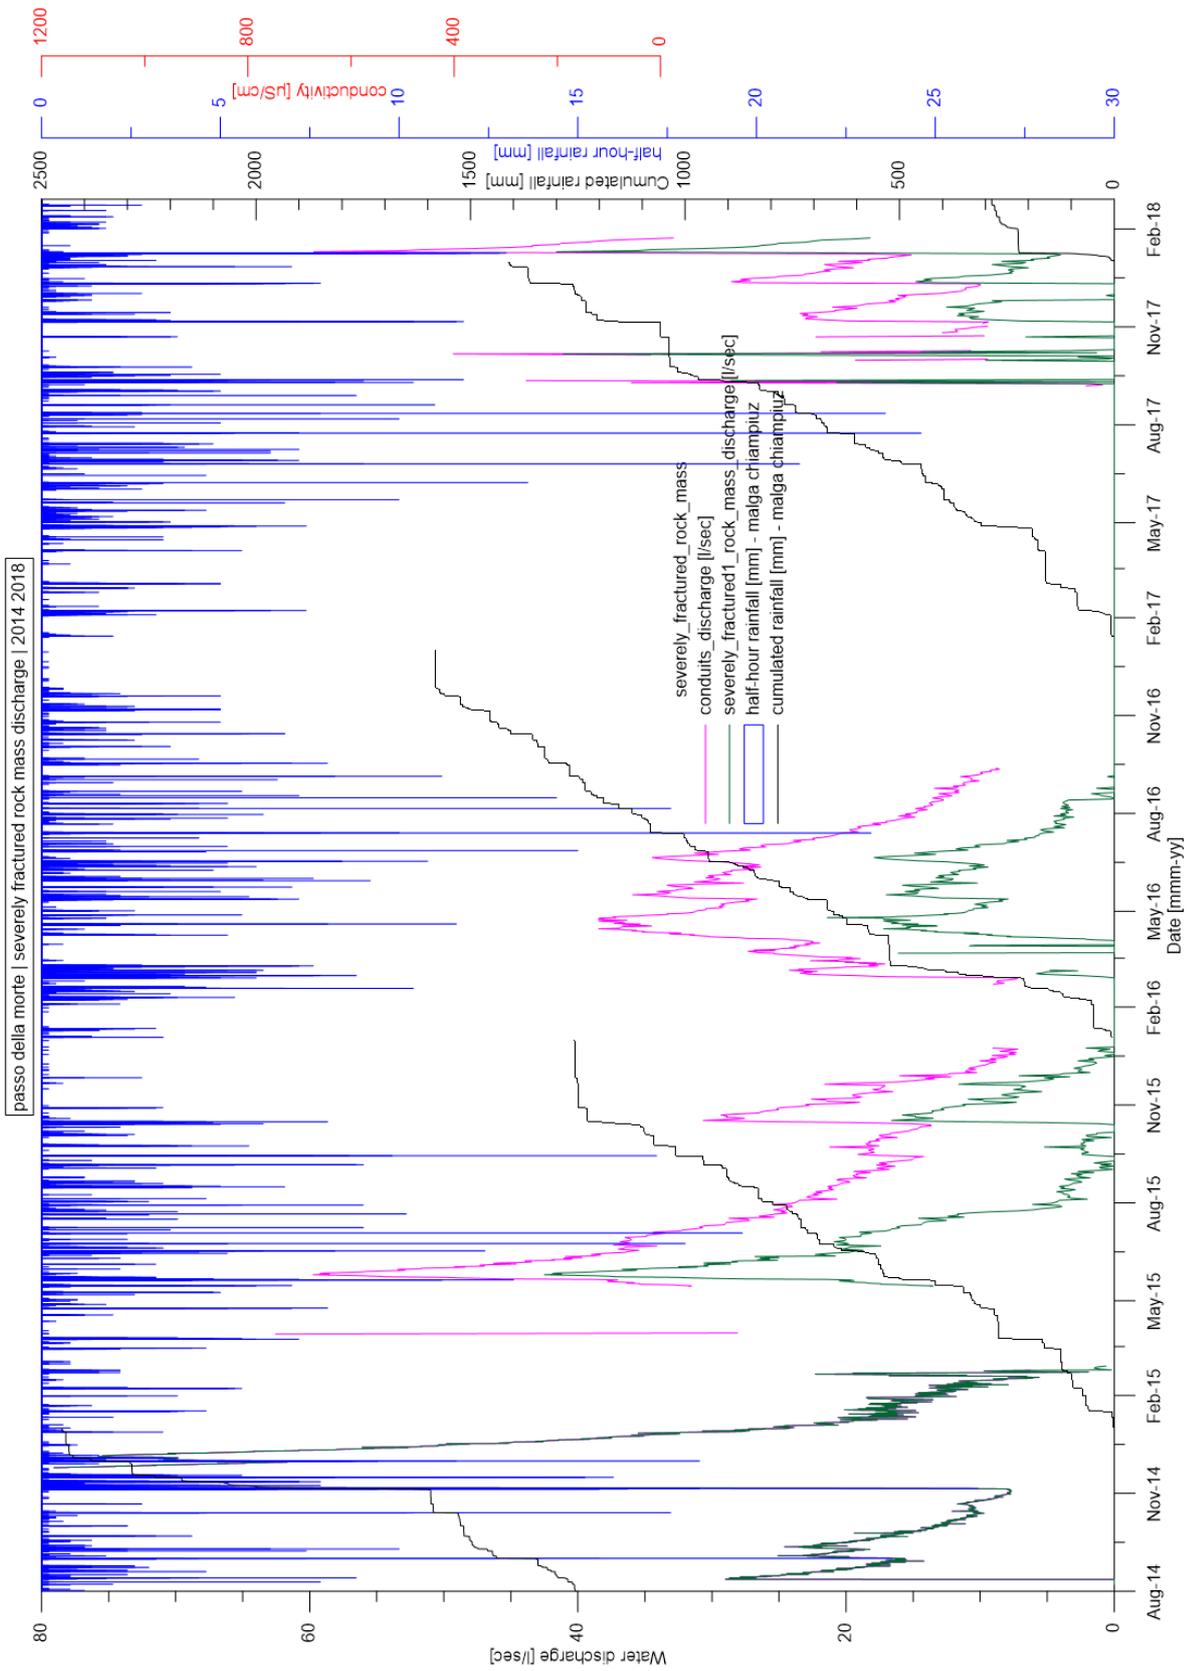
Figure 3-11 Severely fractured rock-mass and San Lorenzo conduits discharge (2014-2018)

The idea leading to the conduits discharge measurements is that the difference between this value and the spring pk 857 m value it might be a good estimation of the severely fractured dolomite discharge (Figure 3-11). That 150 m long section of the San Lorenzo tunnel (starting at pk 450 m

ca) is intercepting the groundwater circulation in the dolomite tectonized by overthrusting. Before April 2016, the spring discharge was flowing on another instrumented weir, so the conduits discharge could be reasonable assumed as completely originated by the fractured dolomite.

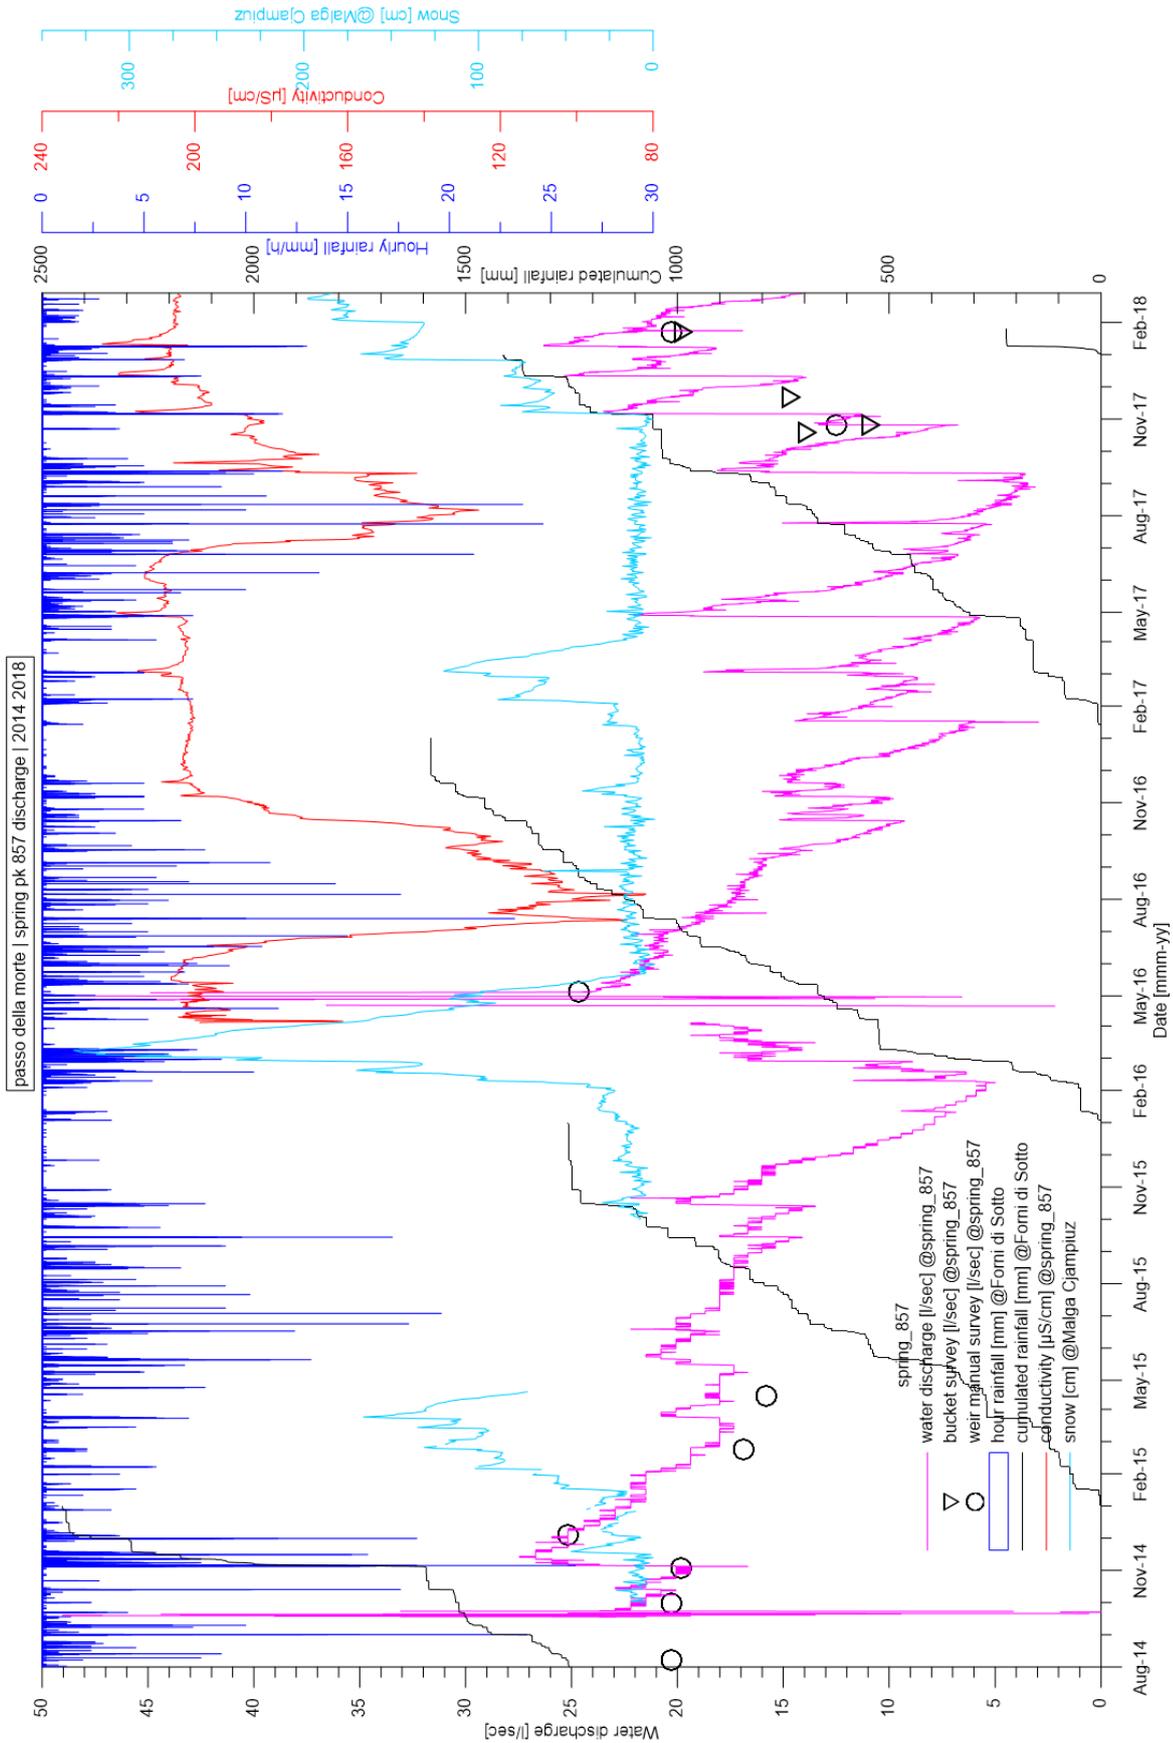
Figure 3-12 Spring pk 857 m water discharge

Discharge measures have been frequently verified by alternative methods: catching the water flow and timing the fill-time of a 75-liters pool and by analytic formulae on manual level measures on the notch section (spot measures in Figure 3-12).

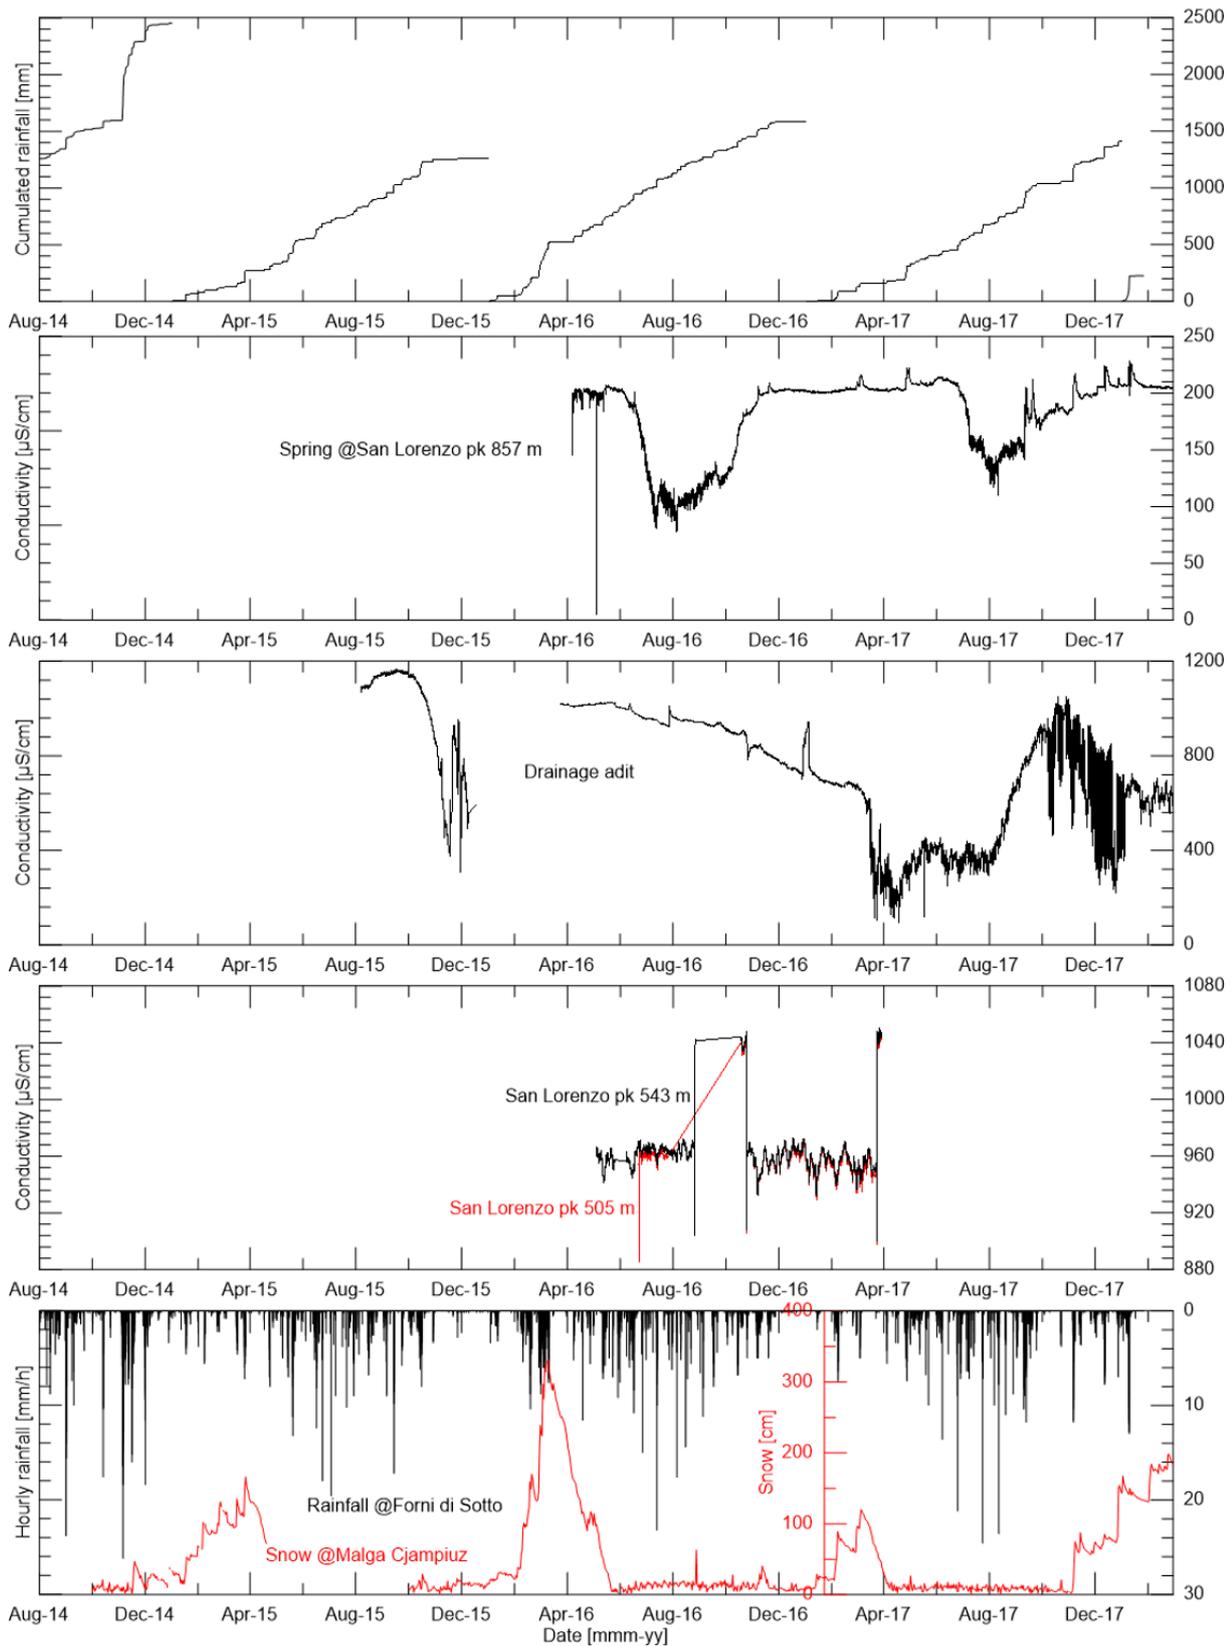
Figure 3-13 From the top: cumulated rainfall, electric conductivity at spring pk 857, at drainage adit, into San Lorenzo tunnel, hourly rainfall (black) and snow cover (red). For the location, see Figure 3-4.

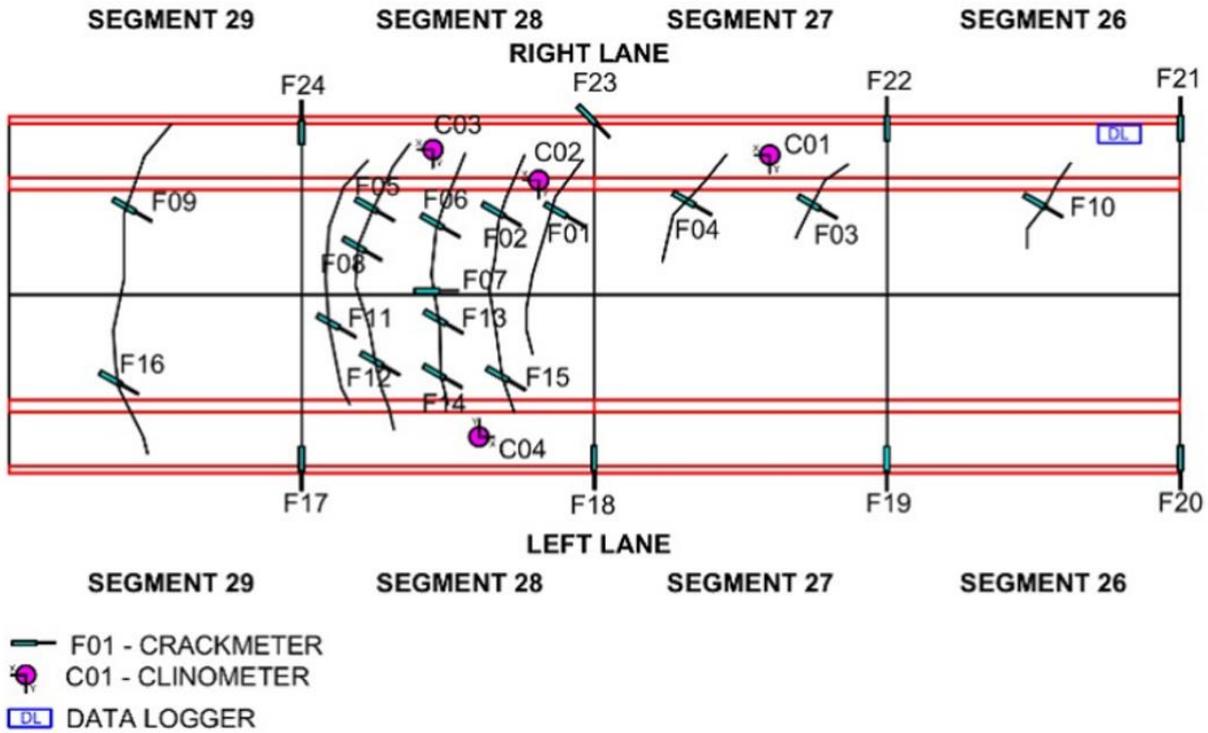
Figure 3-15 Structural monitoring on lining segments 26-29 of the San Lorenzo tunnel

The monitoring system is composed by 24 crackmeters, 4 bi-axial clinometers and a low cost plastic optical fiber sensor.

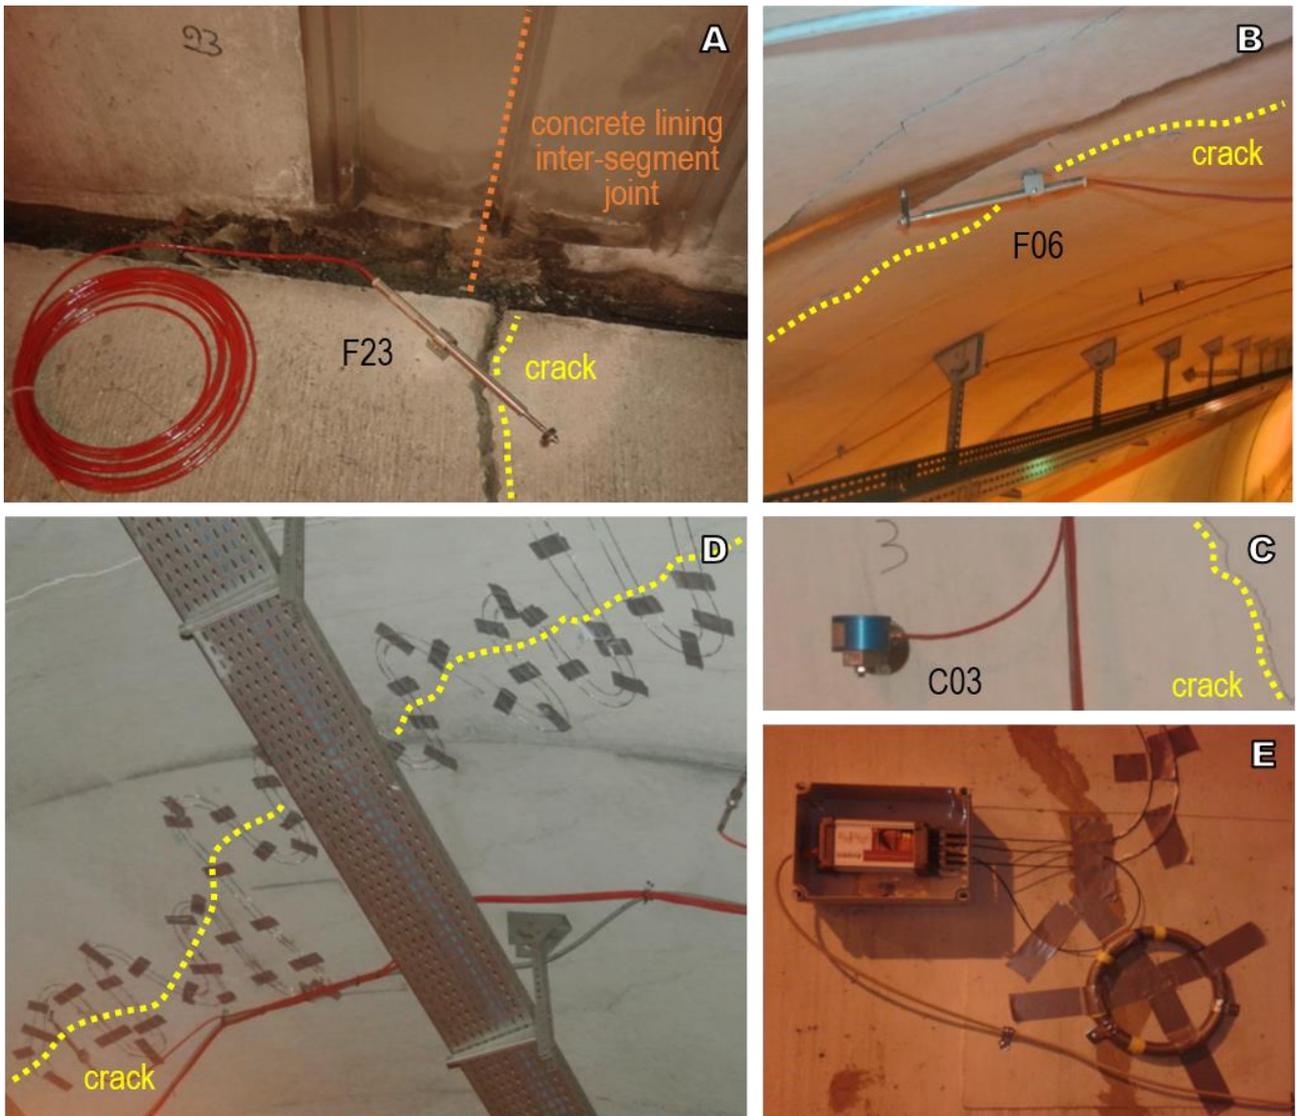
Figure 3-16 Monitoring instruments at tunnel lining segment 26-29. Clockwise: crackmeter F23 on lining joint, (B) crackmeter F06 on the roof, (C) clinometer C03 on the roof, optical fiber on the roof (D), reference fiber loop installation loop (E)

Active instrumentation is shown in Figure 3-16. In the concrete lining, the crackmeter were installed inclined of 45° with the main crack direction.

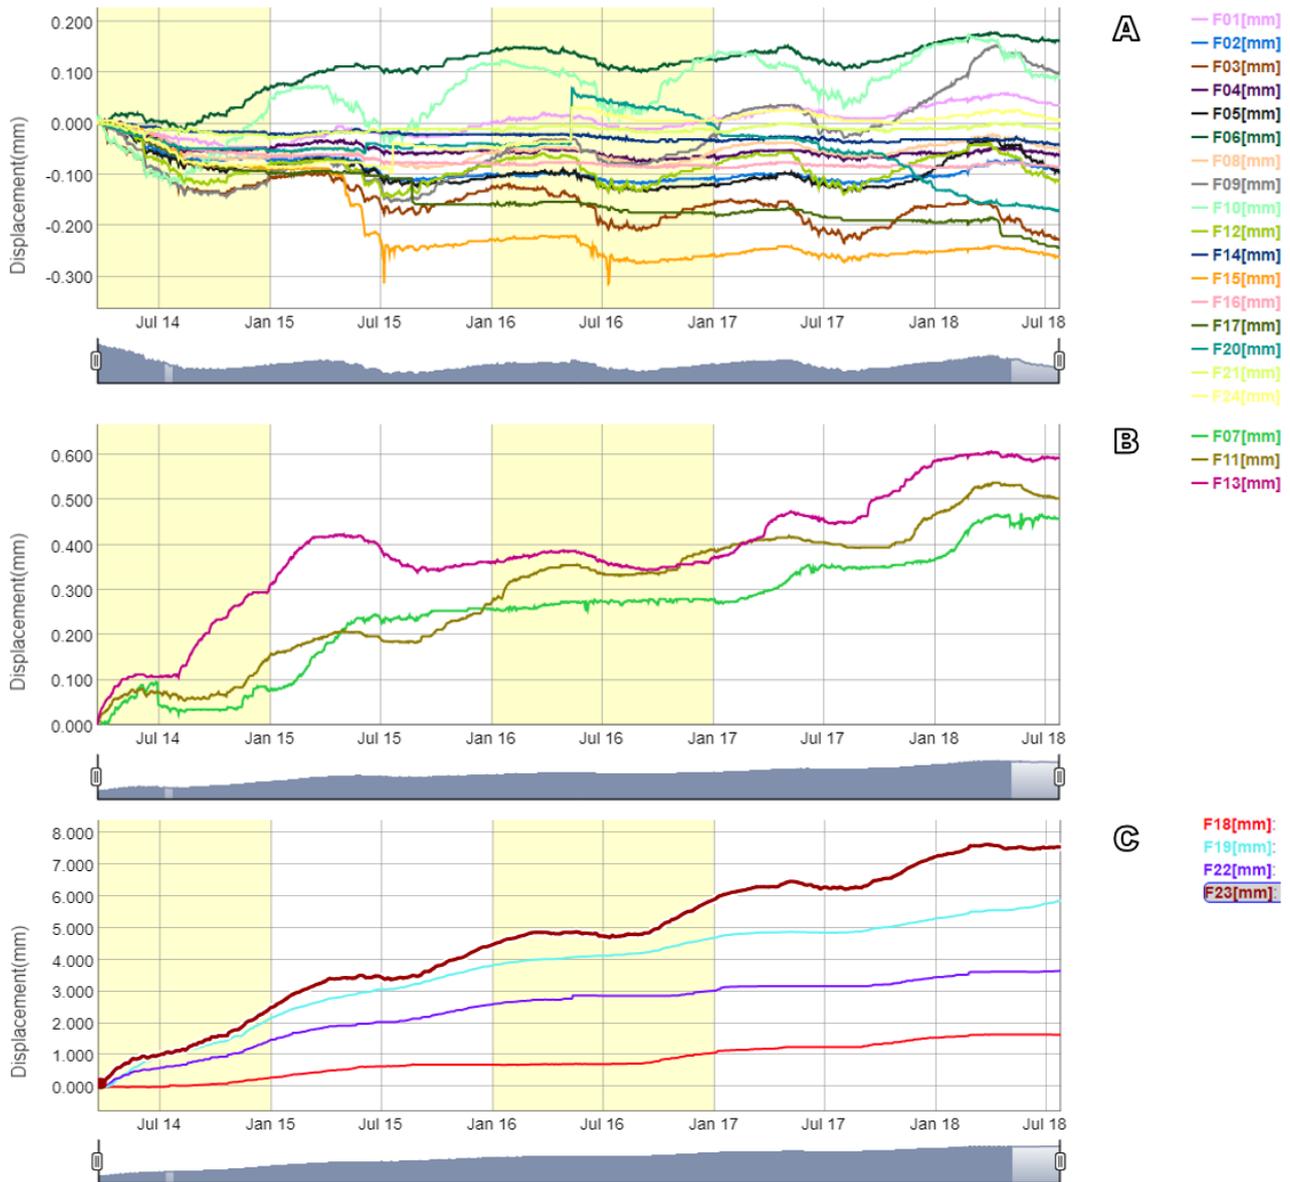
Figure 3-17 Deformations in the road tunnel lining. Instruments are grouped by the displacements magnitude, up to 0.2 mm (A), 0.6 mm (B) and 8 mm (C, 2014-2018. Screenshot of the online monitoring portal).

In Figure 3-17 the bar extensometers displacements is presented, instruments trends are grouped based on the vector magnitude, relatively up to 0.2, 0.6 and 8 mm. Generally, cracks show an opening trend. Extensometers can be gathered together by those installed on the lining cracks and in inters-segments lining joints.

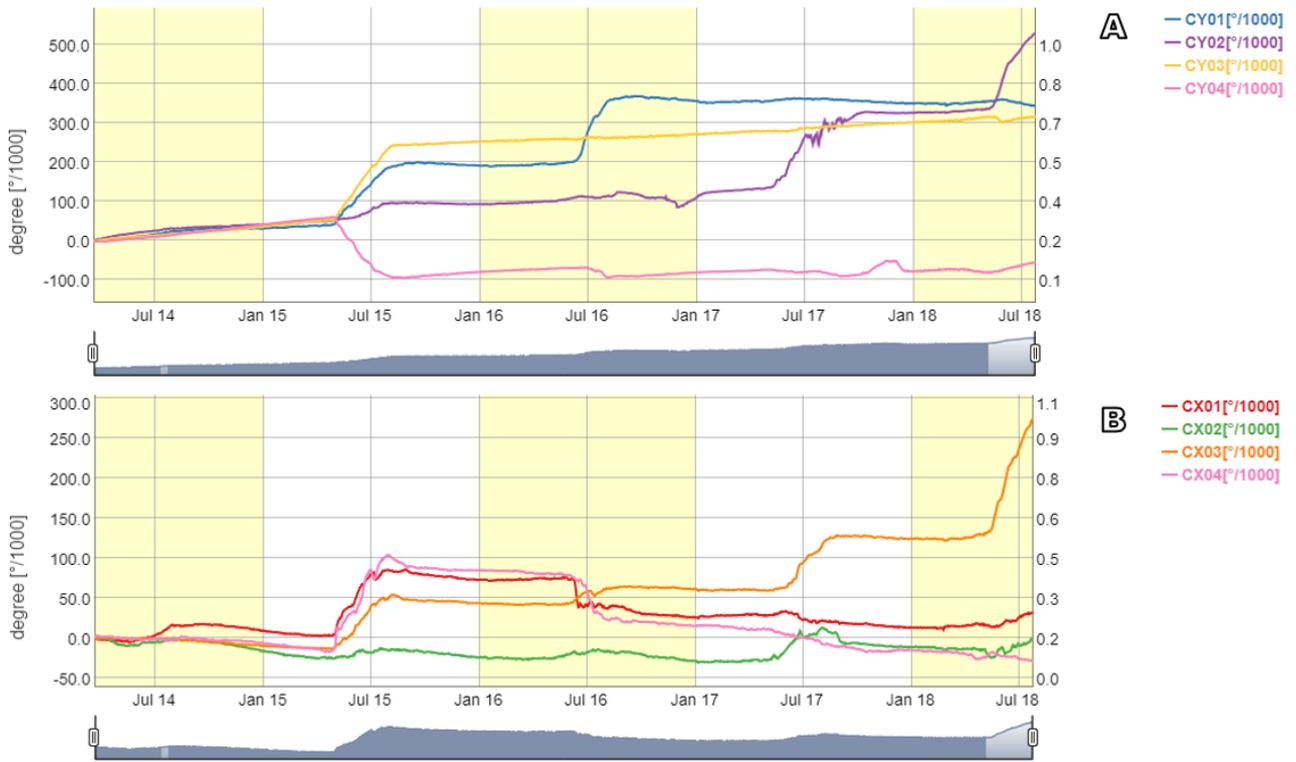
Figure 3-18 Rotations in the road tunnel lining. Top-down: (A) rotations perpendicular to the tunnel axis, (B) rotations parallel to the tunnel axis (2014-2018. Screenshot of the online monitoring portal).

The cumulated tilt angles measured by four clinometers is graphed in Figure 3-18 divided between perpendicular (A) and parallel (B) to the tunnel axis. In 2015, clinometer C04 change his rotation pattern, which might suggest a kind of plastic hinge in the concrete lining [31]. This observation can anticipate a loosening of stiffness of the tunnel section.

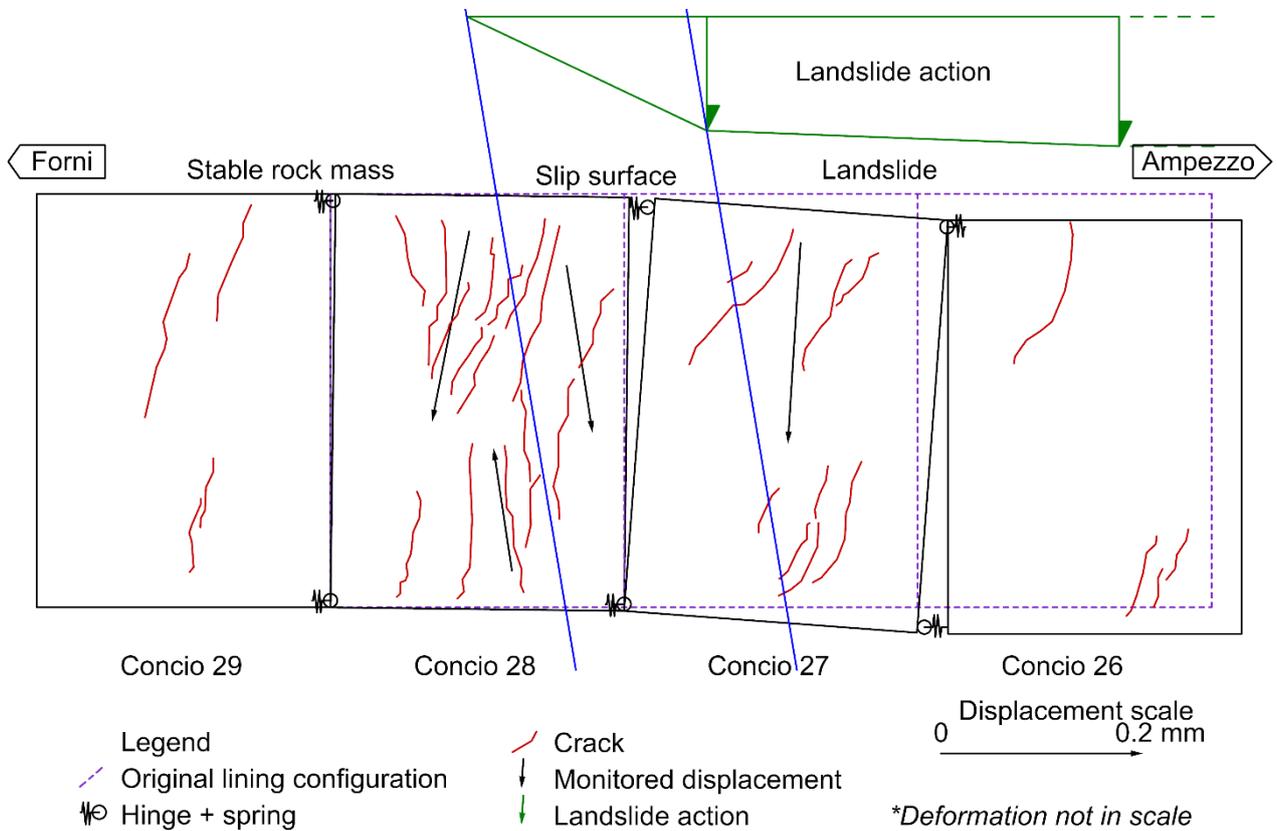
Figure 3-19 Proposed static scheme of the tunnel lining at the landslide crossing (segments 26-29)

A simplified scheme of the concrete lining crossing the slip surface at pk 300 m ca is proposed in Figure 3-19.

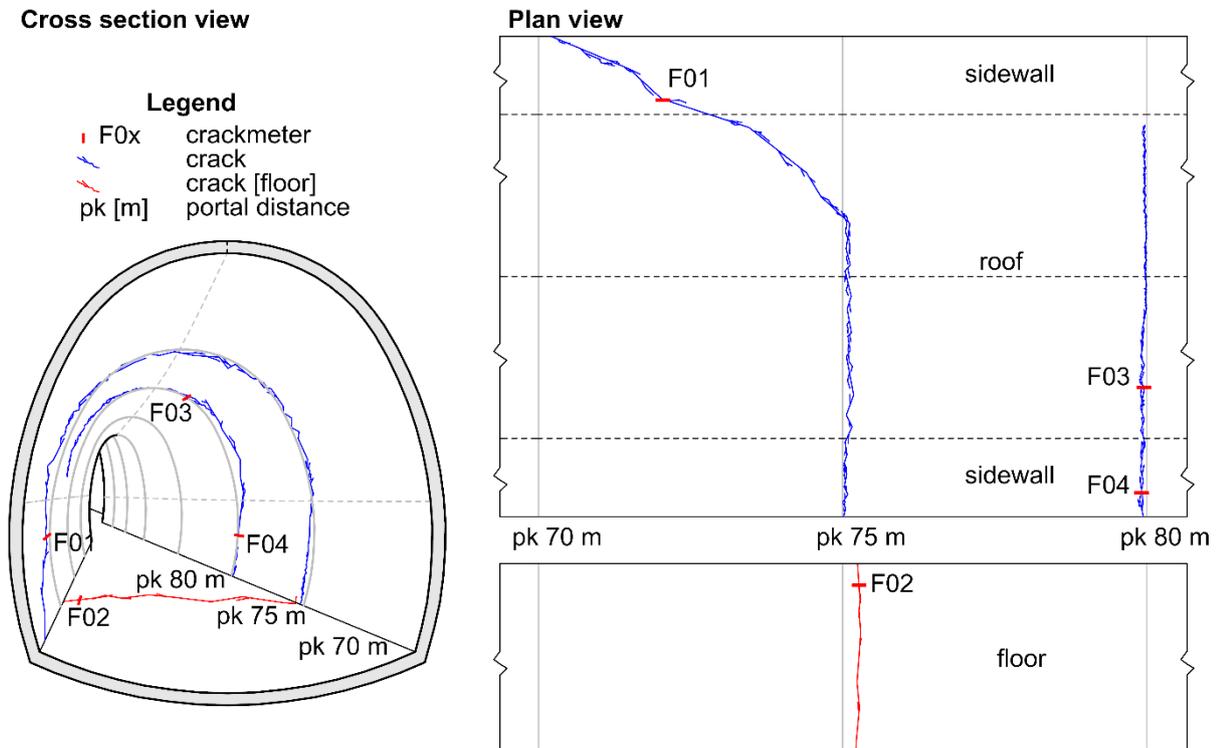
Figure 3-20 Structural monitoring in the drainage tunnel lining

On the first week of August 2017, four crackmeters were installed in the drainage tunnel lining where the tunnel left the landslide body entering in the sound rock mass. This new monitoring section become necessary in order to establish a correlation between rainfalls, i.e. landslide activity, and damaging the concrete lining. In Figure 3-20, the instrumented tunnel sections are shown.

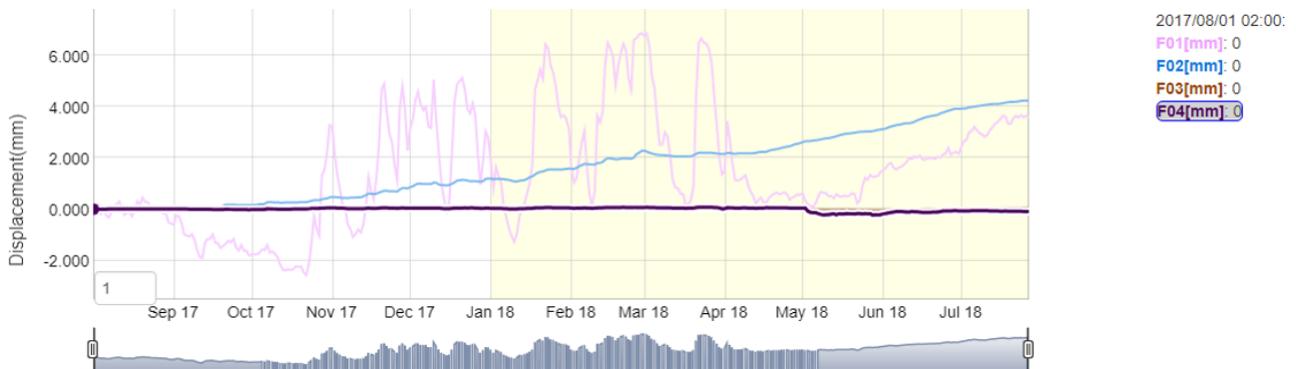
Figure 3-21 Deformations in the drainage tunnel lining (2017-2018. Screenshot of the online monitoring portal)

In Figure 3-21, the lining deformations of the drainage adit are shown for the monitored time span. Irregularity on crackmeter F01 signal is probably related to a bad quality data transmission due to a too long cable path between data logger and transmission device, i.e. the distance entrance-monitored section is around 80 meters.

Crackmeters F01 and F02 shown an opening tendency, the displacements are in the order of magnitude of few millimeters. On the contrary, crackmeters F03 and F04 present negligible records.

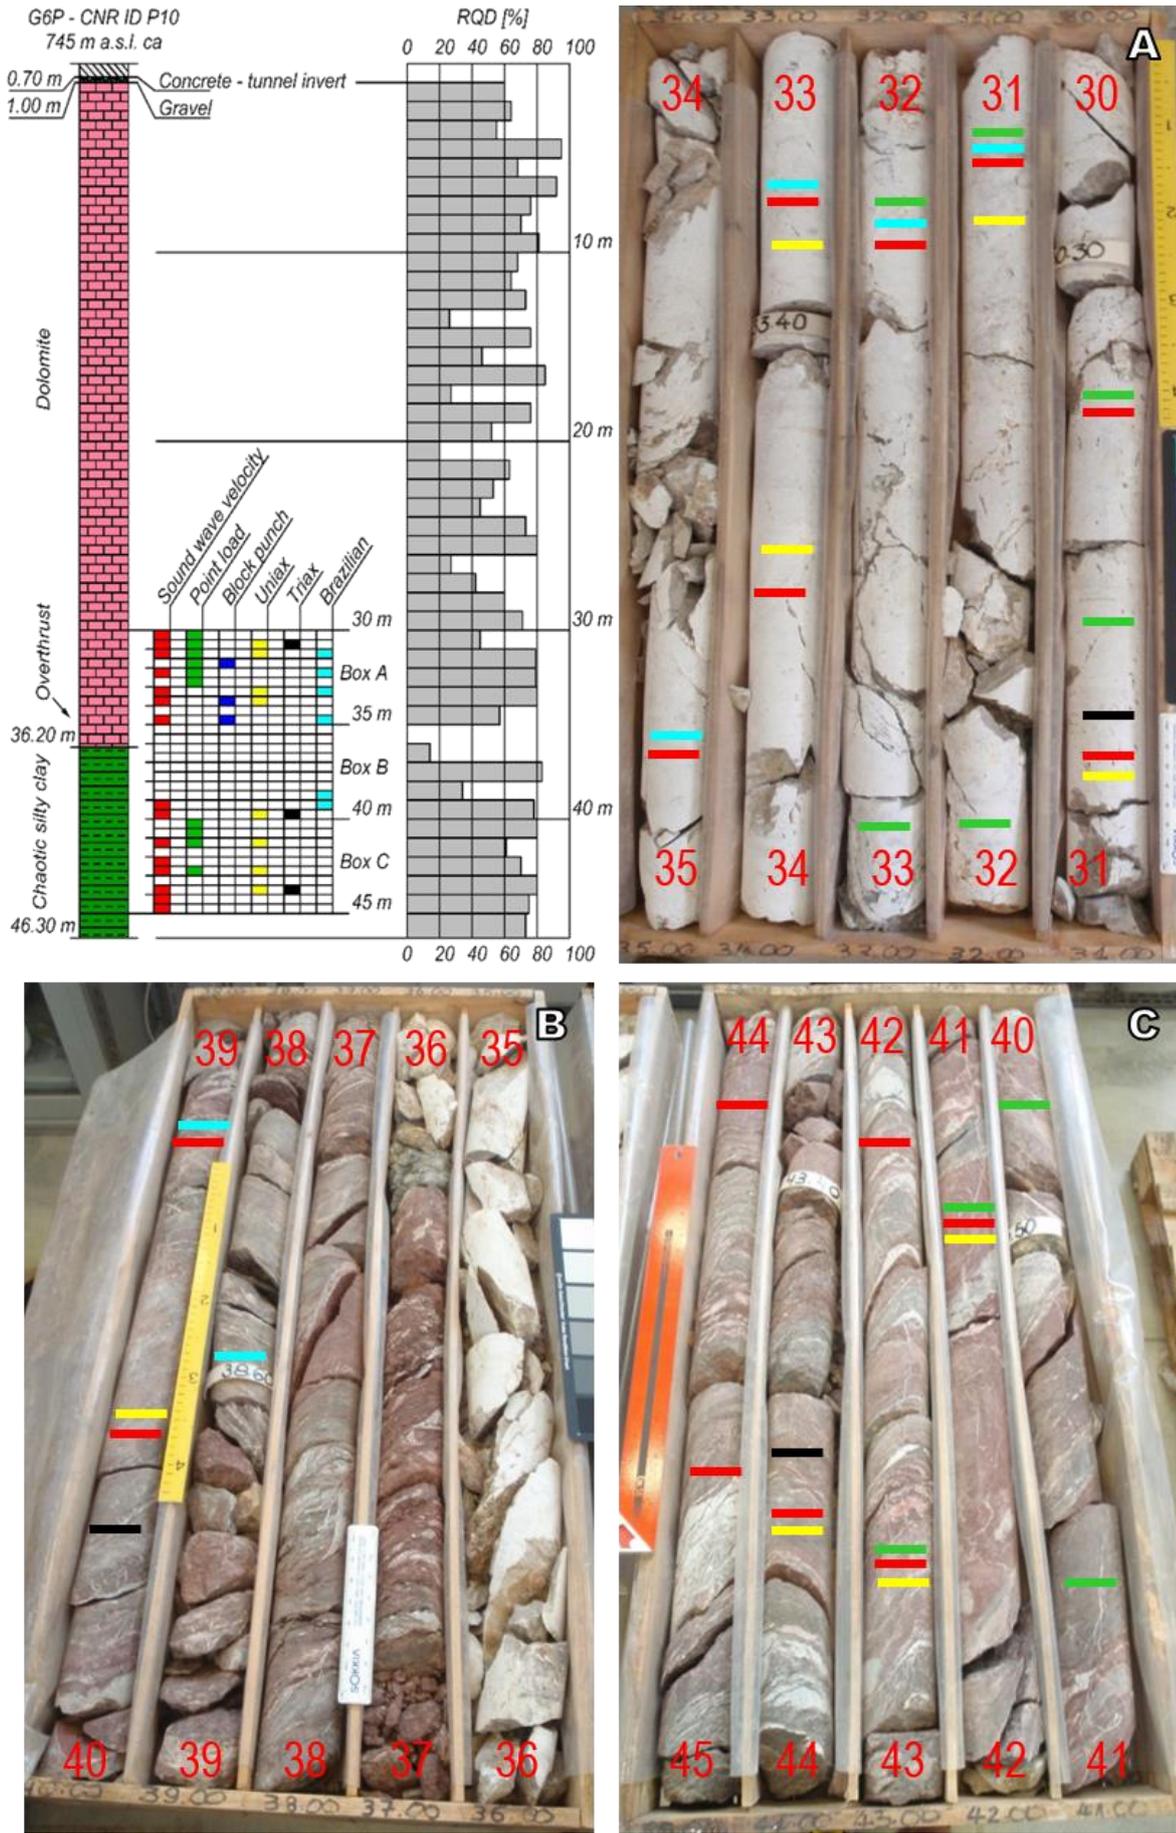
Figure 4-1 G6P (P10) core log boxes and testing localizations

The specimens were taken from G6P borehole (Figure 3-4), where the dolomite-clay transition was detected at 36.20 m depth. In the boxes well-maintained 15-years old core logs, with a diameter of 100 mm can be found.

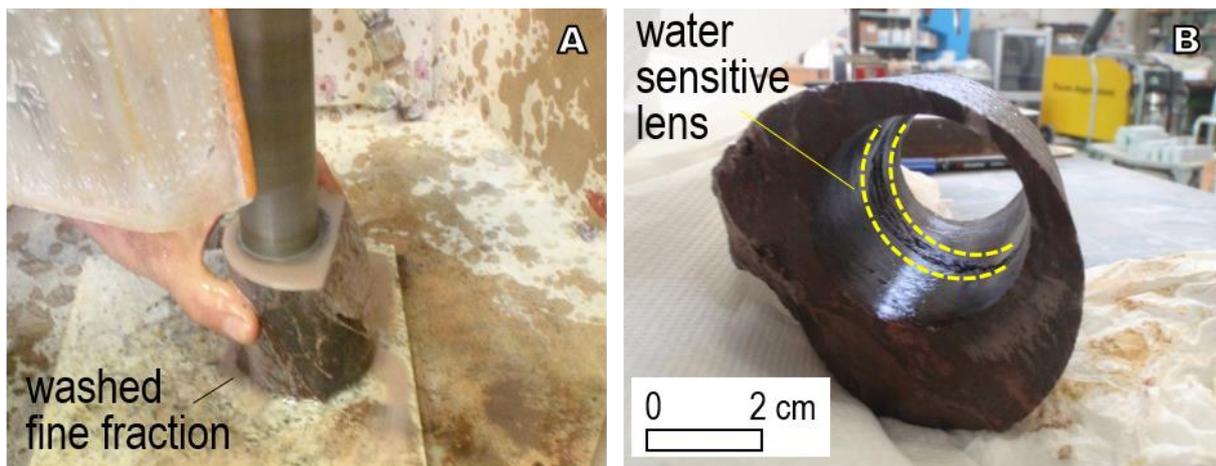
Figure 4-3 Sample coring: a visible lens of water sensitive material (left), muddy drilling fluid, i.e. water (right)

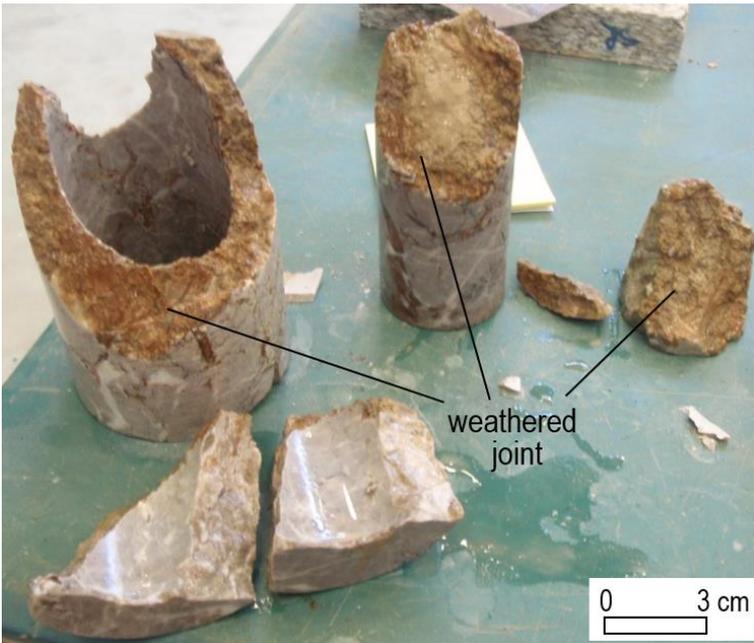
Figure 4-4 Open fracture in a dolomite specimen intercepted during coring stage

The coring of the dolomite material was generally more effective, with the exception of the logs nearby the overthrust surface. Frequently, those samples broke up along pre-existing open fractures (Figure 4-4)

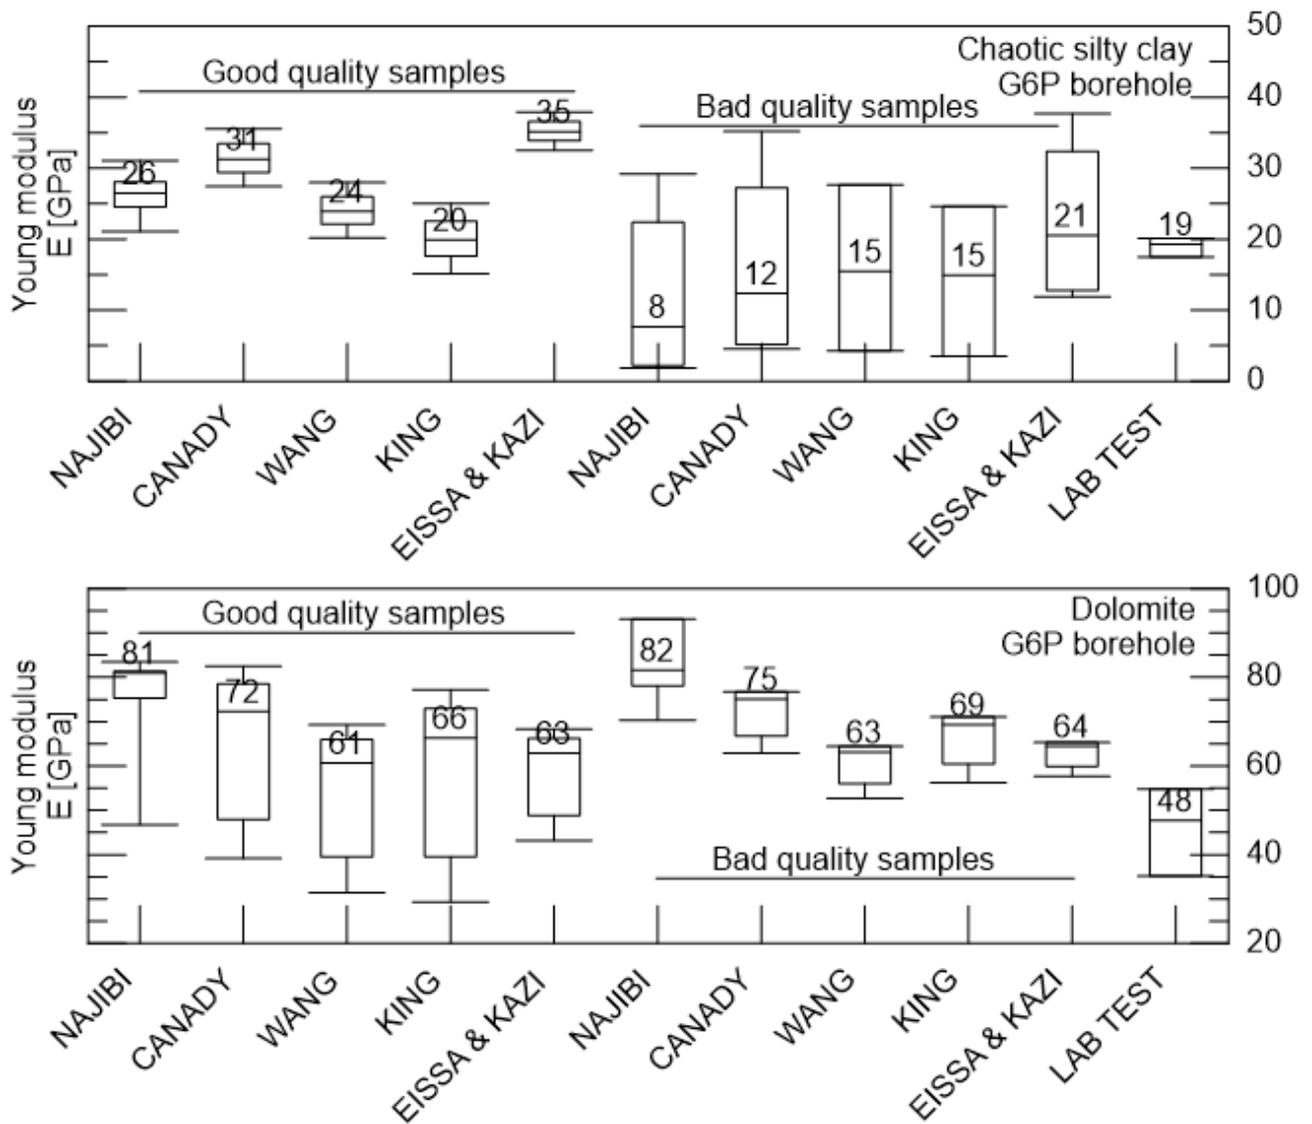
Figure 4-6 Young modulus calculated with different formulae and derived from lab testing

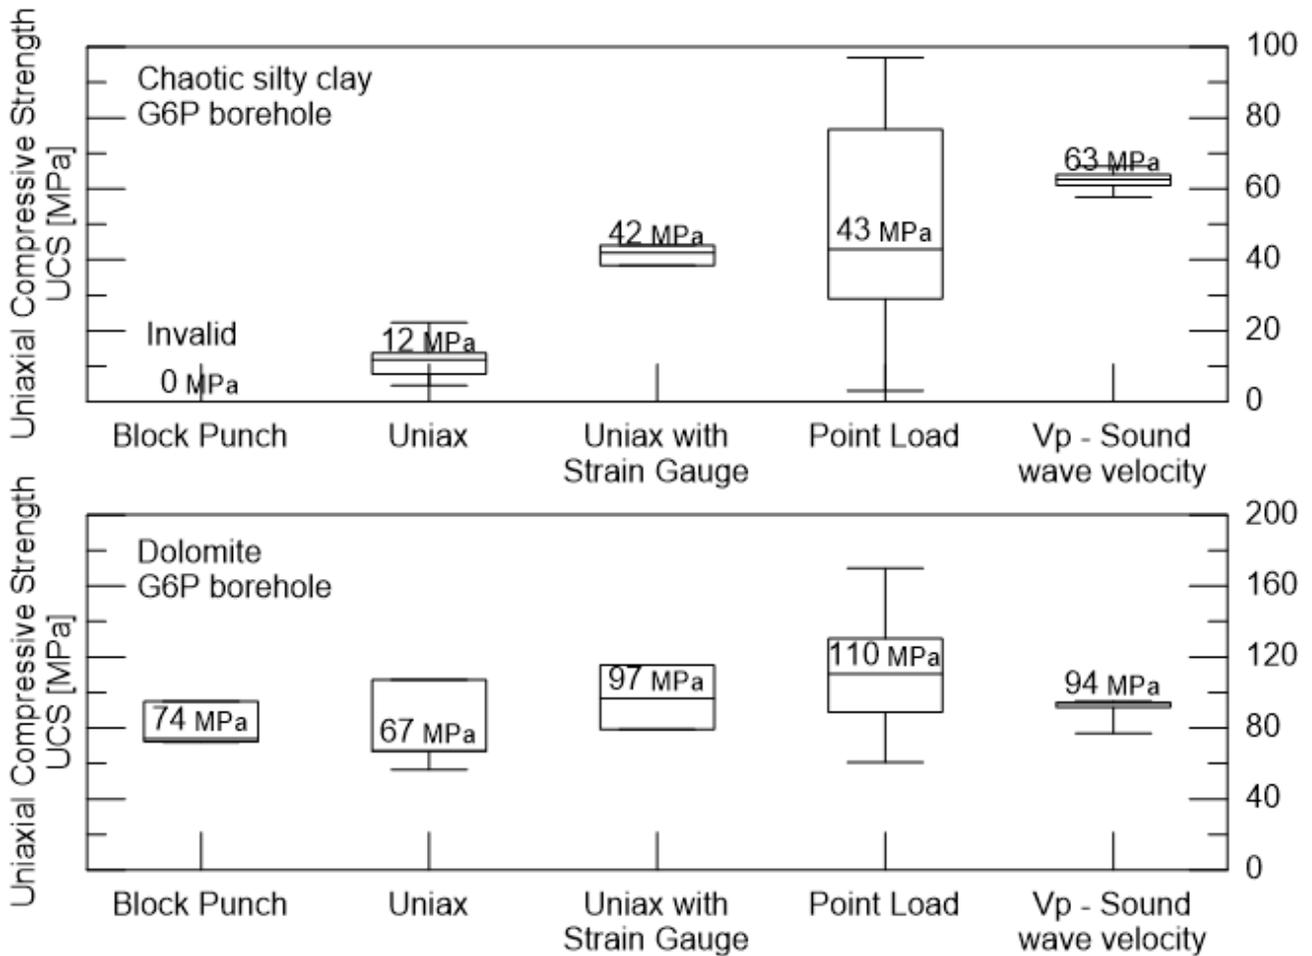
Figure 4-7 Uniaxial Compressive Strength

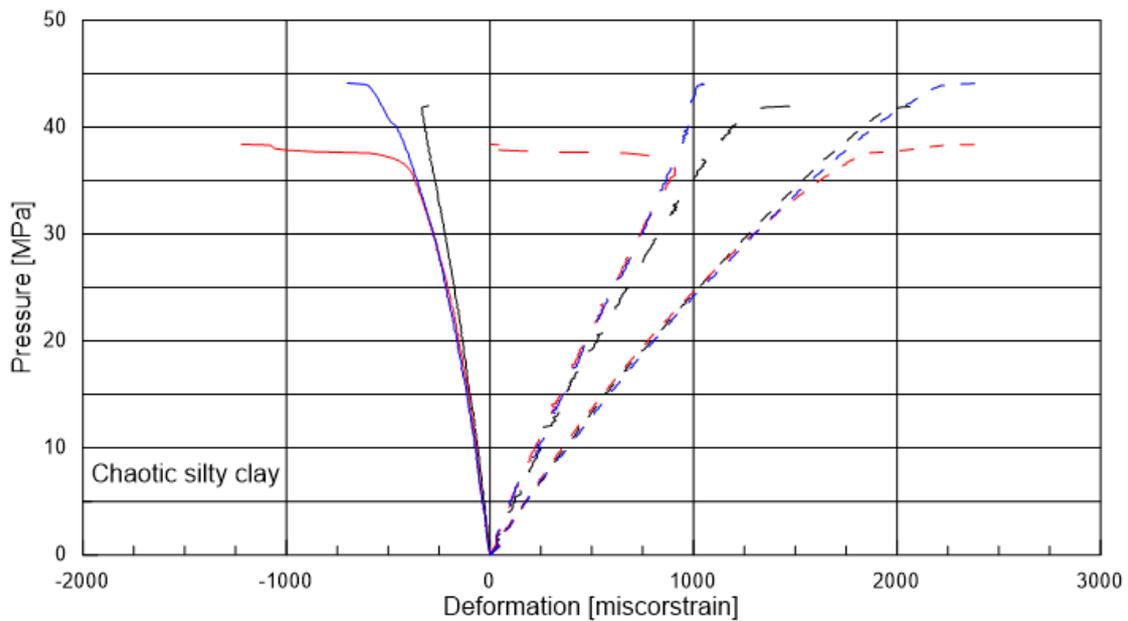
Figure 4-8 Uniaxial compression tests equipped with strain gauges

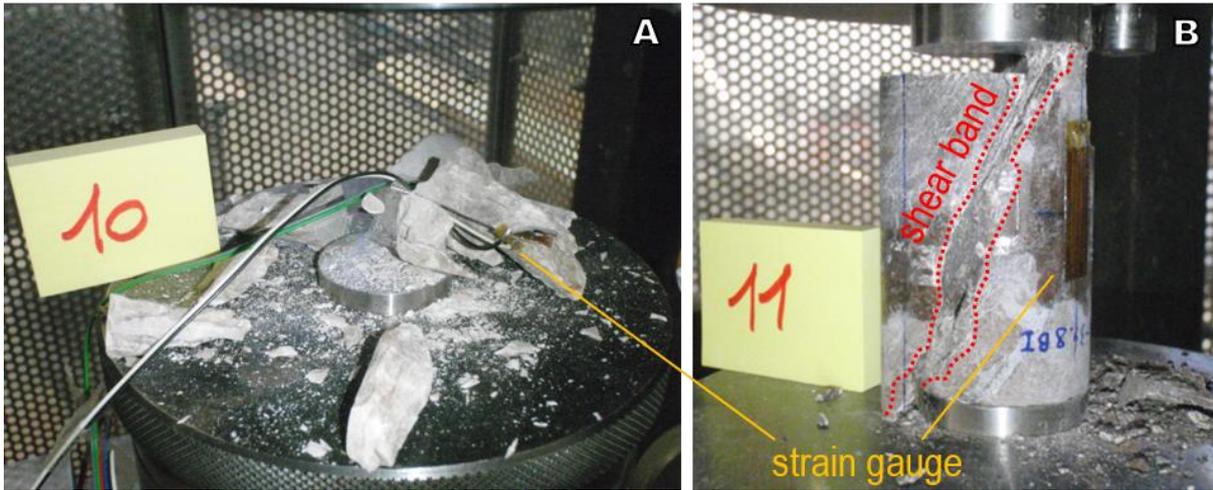
Figure 4-9 Uniaxial test on dolomite (A) and chaotic silty clay (B)

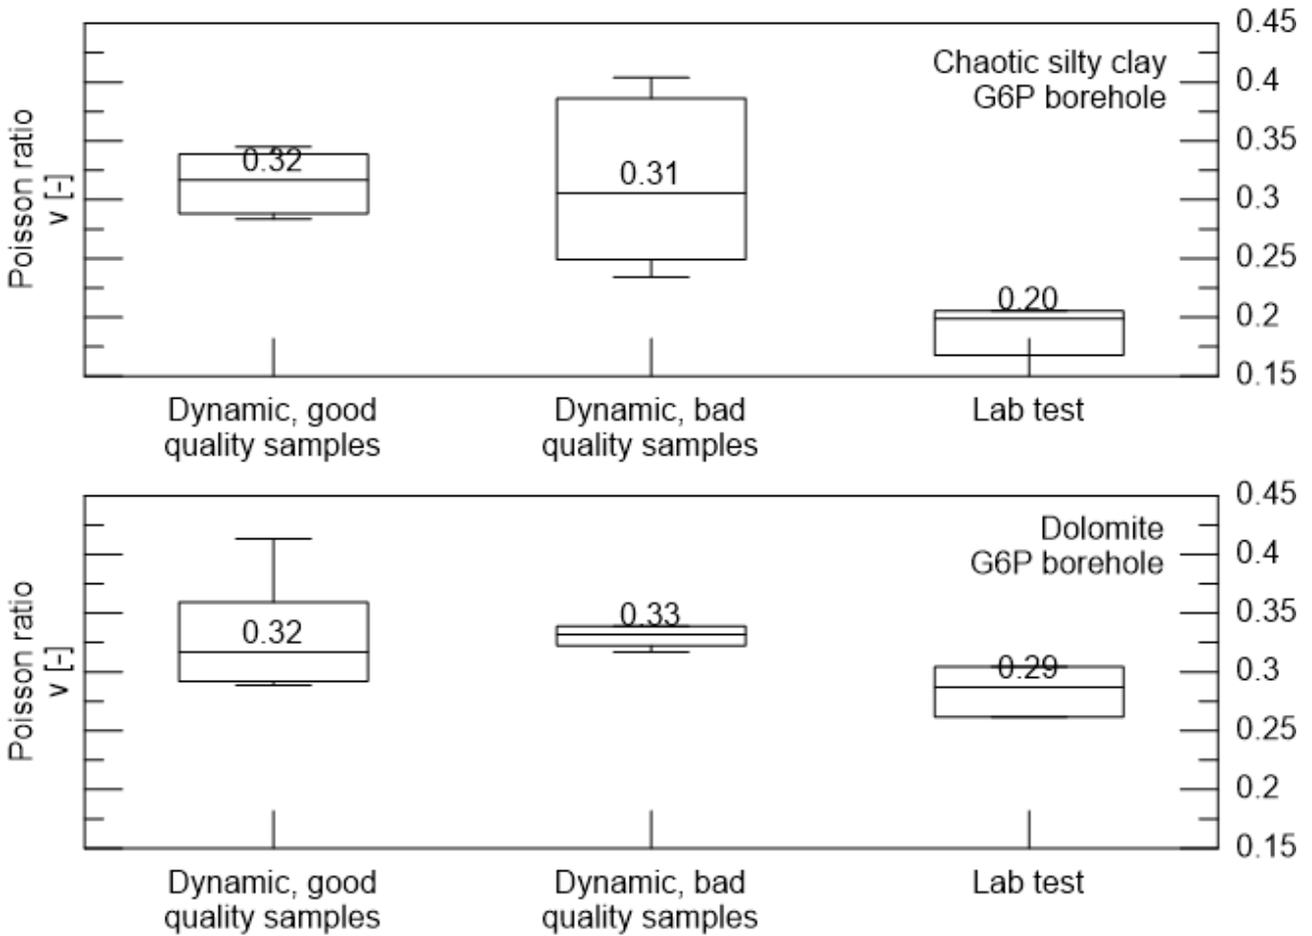
Figure 4-10 Poisson ratio
