**DOTTORATO DI RICERCA IN  
INGEGNERIA CIVILE, CHIMICA, AMBIENTALE E DEI MATERIALI**

**INFRASTRUCTURE MAINTAINANCE  
AND COUNTERMEASURES PLANNING  
IN COMPLEX GEOLOGICAL  
AND GEOMORPHOLOGICAL SETTINGS**

PRESENTATA DA GIACOMO TEDESCO

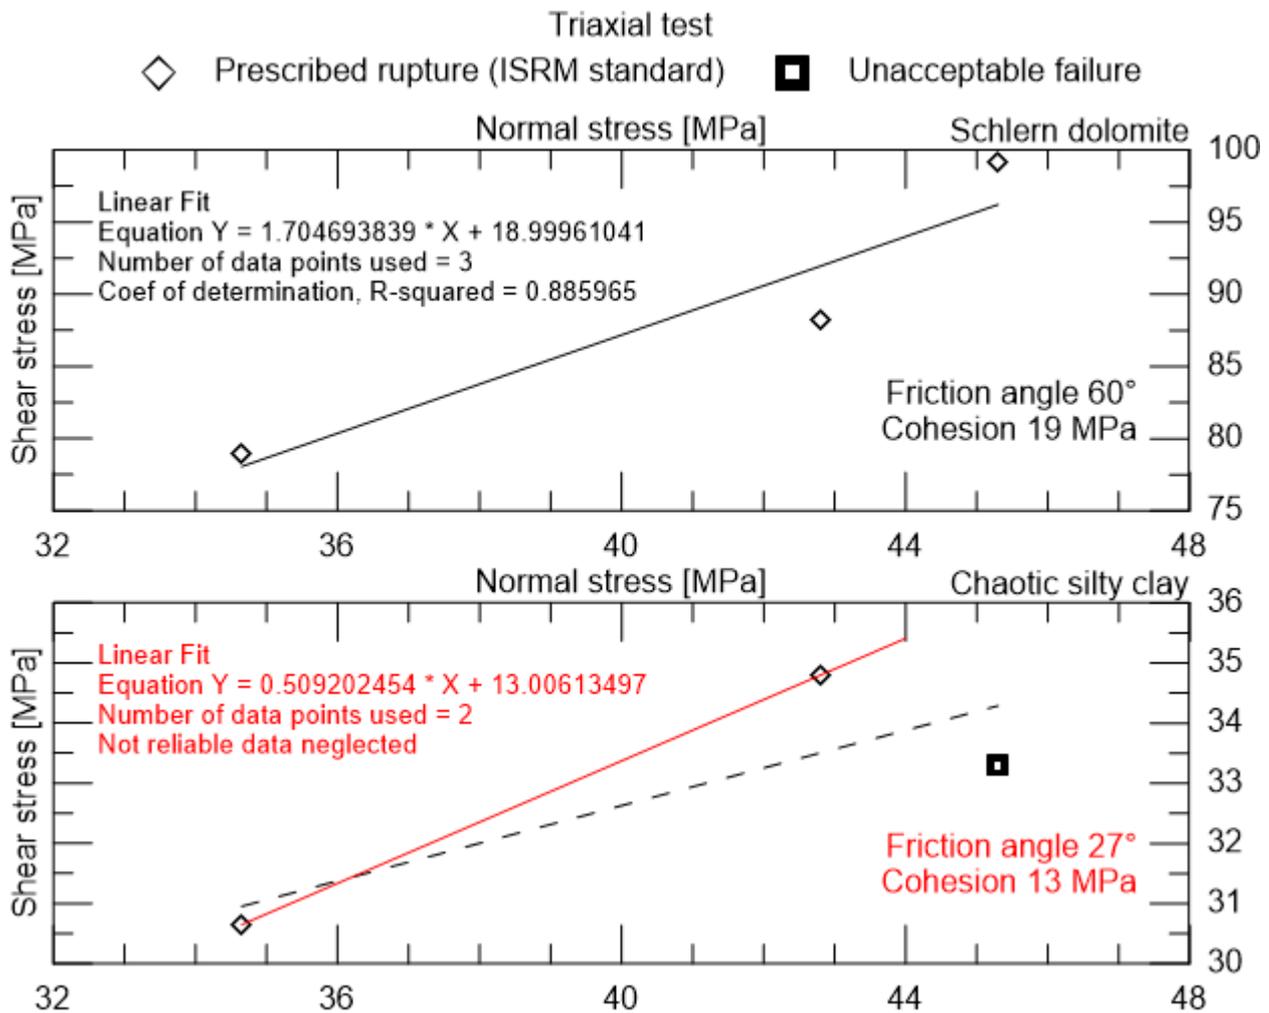
Figure 4-11 Triaxial test

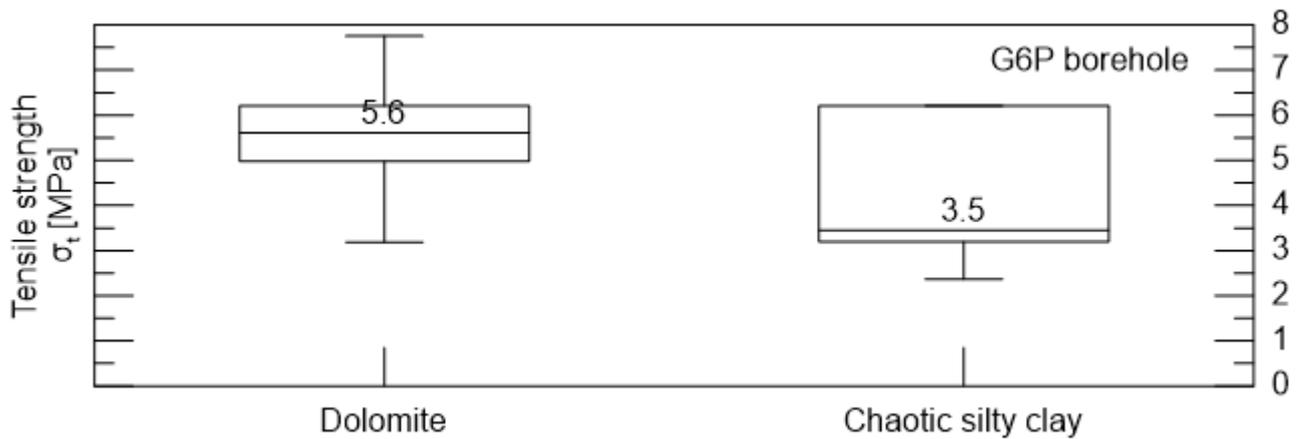
Figure 4-12 Tensile strength from indirect (Brazilian) test

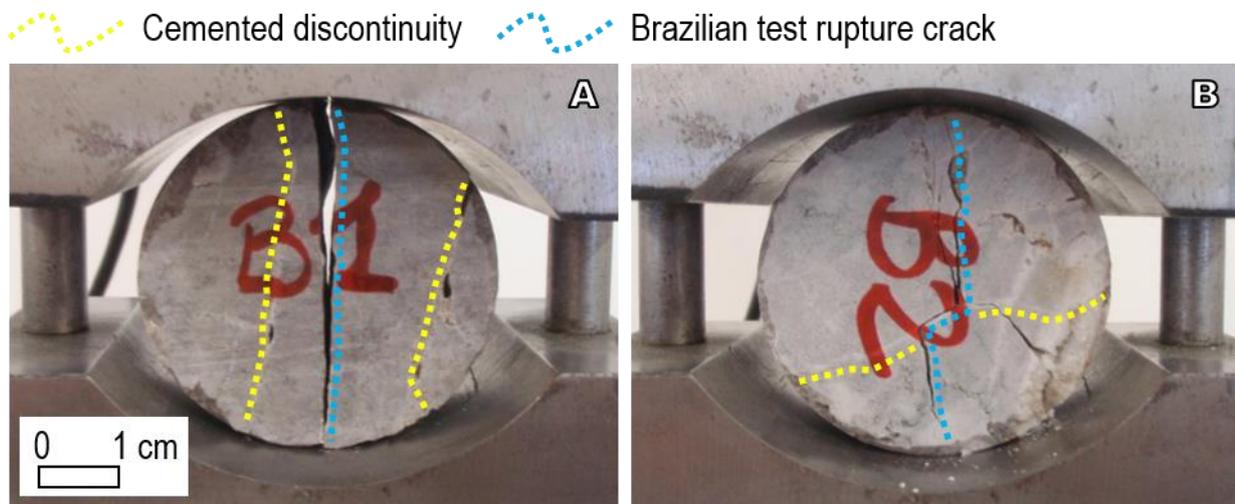
Figure 4-13 Indirect tensile test (Brazilian) sample failures. Developed ruptures look completely (A) or partially (B) not dependent from the cemented cracks.

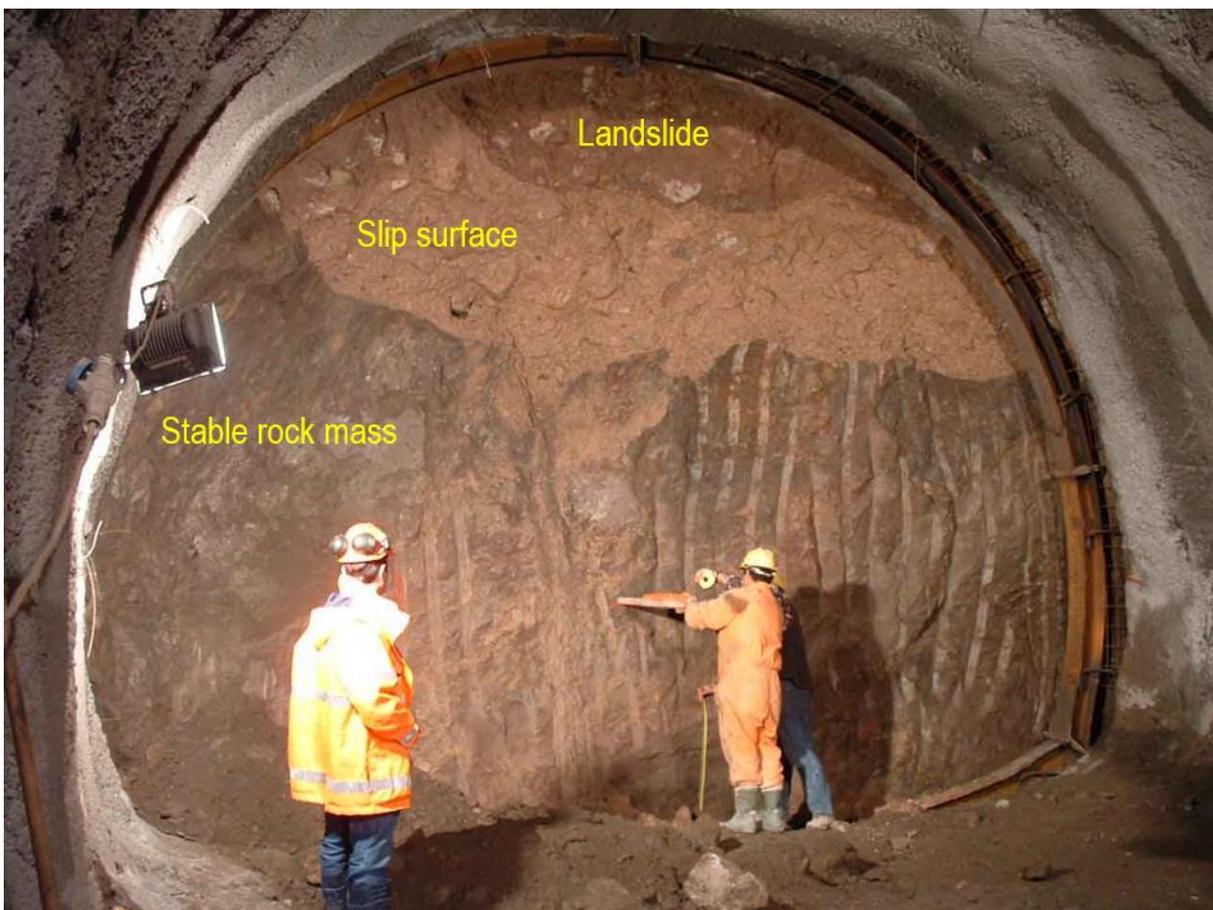
Figure 5-1 Slip surface intercepted during the drainage tunnel excavation, note the thickness of 2 m ca

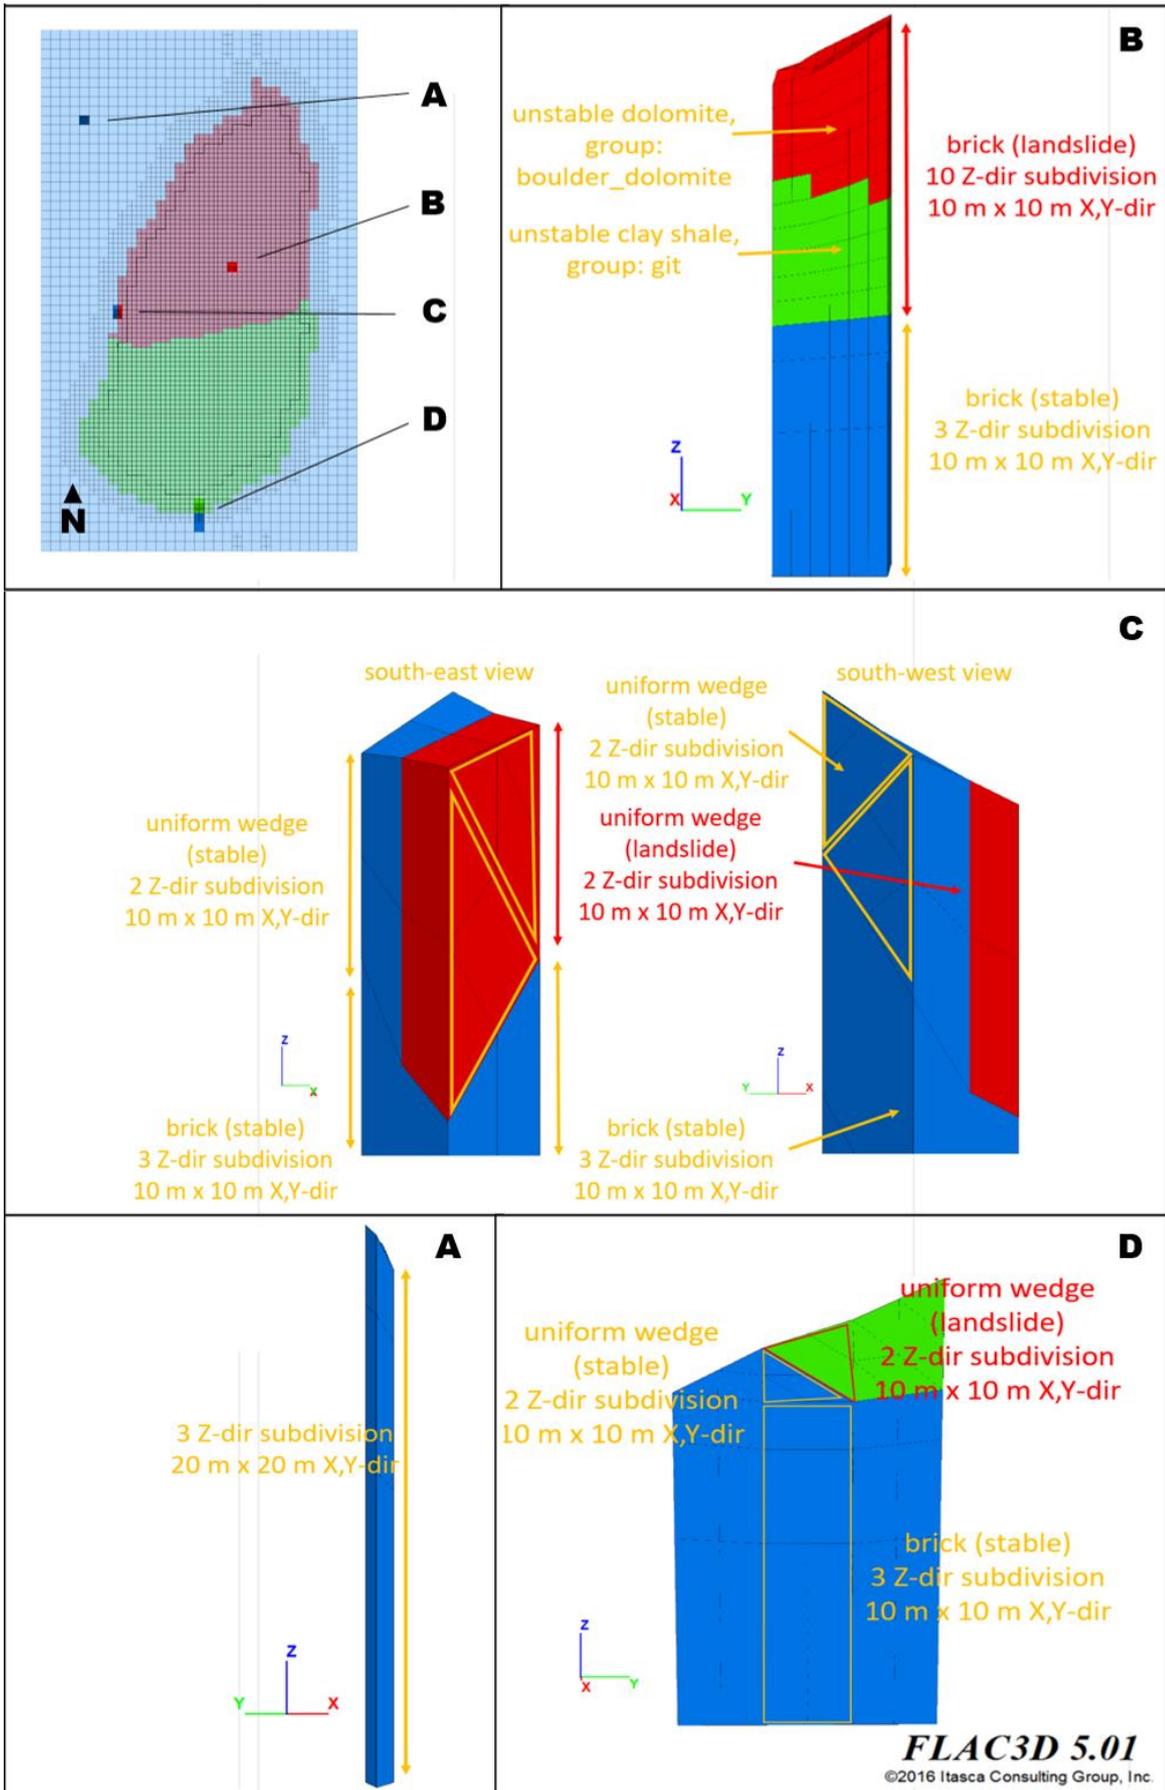
Figure 5-4 Flac3D grid (mesh) construction details

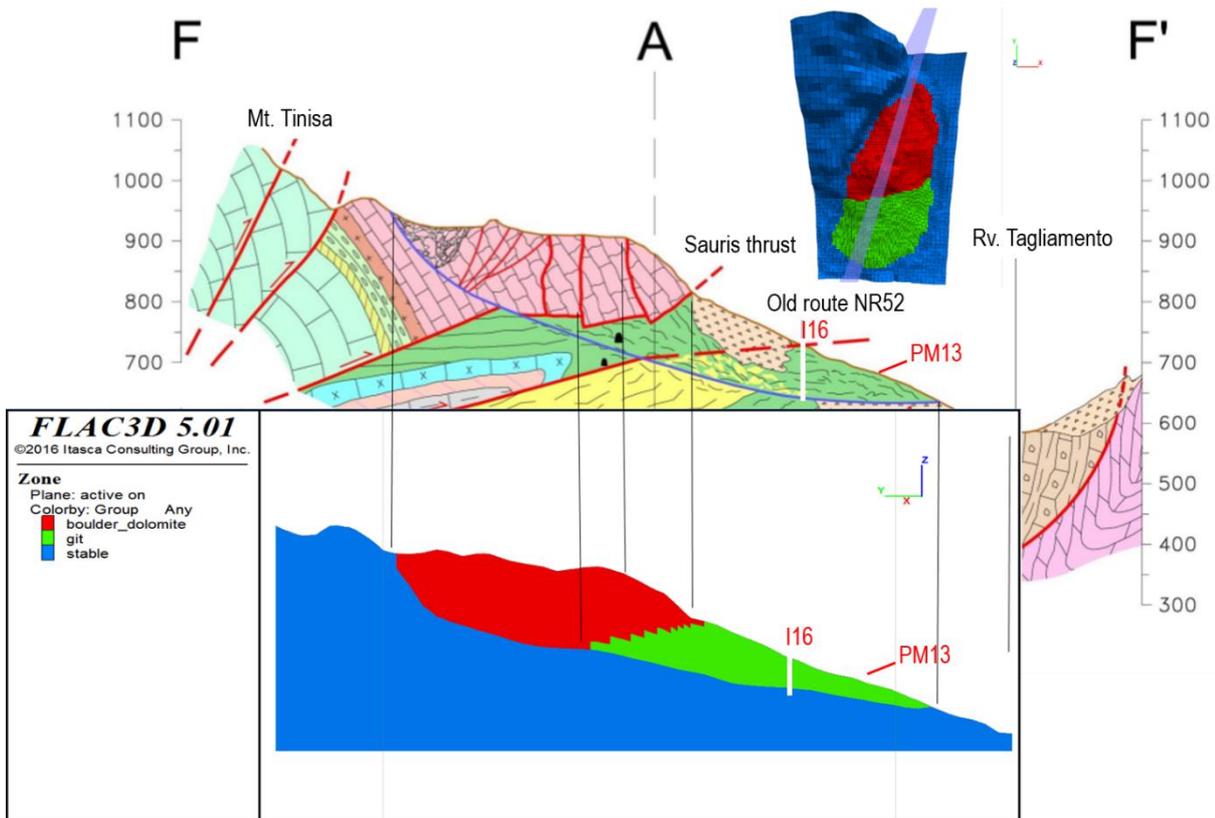
Figure 5-5 Comparison between geological and modeled sections

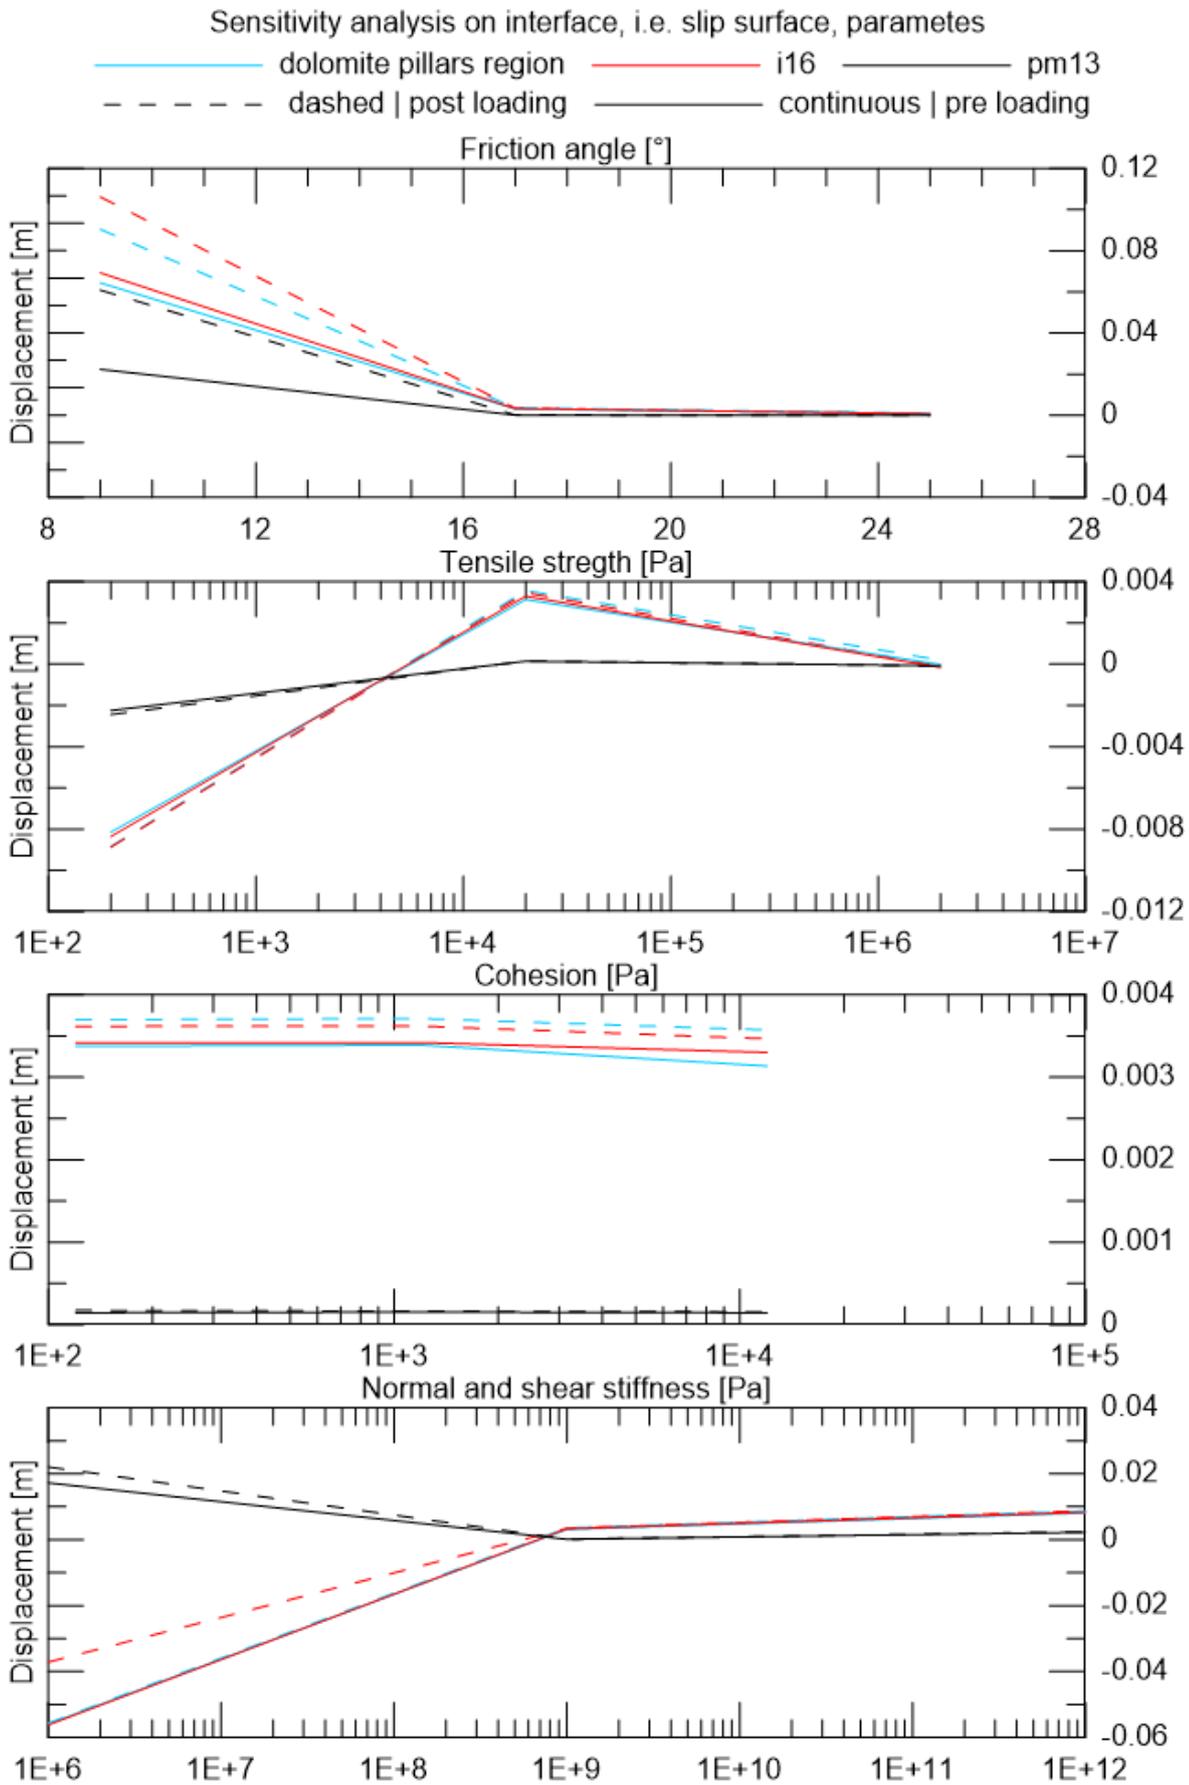
Figure 5-6 Sensitivity analysis on the landslide slip surface, i.e. interface elements

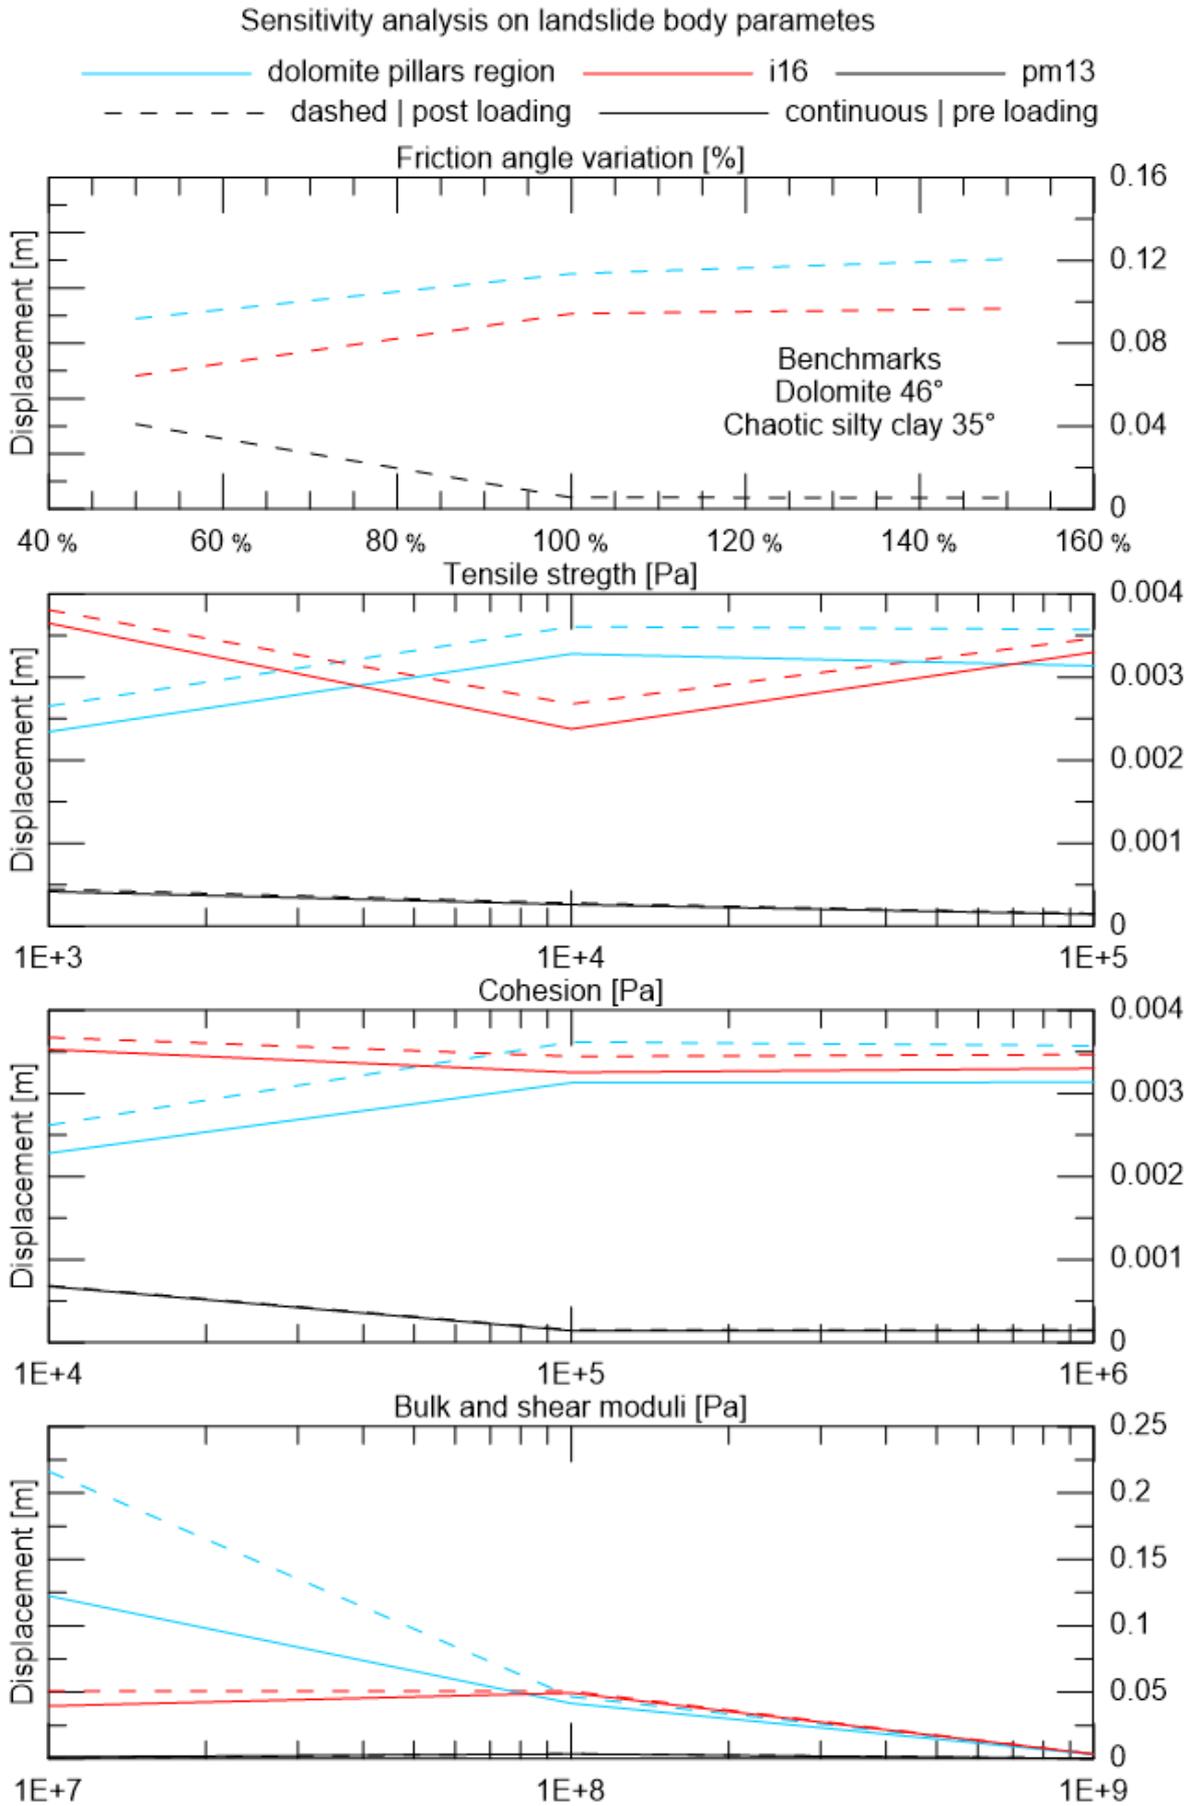
Figure 5-7 Sensitivity analysis on the landslide body materials

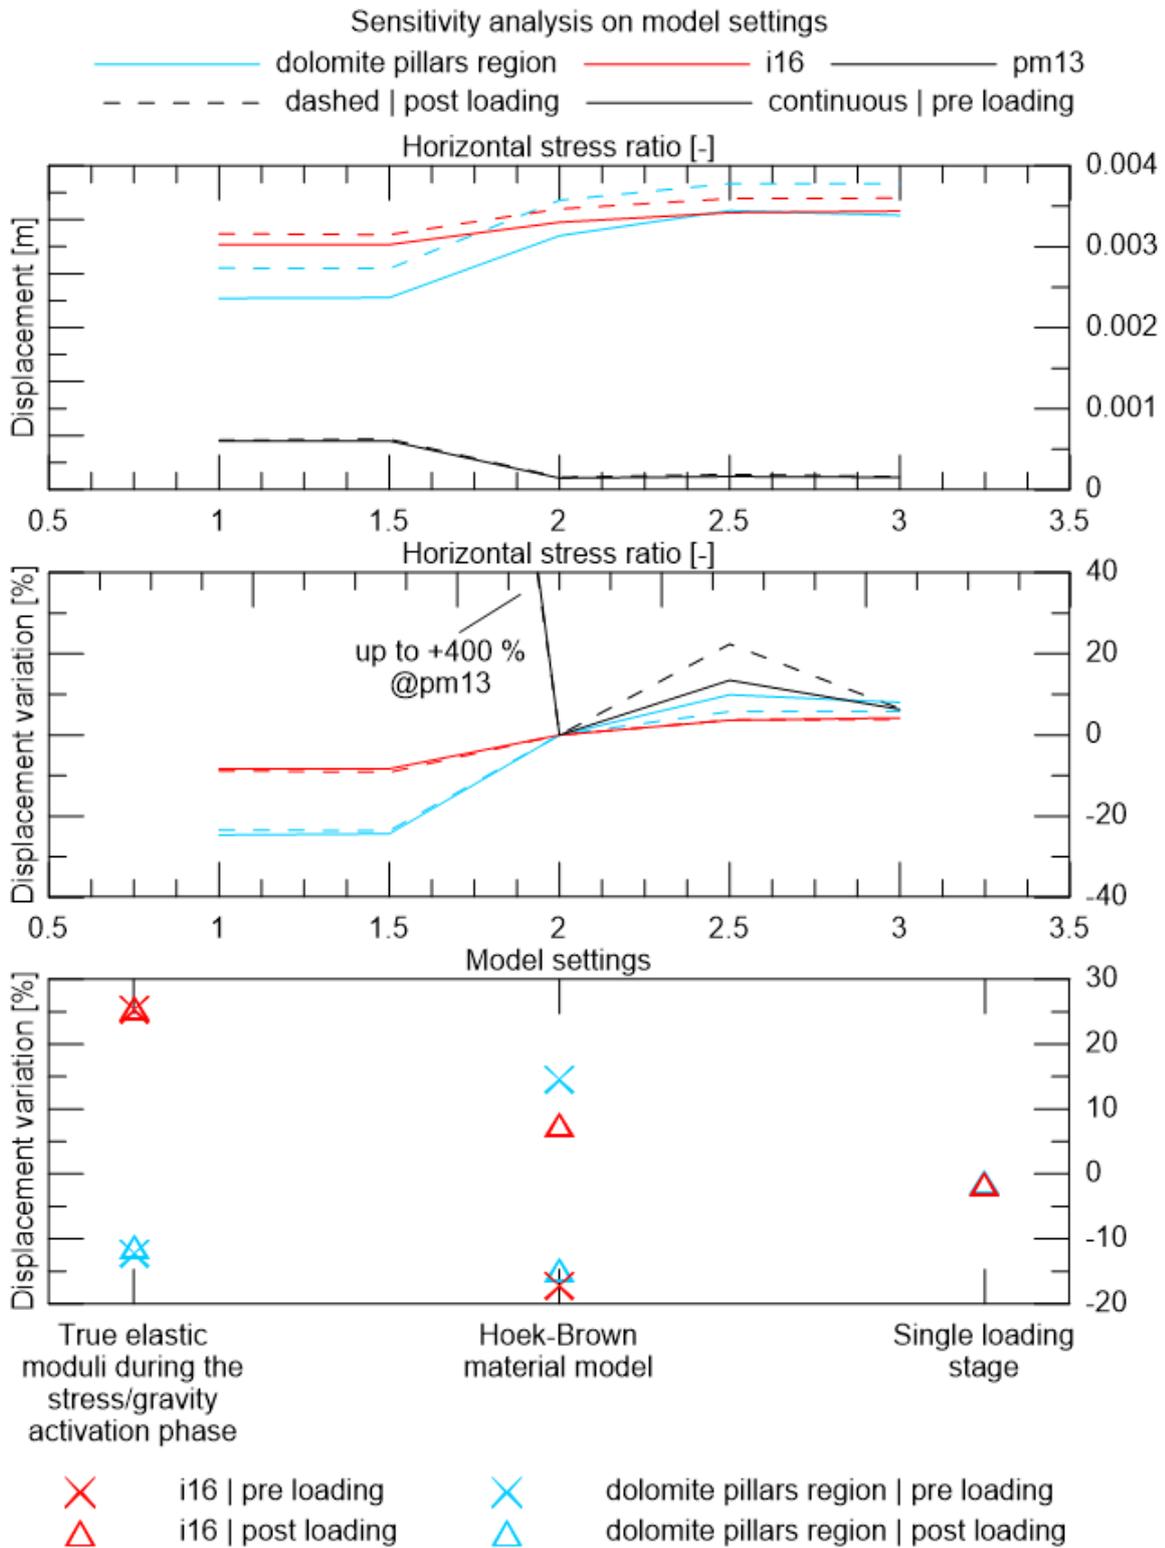
Figure 5-8 Sensitivity analysis on general model settings

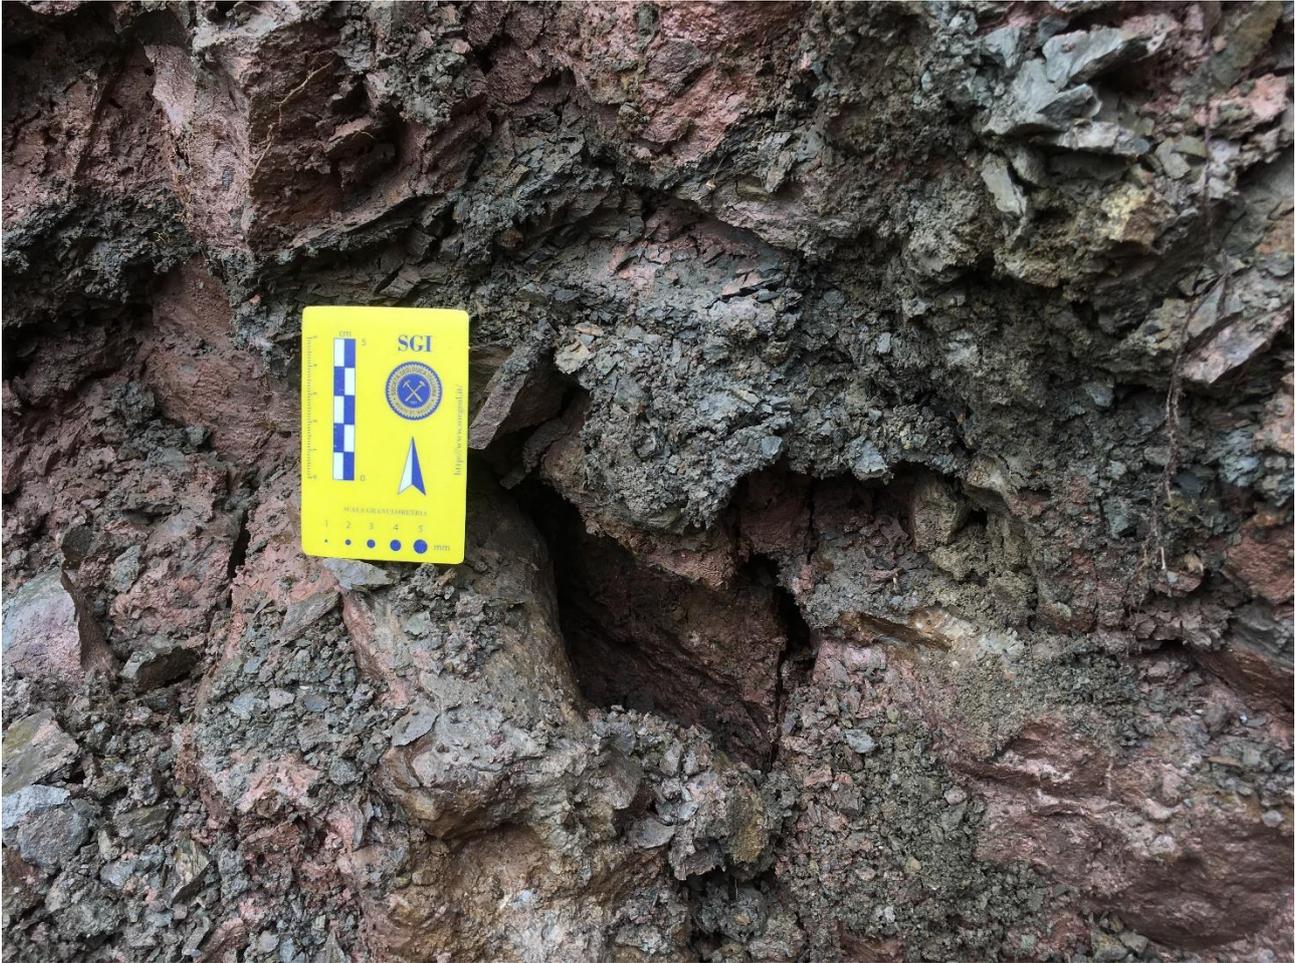
In Figure 5-9 the weathered material by water contact is shown, it has been assumed representative of the slip surface material.

*Figure 5-9 Weathered chaotic silty clay material at the Passo della Morte slip surface daylighting at the landslide toe*

The friction angle for the wet condition of the slip surface is set equal to 14° as found in literature [20] referred to a rotational-sliding slope movement on the East flank of the Passo della Morte landslide.

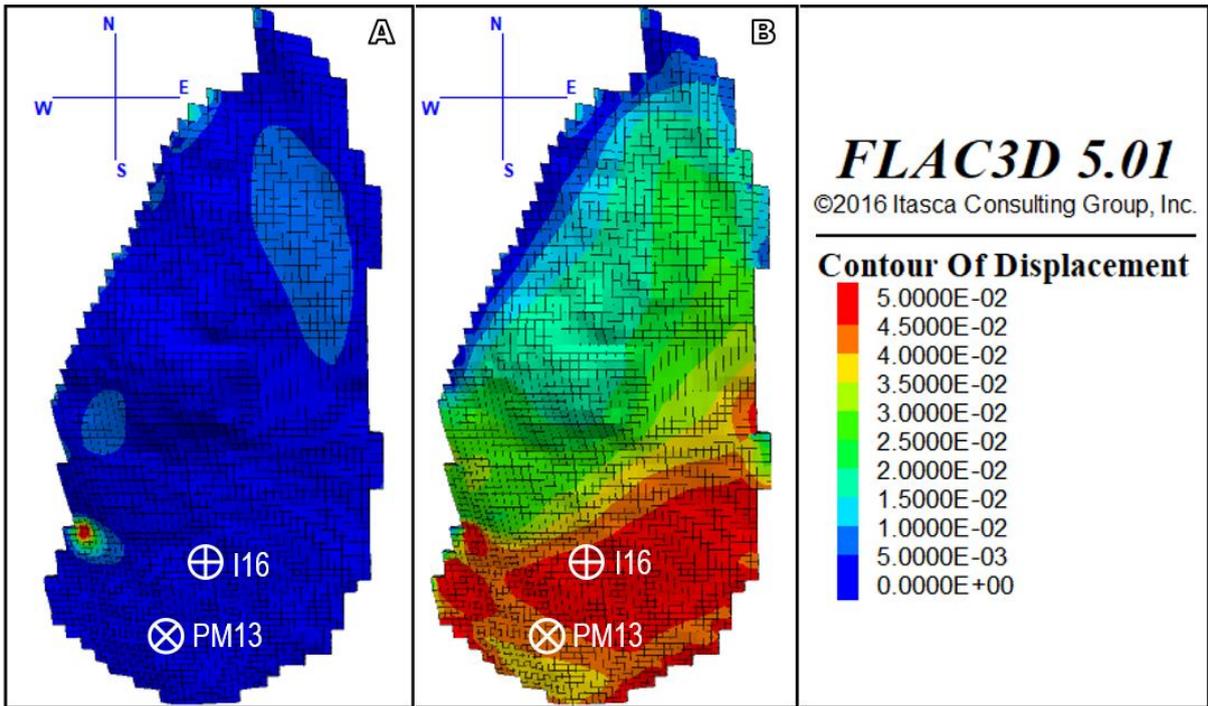
Figure 5-10 Displacements pre (A) and post (B) an extreme rainfall event, i.e. slip surface dry (A) and wet (B)

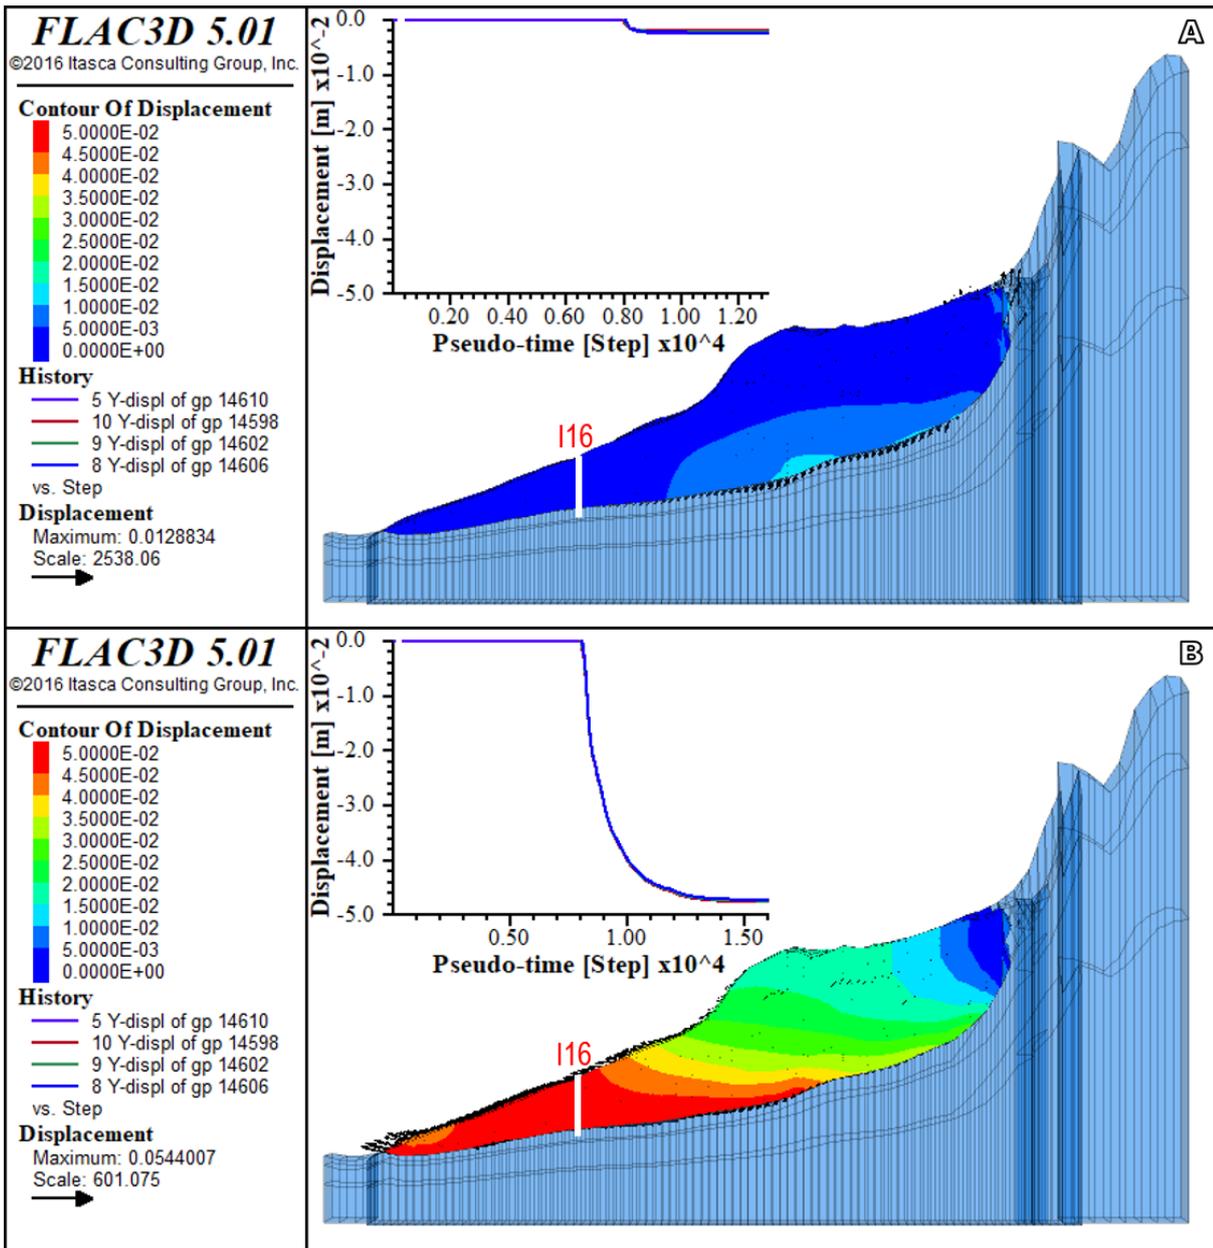
Figure 5-11 Section including I16 as reference, displacements pre (A) and post (B) an extreme rainfall event, i.e. slip surface dry (A) and wet (B)

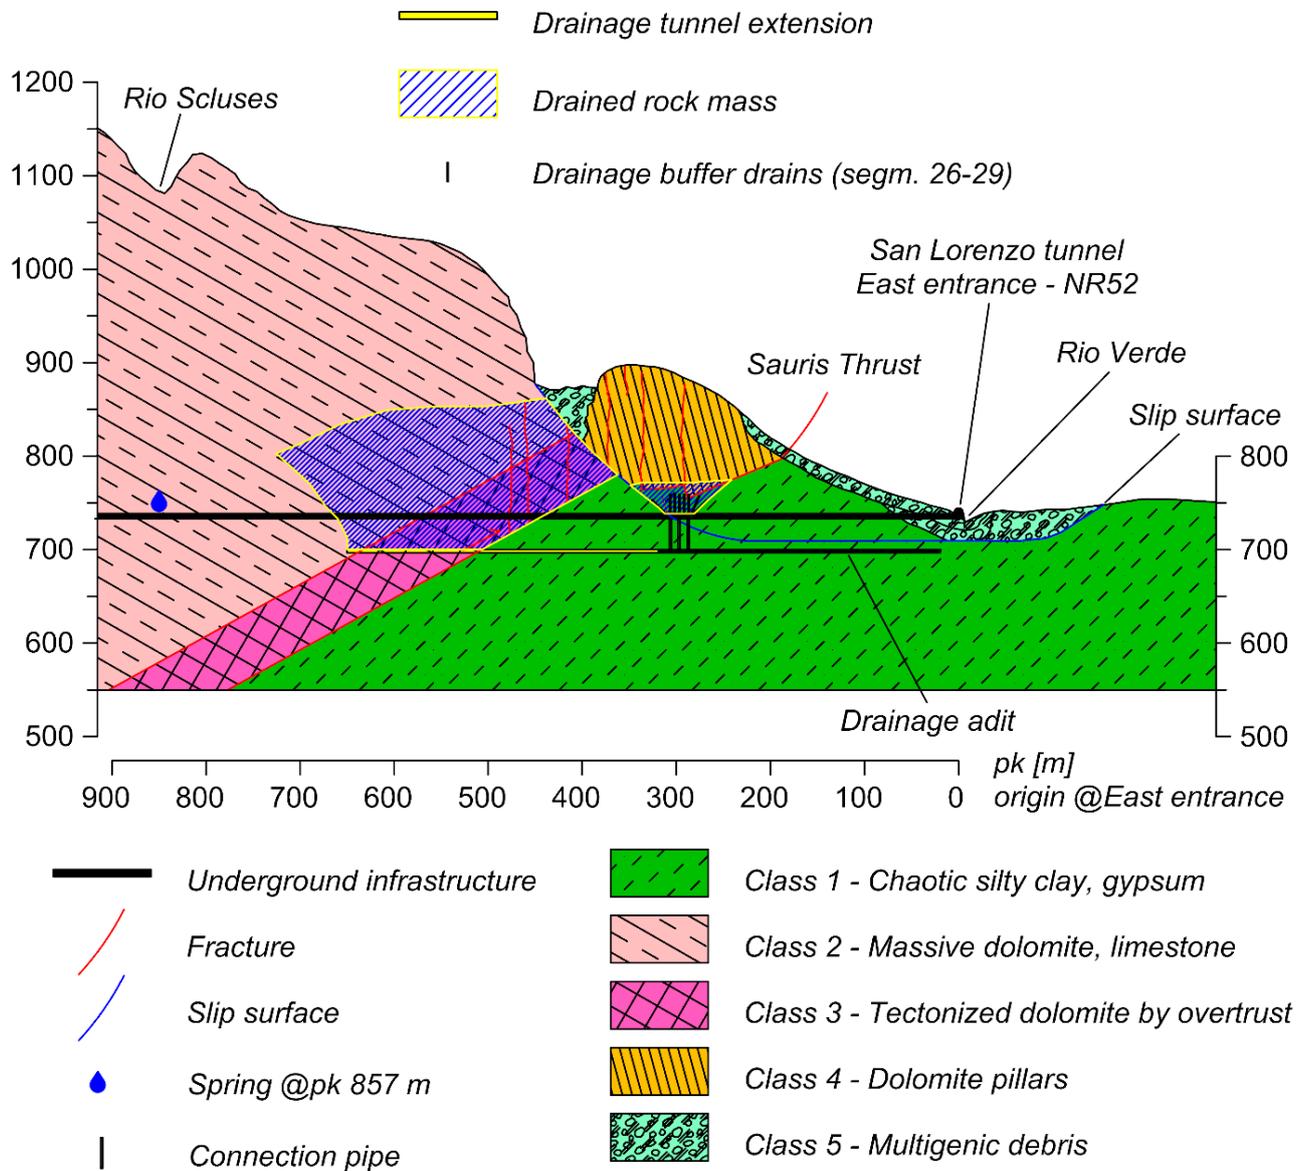
Figure 6-2 Dewatering expected effectiveness of the drainage tunnel extension

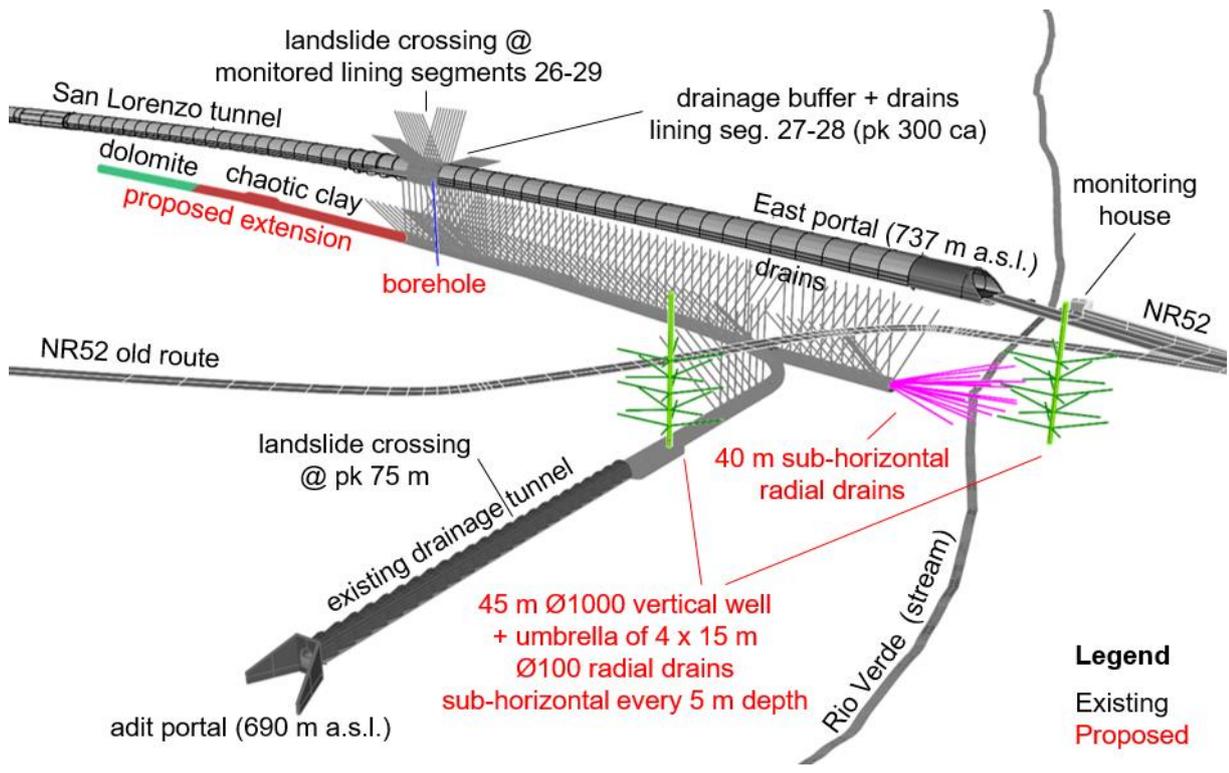
Figure 6-3 Proposed countermeasure works

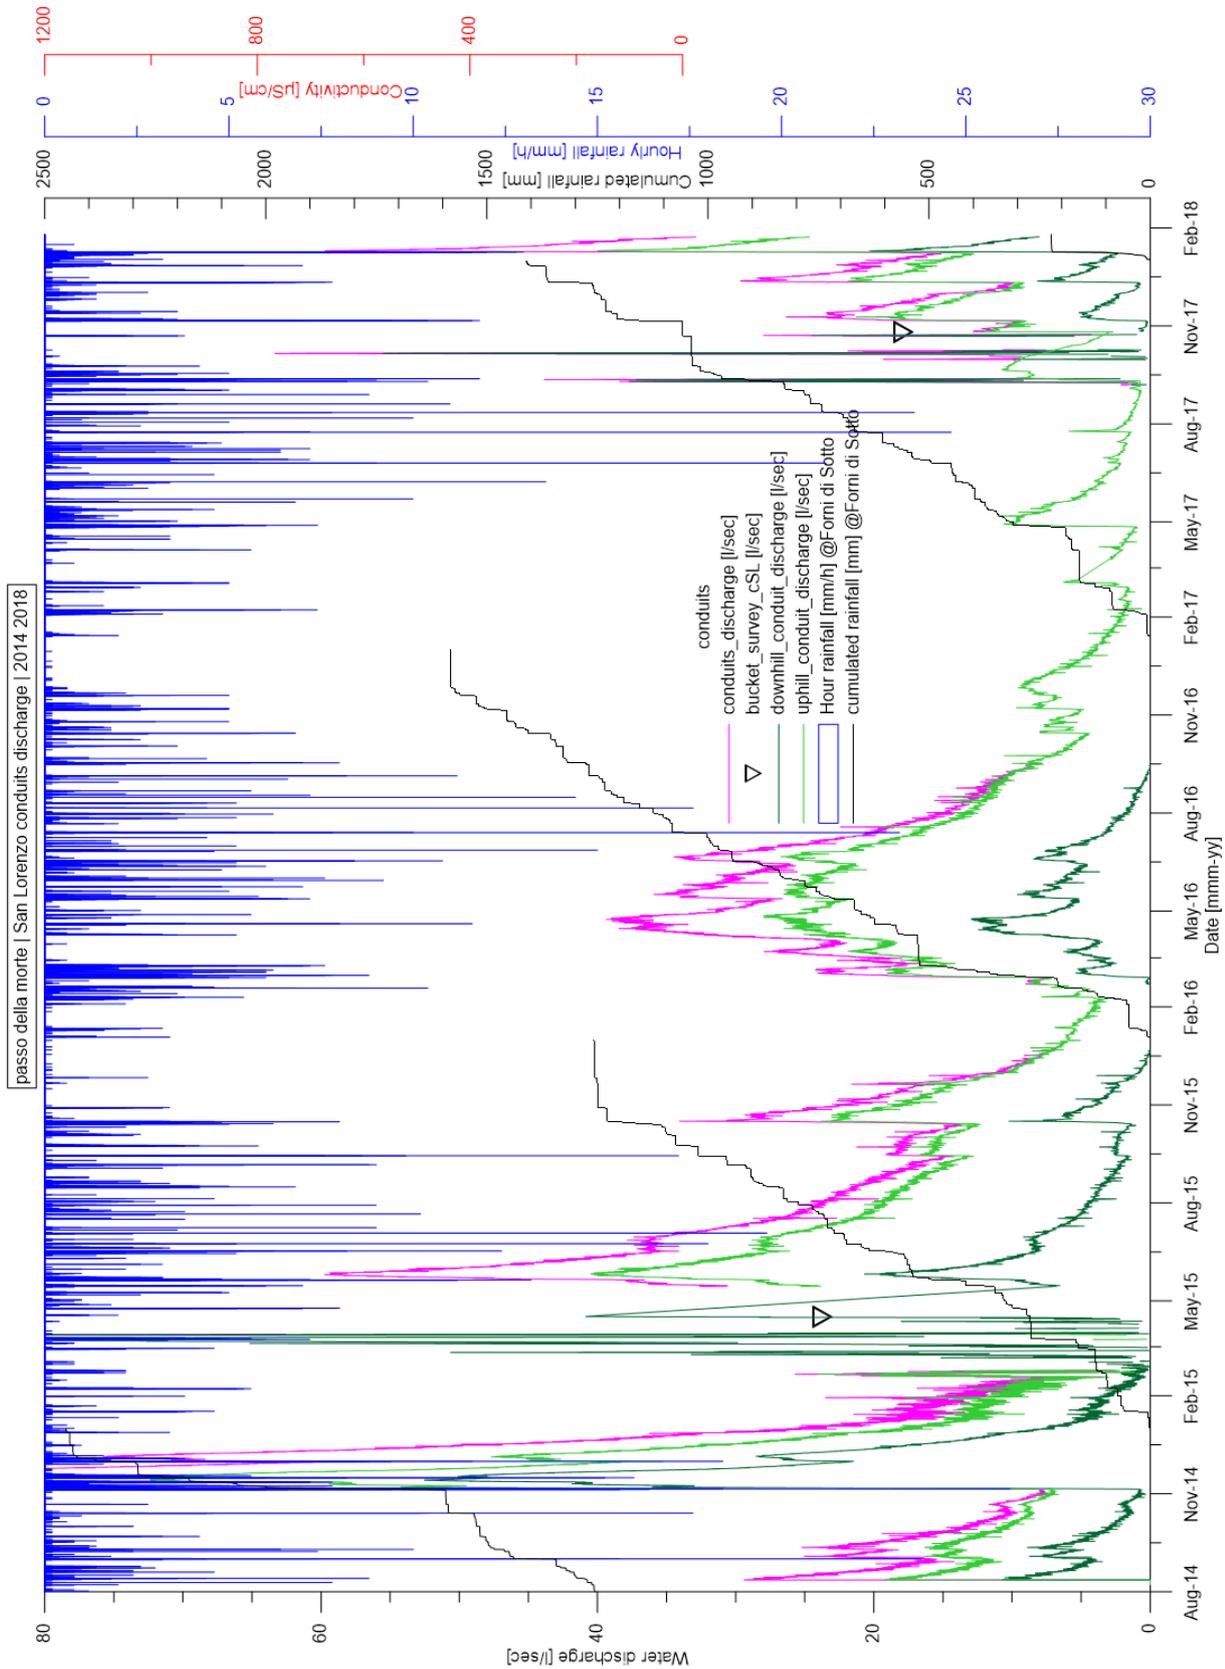
Figure 8-1 Conduits discharge (2014-2018)
