**DOTTORATO DI RICERCA IN  
INGEGNERIA CIVILE, CHIMICA, AMBIENTALE E DEI MATERIALI**

**INFRASTRUCTURE MAINTAINANCE  
AND COUNTERMEASURES PLANNING  
IN COMPLEX GEOLOGICAL  
AND GEOMORPHOLOGICAL SETTINGS**

PRESENTATA DA GIACOMO TEDESCO

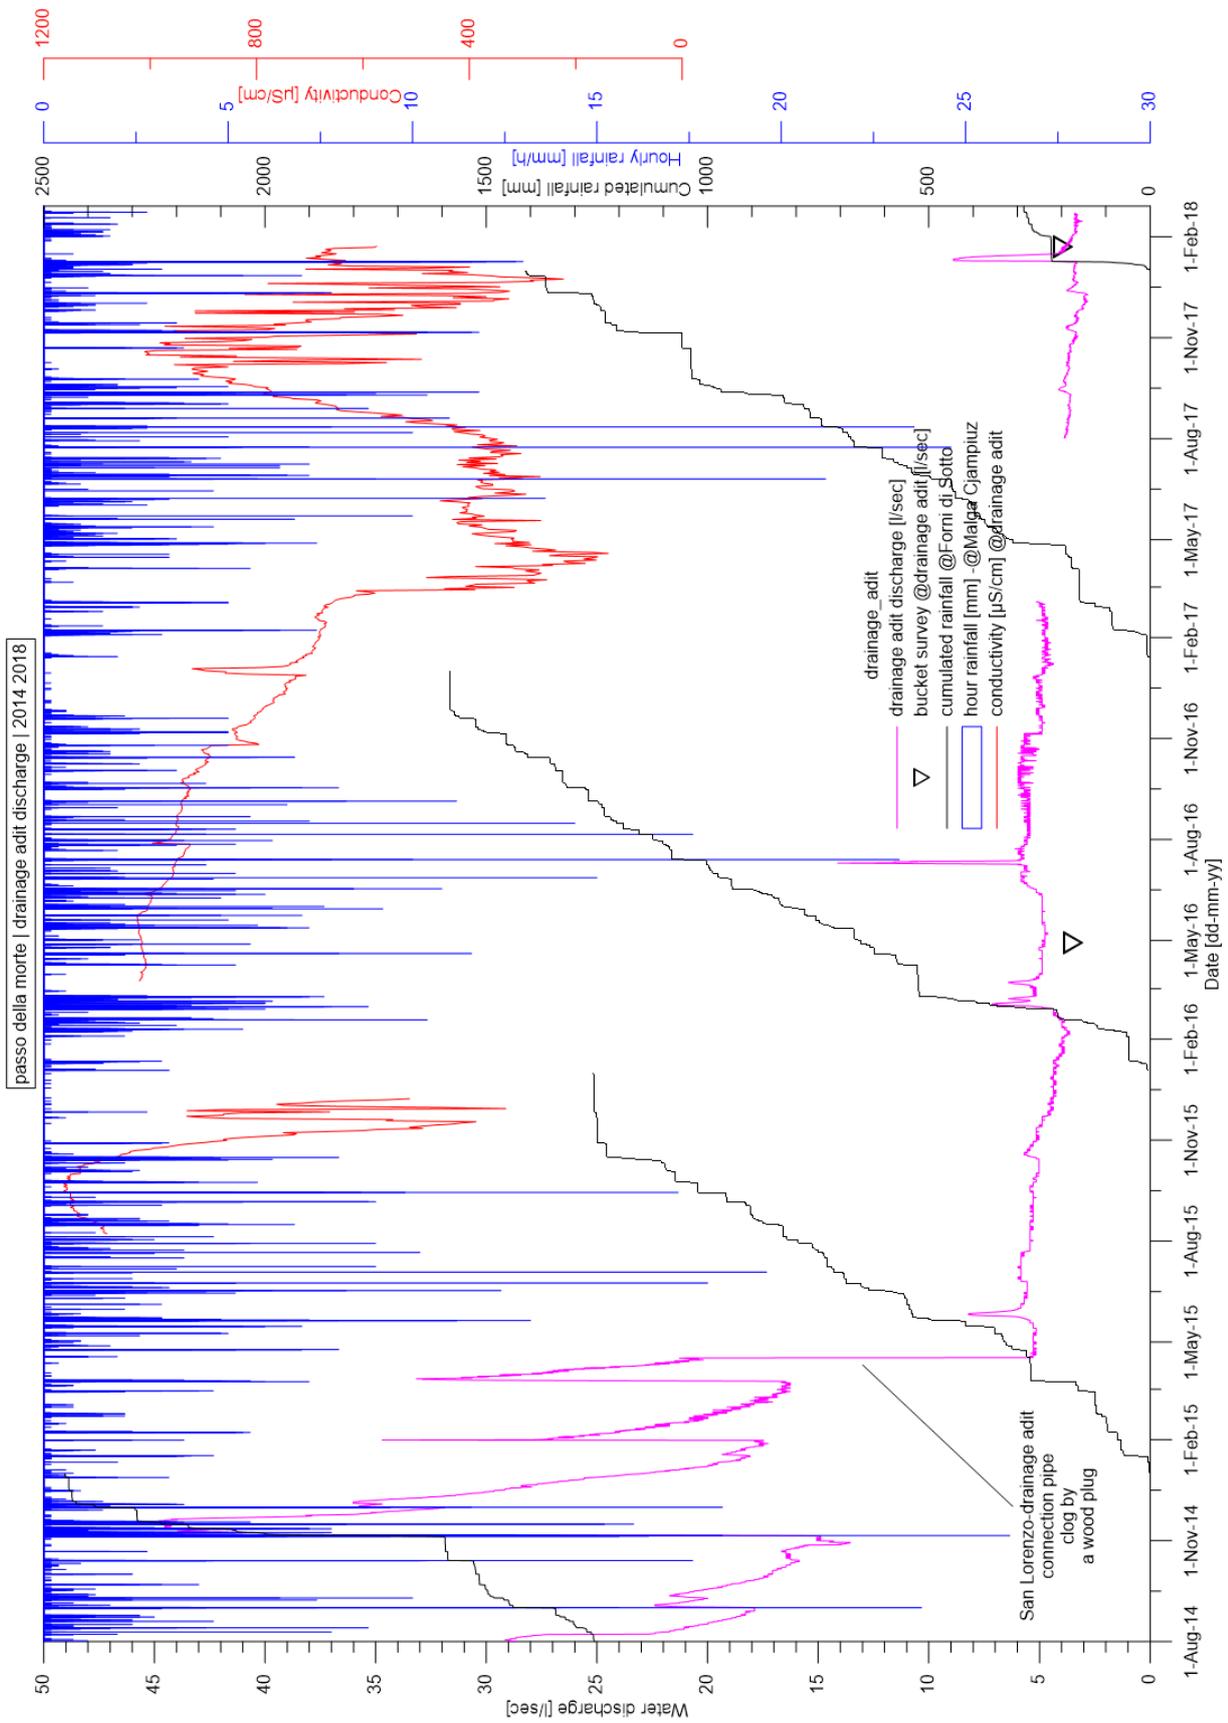
Figure 8-2 Drainage adit discharge (2014-2018)

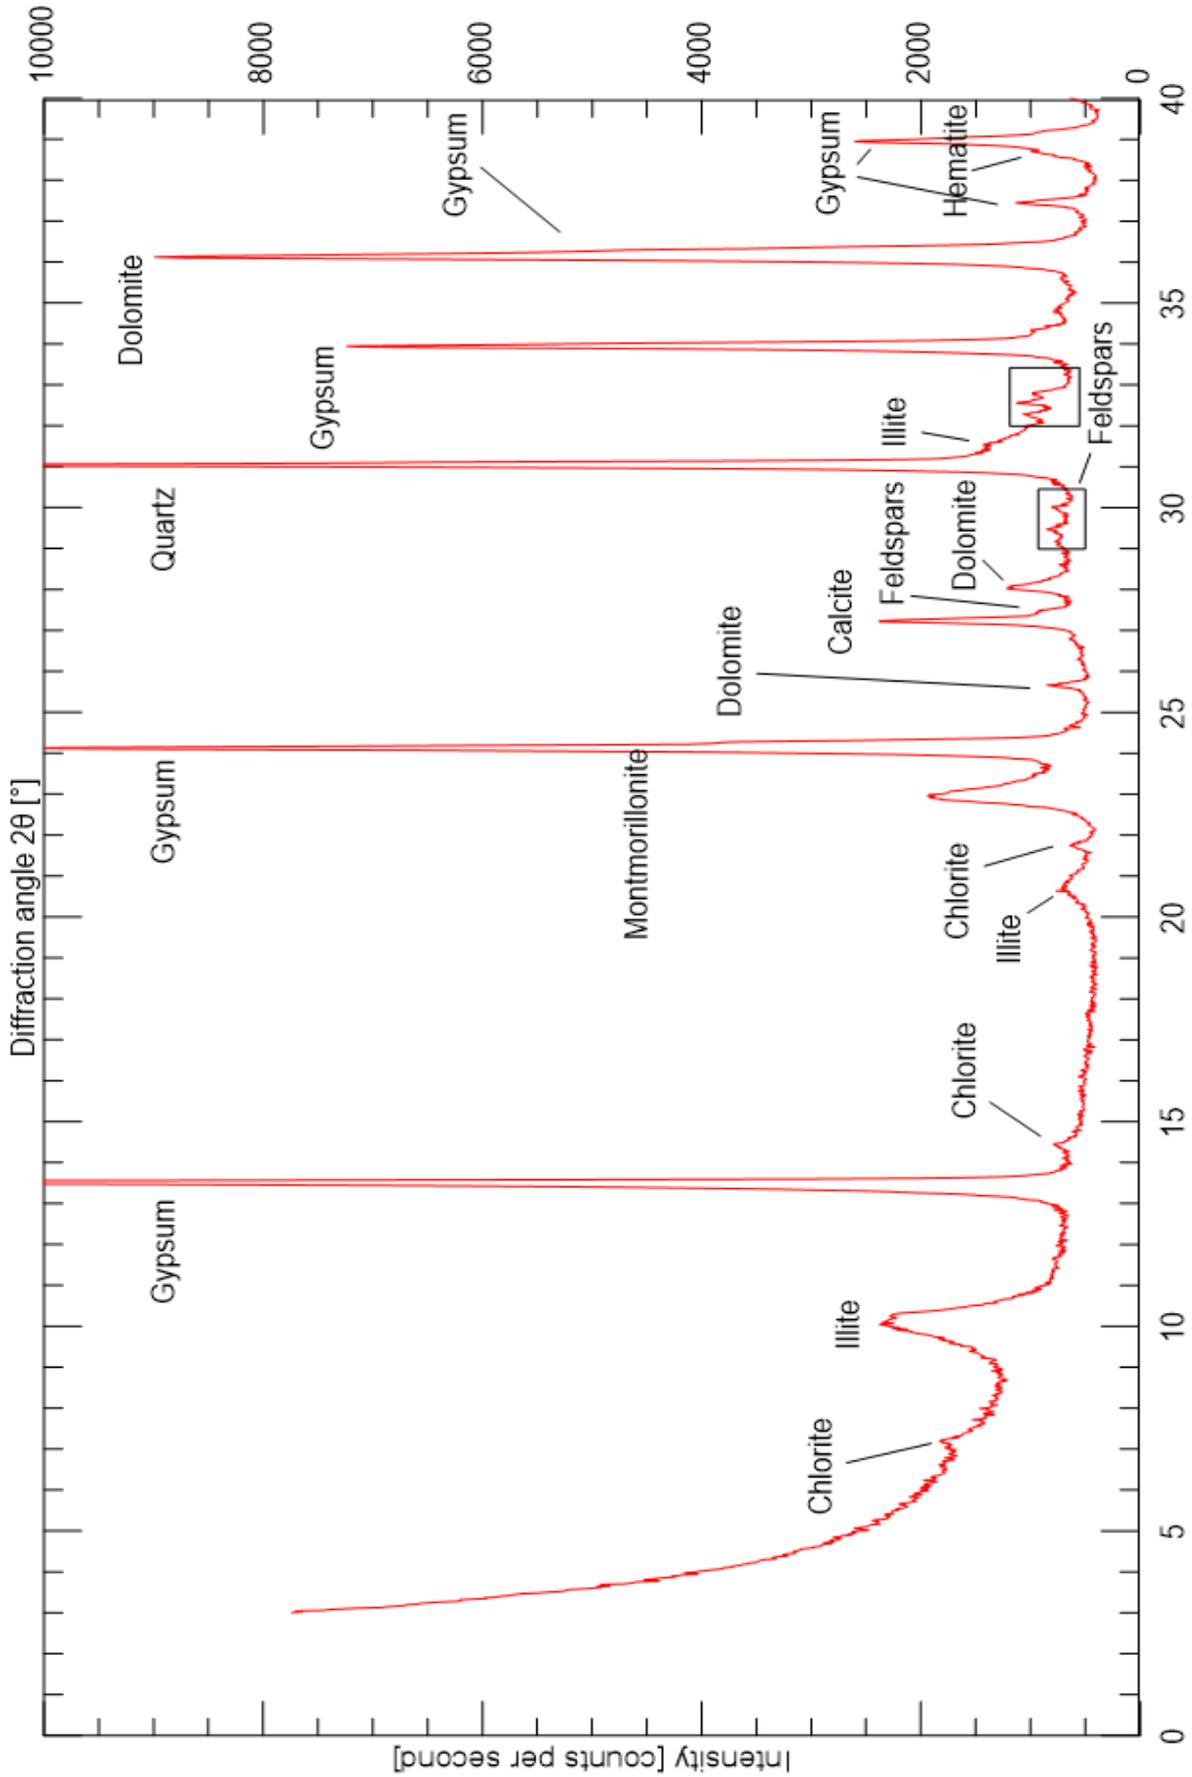
Figure 8-4 X ray diffraction on G4I sample

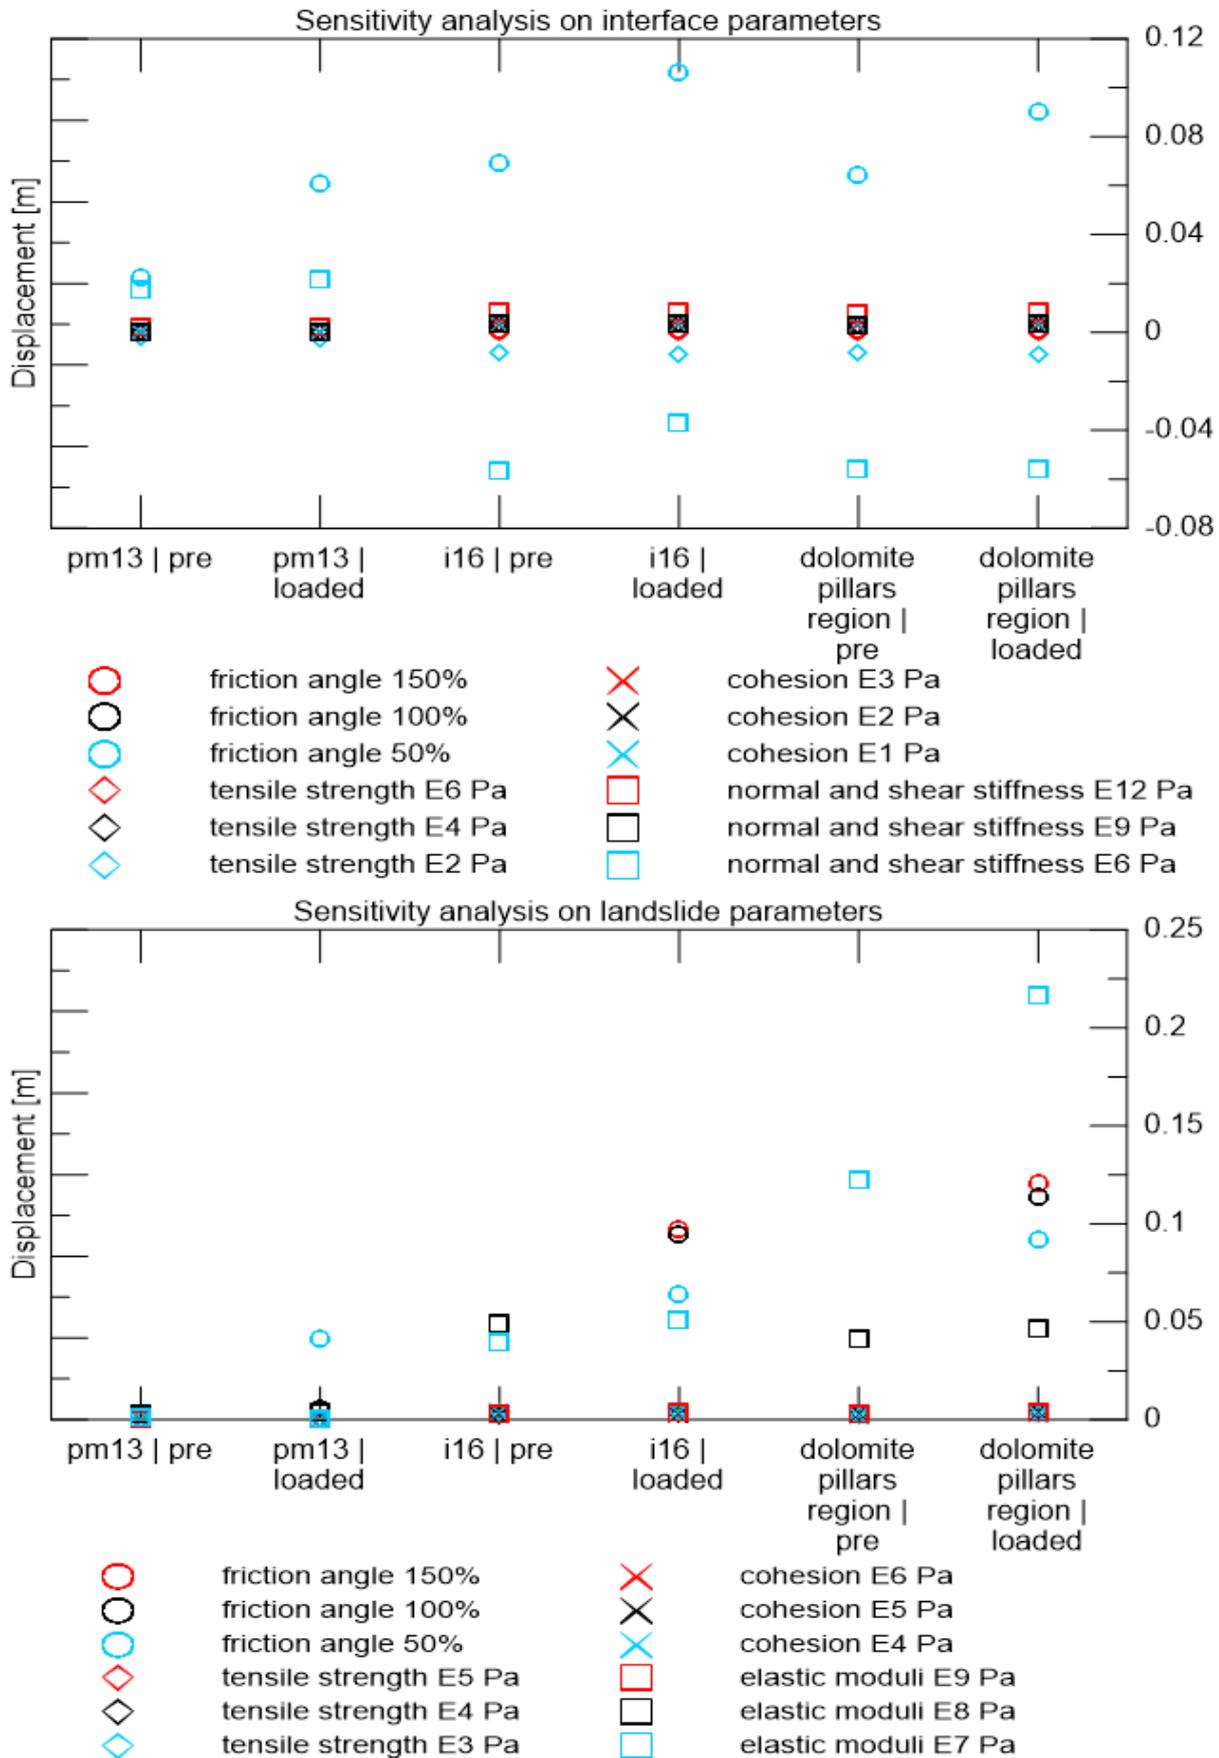
Figure 8-6 Sensitivity analysis absolute displacements. Top-down: on slip surface (interface) and landslide body properties

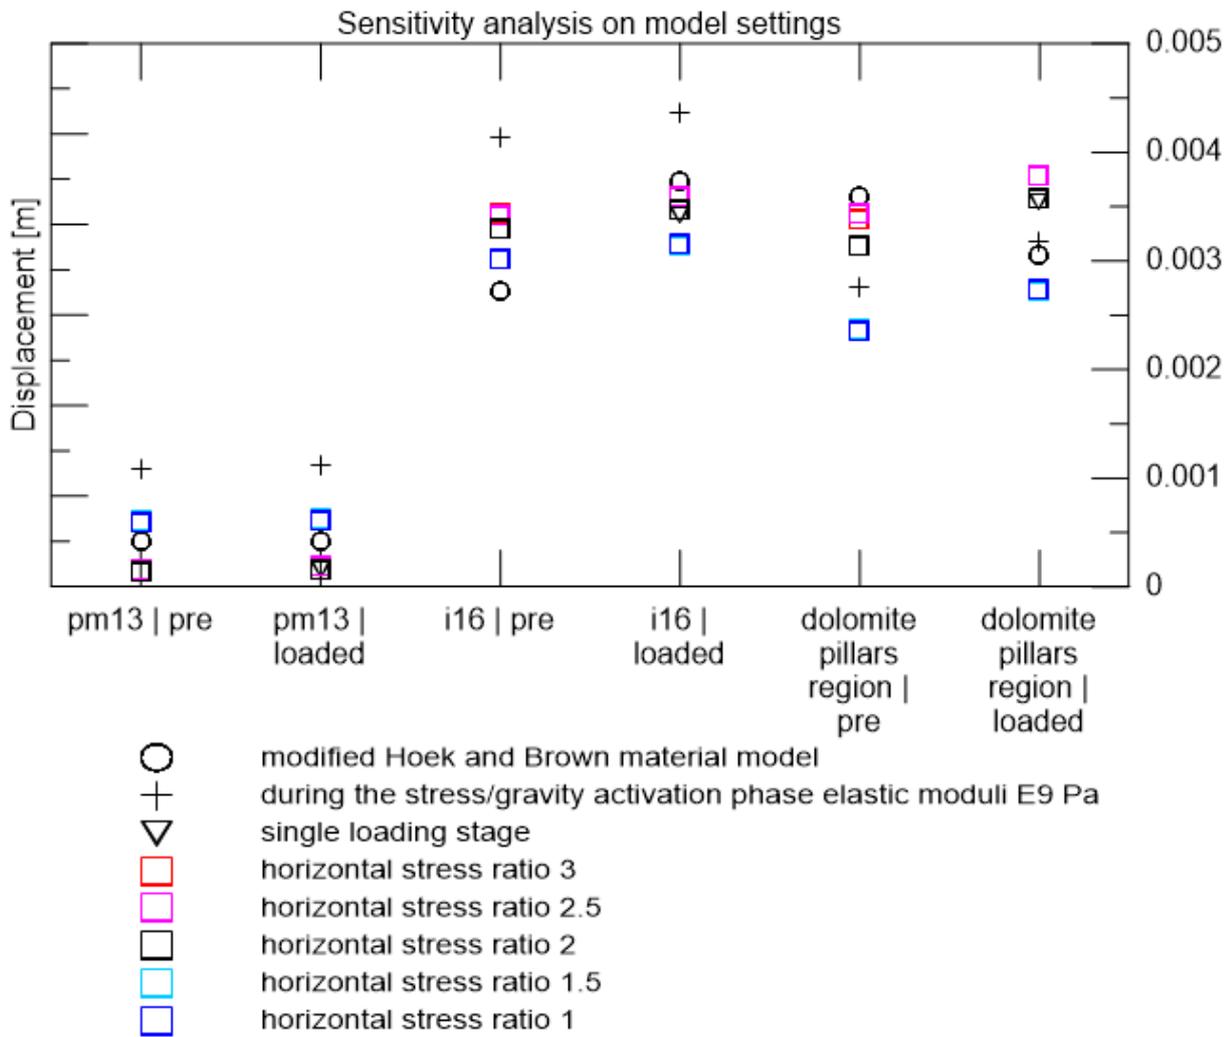
Figure 8-7 Sensitivity analysis absolute displacements on model settings variation
