ALMA MATER STUDIORUM
UNIVERSITÀ DI BOLOGNA

INGEGNERIA CIVILE, CHIMICA, AMBIENTALE E DEI MATERIALI

**INTEGRATED APPROACH OF WATER QUALITY MONITORING AND HYDRAULIC
PARAMETER ANALYSIS BASED ON BUILDING INFORMATION MODELING IN WATER
DISTRIBUTION NETWORKS**

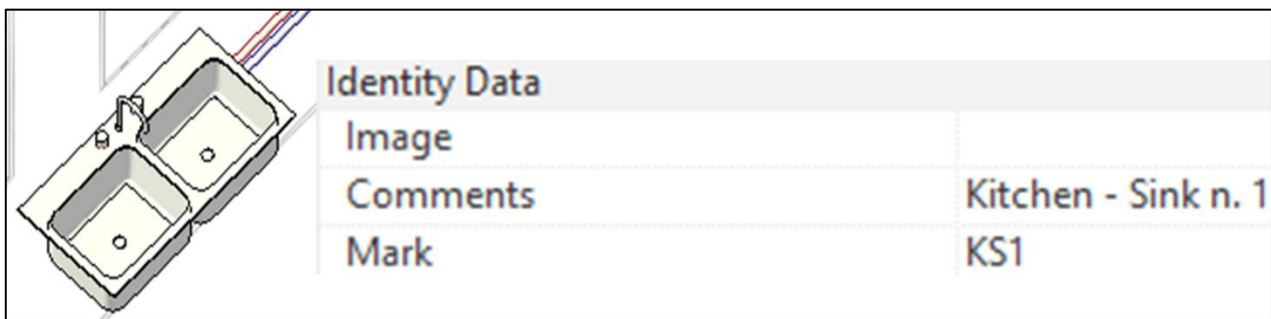
Fig. 20: Sample ID and description related to a sampling point in the properties panel in Revit.

In this operational context, each hydraulic device (sinks and showers), representing a sampling point, has been categorized by assigning a unique code and a detailed description (Table 10). This information is easily accessible in the properties panel of each point, as reported in Figure 20.

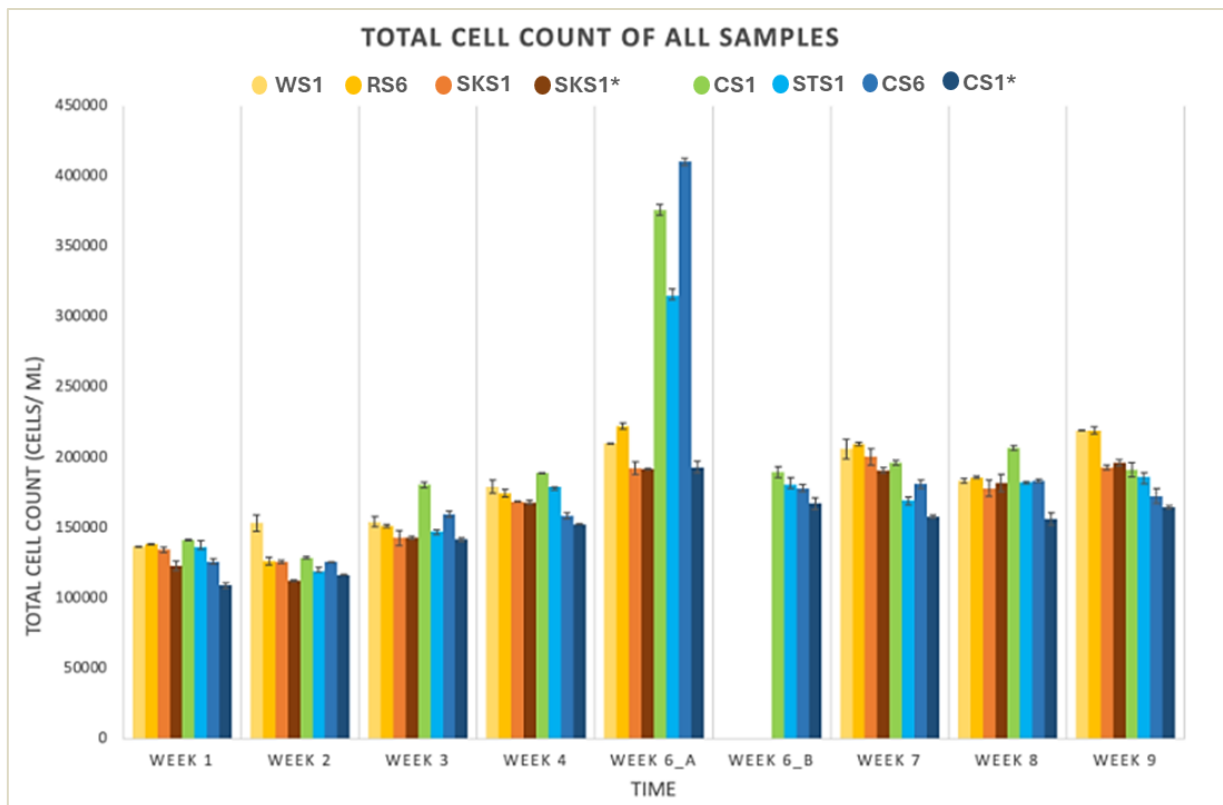
Fig. 27: TCC of all the samples. Shades of yellow refer to Building 1 while shades of blue refer to Building 2 (Zhang, 2021).

In both the Figures the sampling intervals are indicated. In particular, Week 5 is not reported because it corresponds to the holiday break. Consequently, this week is considered as stagnation because taps were not resulting in a reduced flow within the building plumbing. Thus, Weeks 1-4 represent the period before stagnation, whereas weeks 6A-9 represent the period after stagnation.

As indicated in the Figures, significant fluctuations in TCC and ICC were observed after stagnation, which tends to decrease to lower values in the subsequent weeks of tap use. To be more specific, the increase in the counts was more evident in Building 2, rather than Building 1.

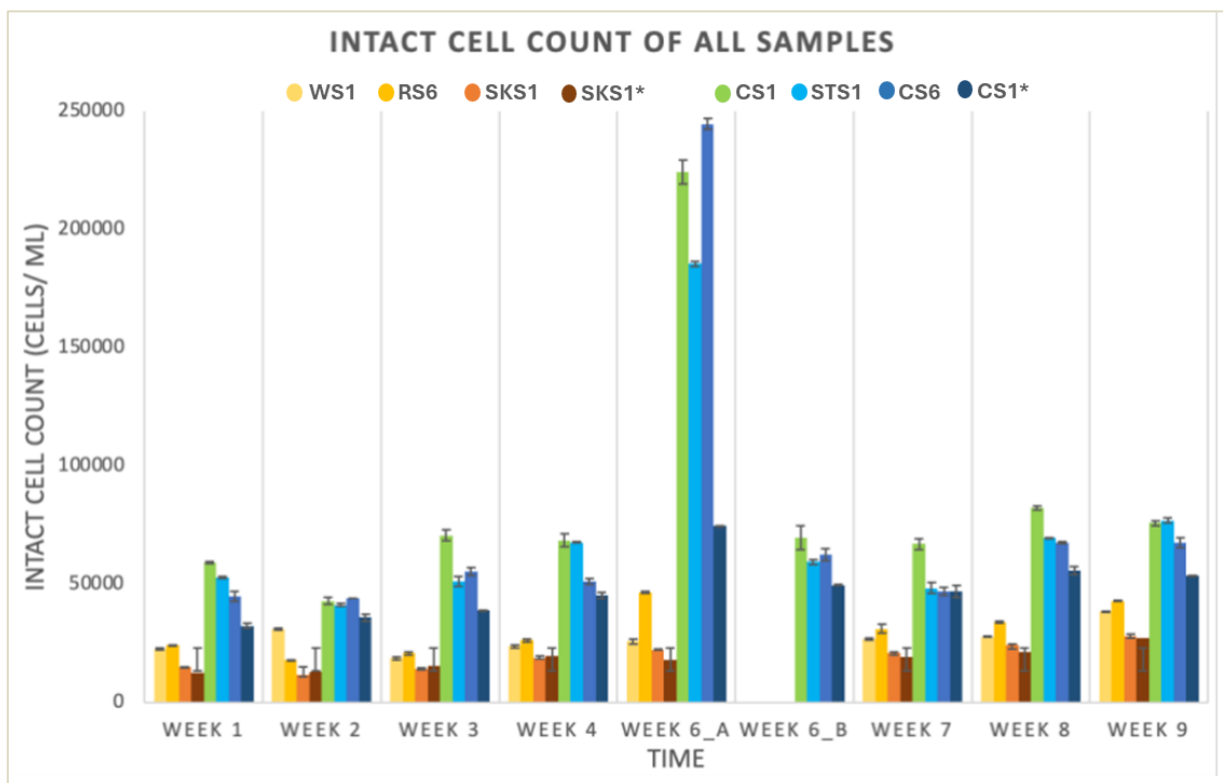
Fig. 28: ICC of all the samples. Shades of yellow refer to Building 1 while shades of blue refer to Building 2 (Zhang, 2021).
