ALMA MATER STUDIORUM
UNIVERSITÀ DI BOLOGNA

DOTTORATO DI RICERCA IN
SCIENZE E TECNOLOGIE AGRARIE, AMBIENTALI E ALIMENTARI
Ciclo XXXVII

*ARTIFICIAL CANALS RESTORATION THROUGH NATURE-BASED
SOLUTIONS: EXPERIENCE IN PO PLAIN WITH A VEGETATION AND
WATER QUALITY VIEW POINT*

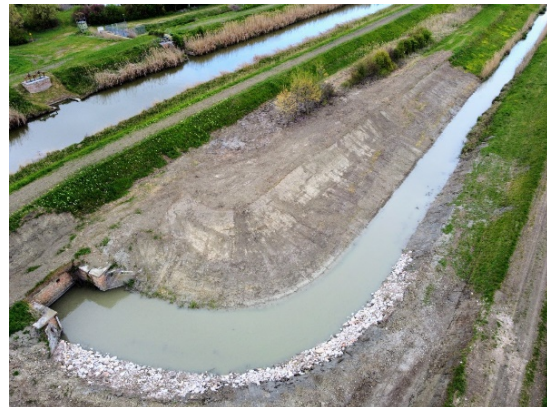
Figure 7 - S1 after intervention.

S1 is situated 4.7 km upstream from the Garda Basso canal outfall (Figure 7), close to the eastern boundary of the Natura 2000 site IT4050022 - SAC SPA - “Biotopes and Environmental Restorations of Medicina and Molinella”, and adjacent to the wetlands of “Tenuta Vallona”. It is also 1 km from the “Oasi del Quadrone”, an historic wetland complex representative of Po Plain habitats. Access is along a 1.7 km track following the left bank of the Garda Basso canal from the Via Bassa bridge southwards, running along the embankment of the Garda Alto canal. The intervention stretches 140 m along the left bank beginning at the point where the Garda Basso canal passes beneath the Garda Alto canal. Morphologically the site consists of two zones: a long, gently sloping bank rising from the canal to the crown of the levee, and a service track bordered by a linear strip of mixed native trees and shrubs.

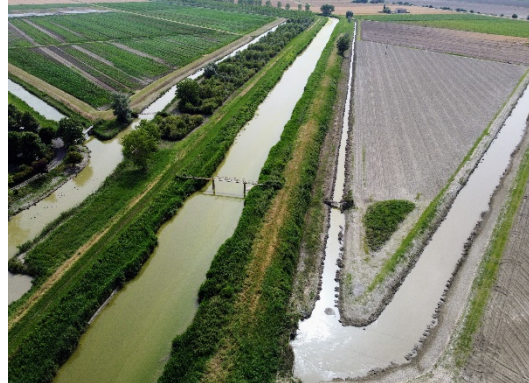
Figure 9 - S2 after intervention.

S2 is located at the end of the Sesto Basso canal (Figure 9), close to the upstream boundary of two Natura 2000 site: IT4050022 “Biotopes and environmental restorations of Medicina and Molinella” and IT4060001 - SCI-SPA “Valli di Argenta”, within the Po Delta Regional Park. It occupies the flat tongue of land at the confluence where the Sant'Antonio canal enters the Sesto Basso canal, spanning both the right and left banks of the two canals (Figure 12). Access is 700 m along the right bank of the Sesto Basso canal from the Via M. Cappelletti bridge, heading southeast towards the Garda Alto canal embankment. Until 2021 the land was cultivated as arable by an adjacent farm.

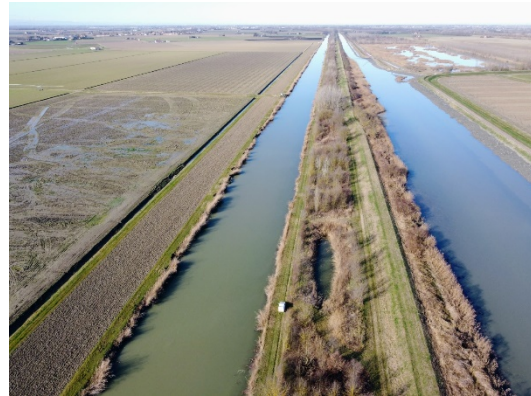
Figure 11 – S4 after intervention.

S4 is situated 400 m upstream of the point where the Lorgana canal enters the Natura 2000 site IT4050022 “Biotope and environmental restorations of Medicina and Molinella” (Figure 11). It is reachable by proceeding 300 m westwards along the left bank of the Lorgana canal from the parking area near the Via Zanolini bridge.

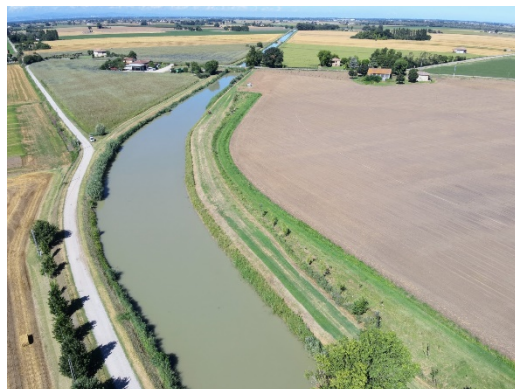
Figure 13 – S5 after intervention.

S5 lies on Allacciante IV Circondario canal (Figure 13), 150 m downstream of the Via Idice Abbandonato bridge. It occupies a position almost equidistant between two Natura 2000 sites, within a predominantly agricultural landscape that lacks natural or semi-natural areas. It is 2.5 km from Natura 2000 site IT4050023 - SCI-SPA “Biotopes and environmental restorations of Budrio and Minerbio” and 3 km from Natura 2000 site IT4060017 - SPA “Po di Primaro e Bacini di Traghetto”.

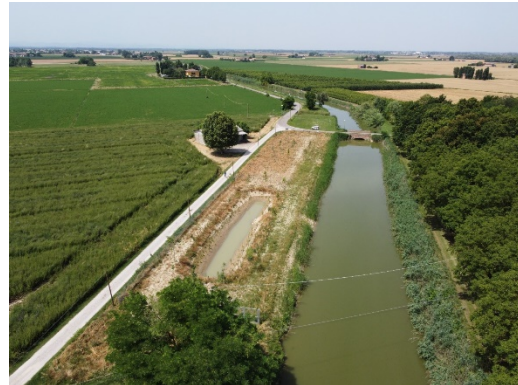
Figure 15 – S6 after intervention.

S6 corresponds to the right bank of the Allacciante IV Circondario canal immediately downstream of the Via Dugliolo bridge (Figure 15). It occupies an intermediate position between the other intervention sites on the canal, lying 1.7 km from Site 5 and 2.8 km from Site 7. Situated in an entirely agricultural landscape, it is 1.3 km from Natura 2000 site IT4050023 - SCI-SPA “Biotopes and environmental restorations of Budrio and Minerbio”.

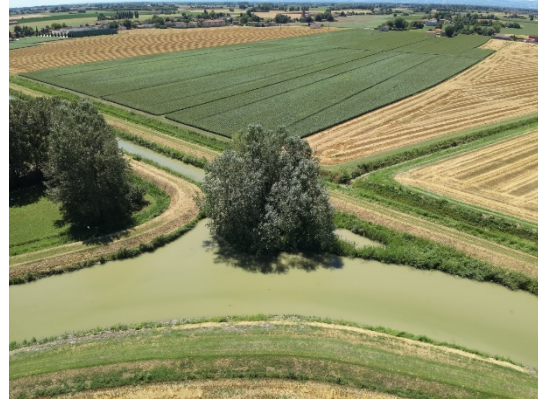
Figure 17 – S7 after intervention.

S7 is at the confluence of Gallina Superiore and Allacciante IV Circondario canals (Figure 17), 600 m upstream of the Via Dugliolo bridge at the outskirts of the hamlet of the same name. It lies halfway between other two sites: 2.8 km upstream of S6 and 2.5 km downstream of S8. At 1 km west of the intervention area is Natura 2000 site IT4050023.

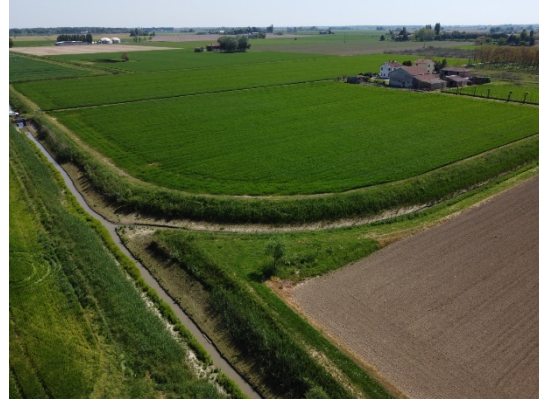
Figure 19 – S8 after intervention.

S8 is situated at the confluence where the Cornamonda Nuova canal enters the Gallina Superiore canal, south-east of the hamlet of Dugliolo (Figure 19). It lies 2.5 km from Site 7 and 2 km in a straight line from the boundary of Natura 2000 site IT4050023 - SCI-SPA “Biotopes and environmental restorations of Budrio and Minerbio”. The surrounding landscape is dominated by arable fields.

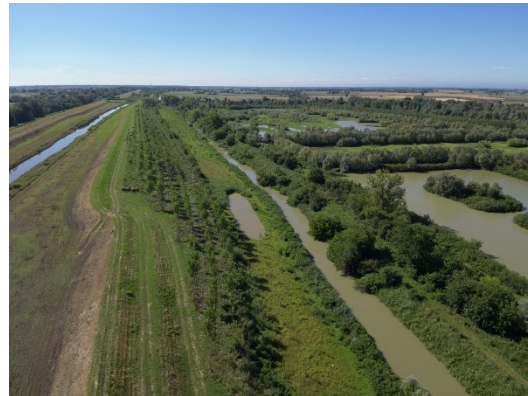
Figure 21 – S9 after intervention.

S9 is the largest intervention area and is situated on the left bank of the Botte canal (Figure 21), inside and toward the northern boundary of Natura 2000 site IT4050024 - SCI-SPA “Biotopes and environmental restorations of Bentivoglio, San Pietro in Casale, Malalbergo and Baricella”. On the opposite bank lies the Gandazzolo Vecchia water retention basin, which comprises various wetlands.

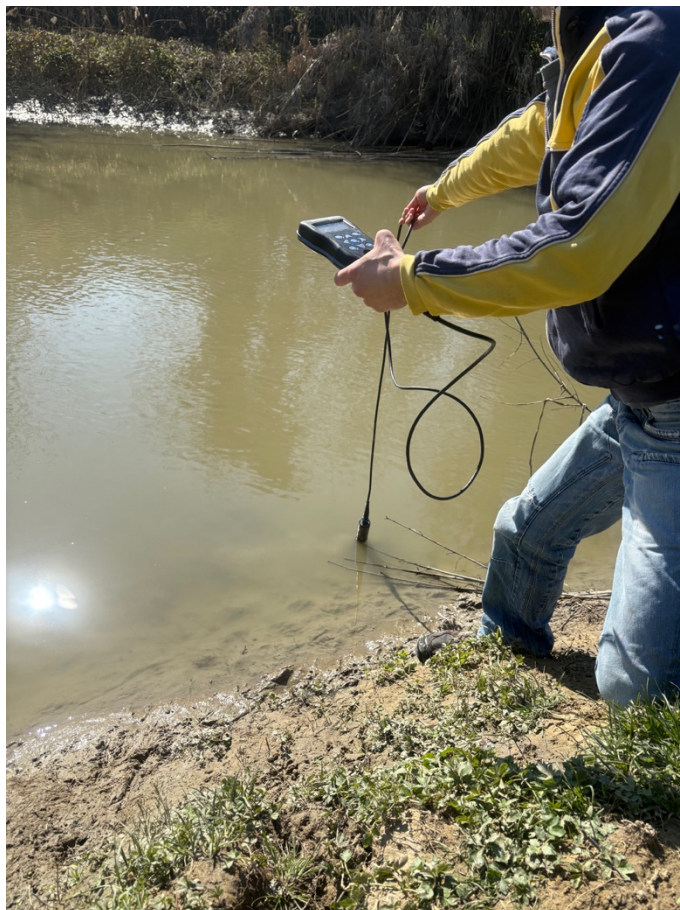
Figure 22 - In field water monitoring.

In the field, water temperature (°C), pH, electrical conductivity ($\mu\text{S}/\text{cm}$), dissolved oxygen (mg/L), nitrate nitrogen (N-NO_3^-) (mg/L), and ammoniacal nitrogen (N-

NH_4^+) (mg/L) were measured using a multiparameter probe (Figure 22, Aquabrobe® 2000).

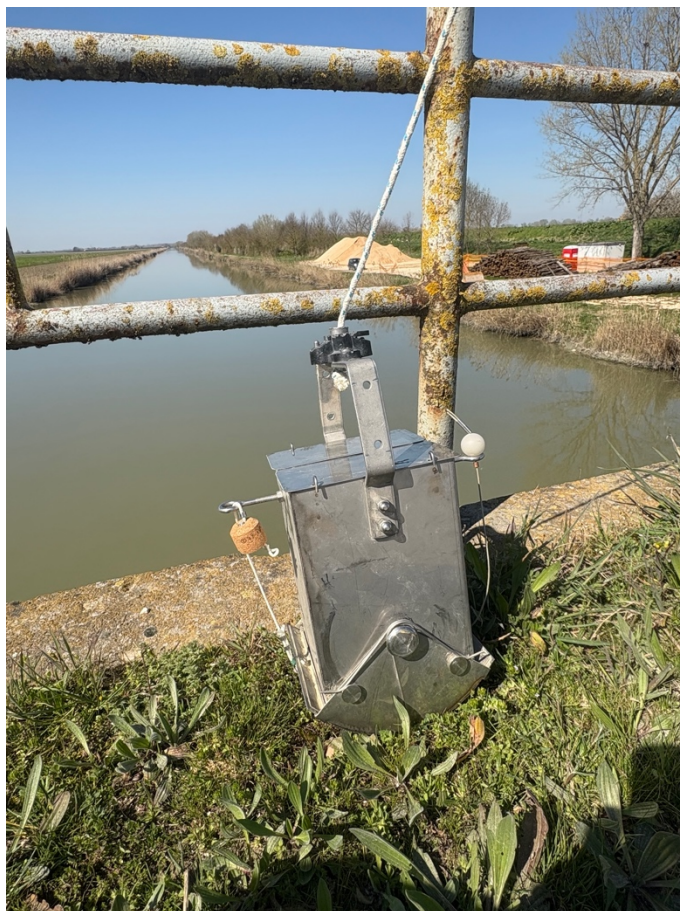
Figure 23 - Ekman dredge.

Sediment was sampled twice a year: in December and July, between 2020 and 2024. Sediment samples were collected using an Ekman dredge (Figure 23), which allowed for the retrieval of a substrate column. The samples were then air-dried, sieved to remove coarse particles (>2 mm), and an aliquot was finely ground and stored in containers for subsequent analysis.

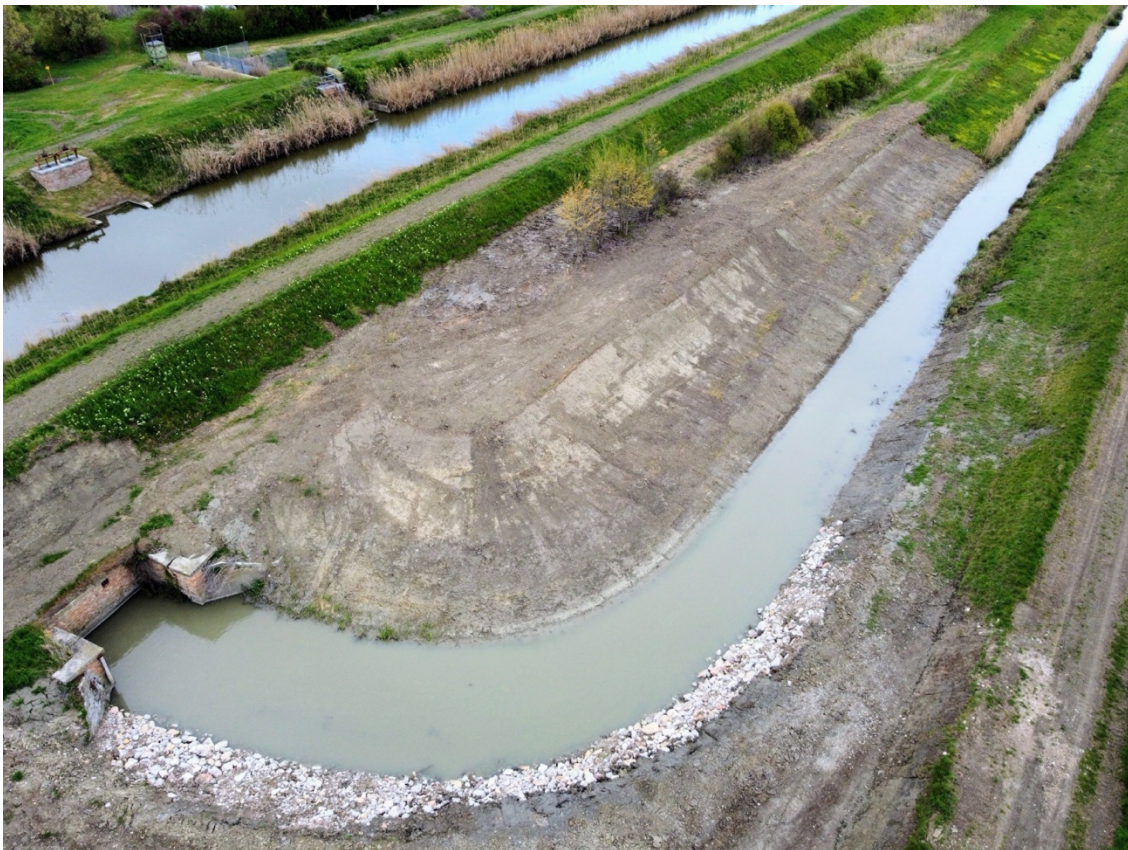
Figure A1 - S1 after intervention.

The intervention stretches 140 m along the left bank beginning at the point where the Garda Basso passes beneath the Garda Alto.

Morphologically the site consists of two zones: a long, gently sloping bank rising from the canal to the crown of the levee, and a service track bordered by a linear strip of mixed native trees and shrubs.

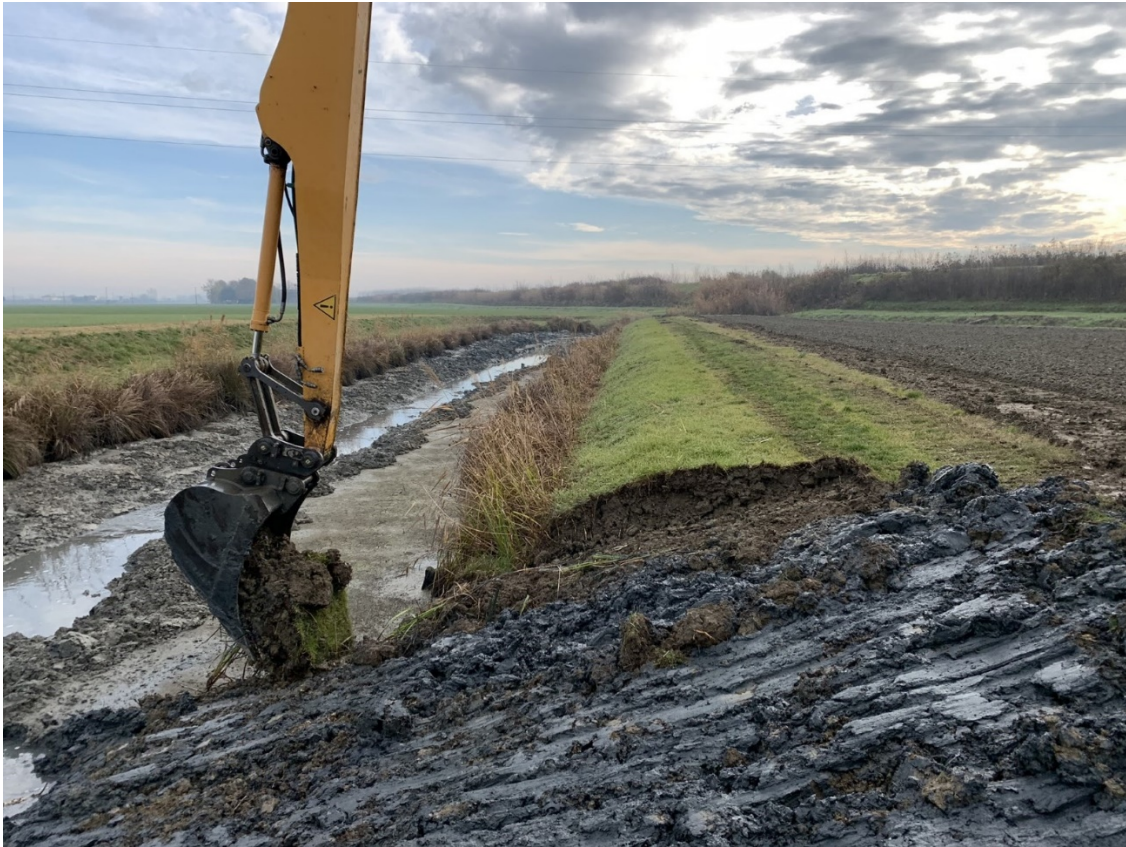
Figure A6 - Bank modification intervention at S2.

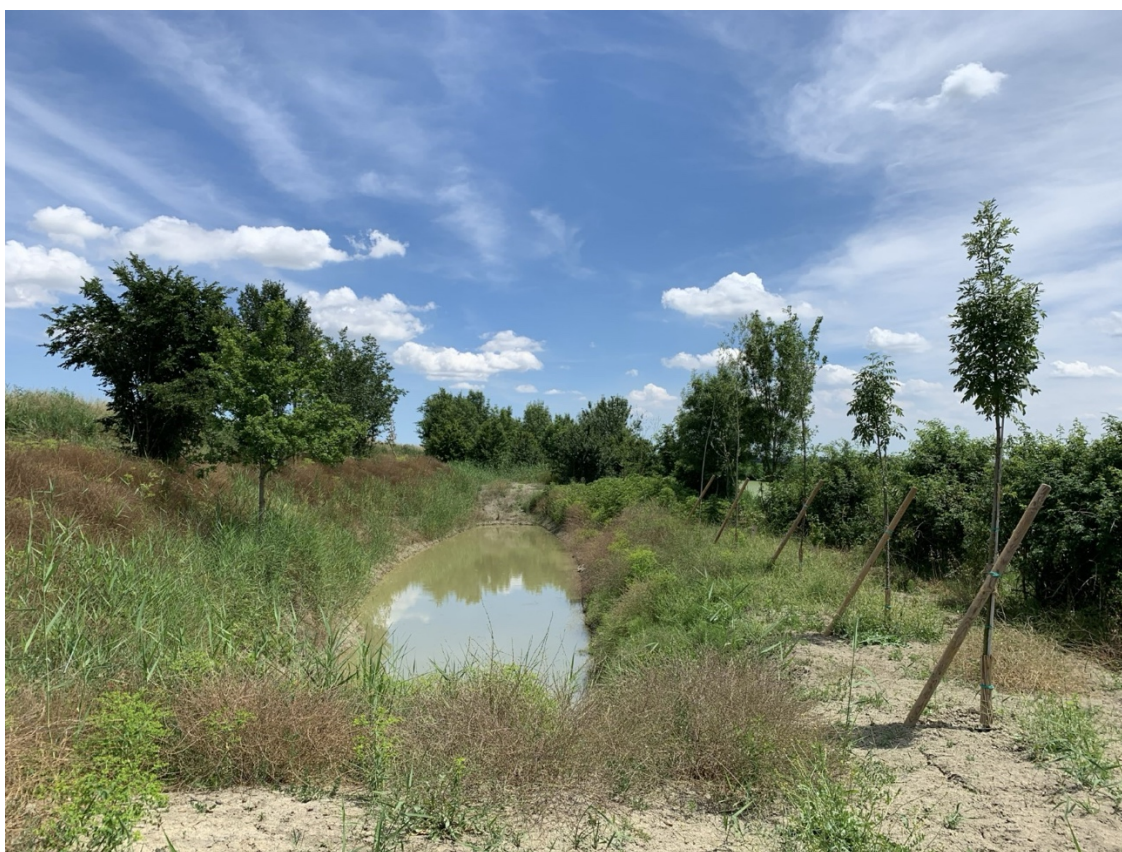
Figure A9 – Ponde created at S4.

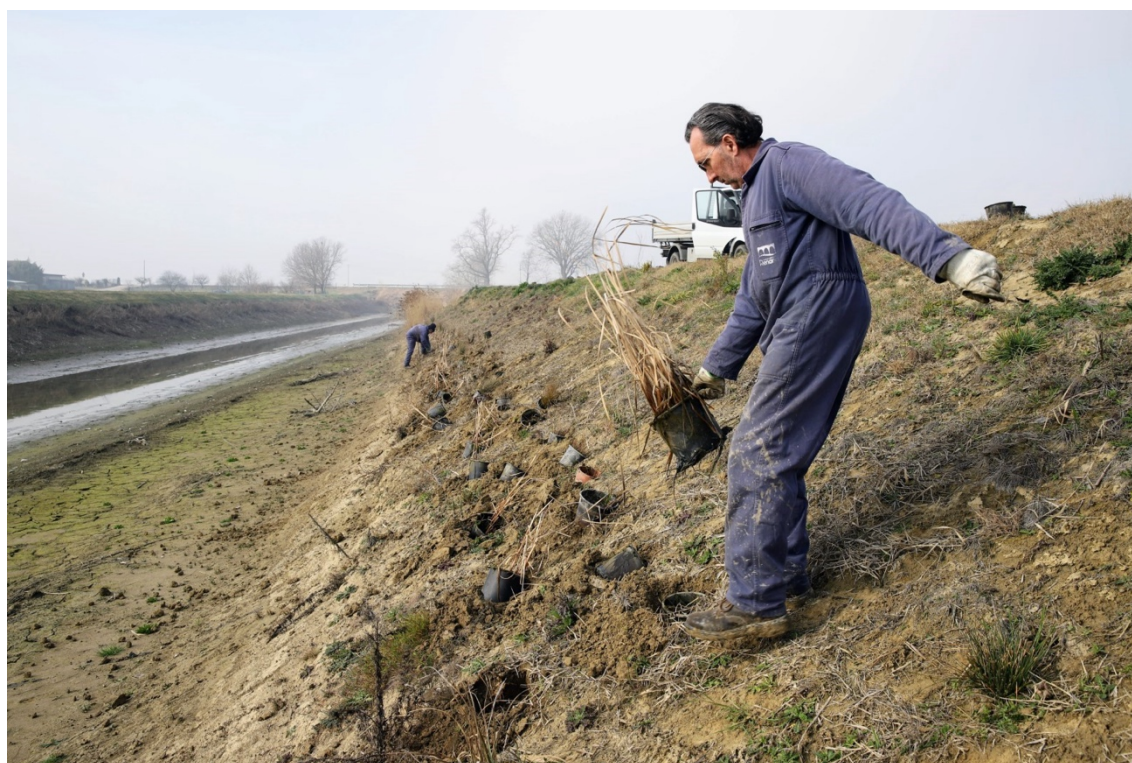
Figure A12 - Planting wetland plants at S5.

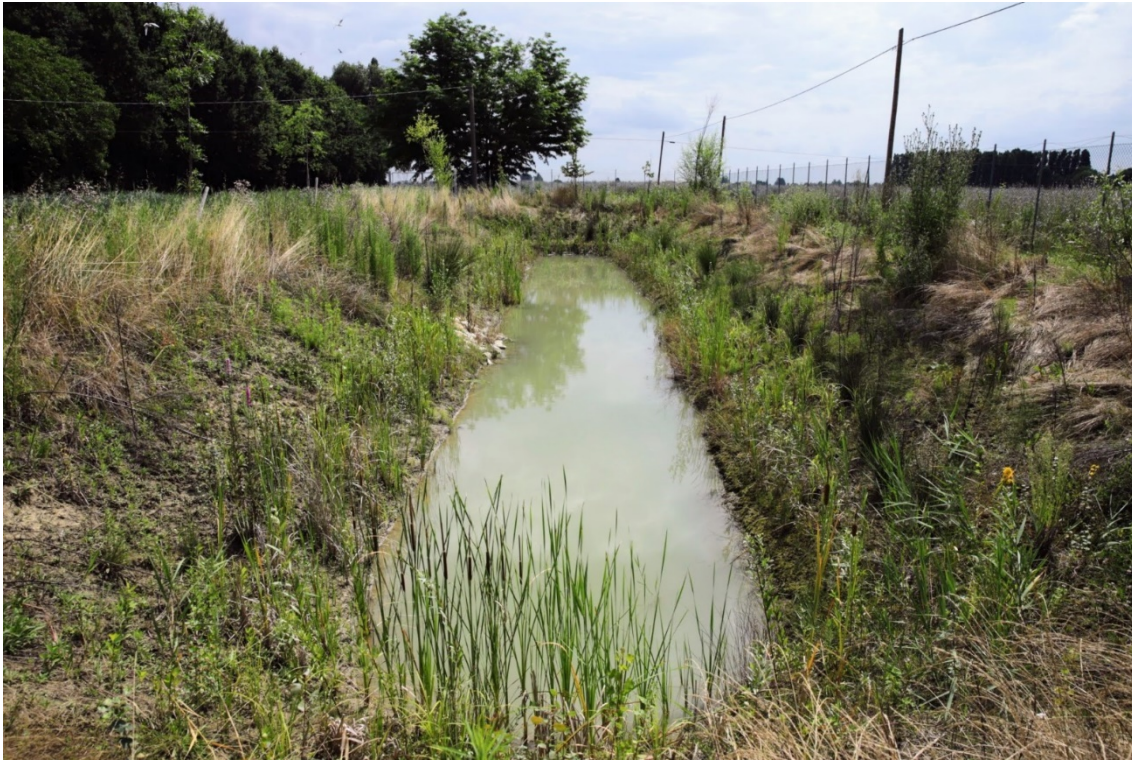
Figure A15 – Pond created at S6.

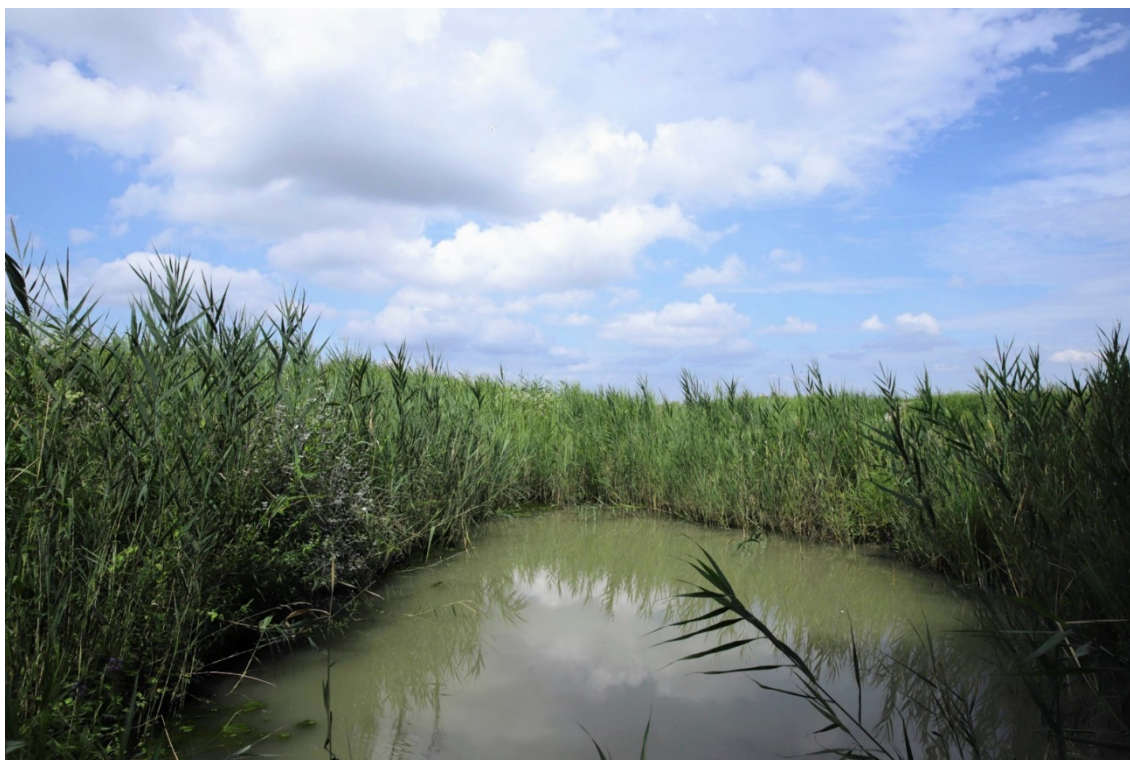
Figure A18 – Pond created at S7.

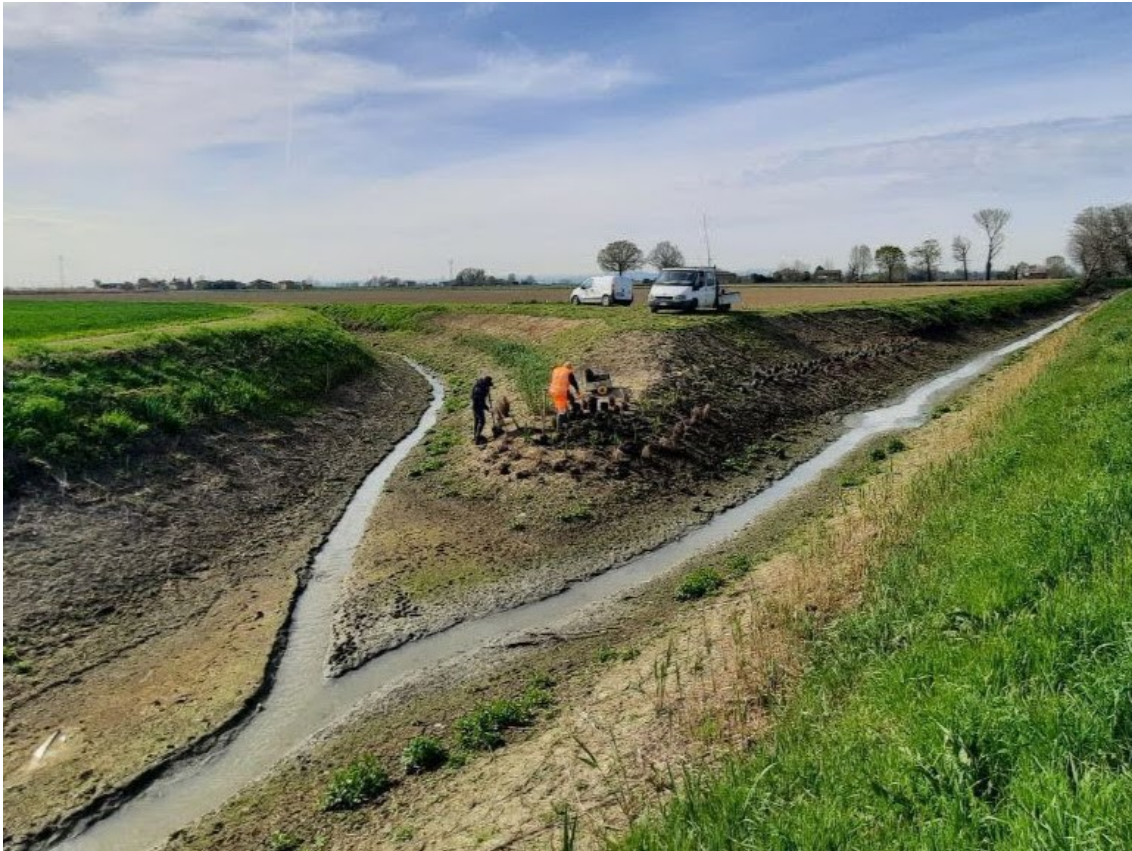
Figure A21 - Planting wetland plants at S8.
