**Alma Mater Studiorum – Università di Bologna**

**Science for Conservation**

**MULTI-POLLUTANTS IMPACT ON MODERN CEMENT  
BUILT HERITAGE**

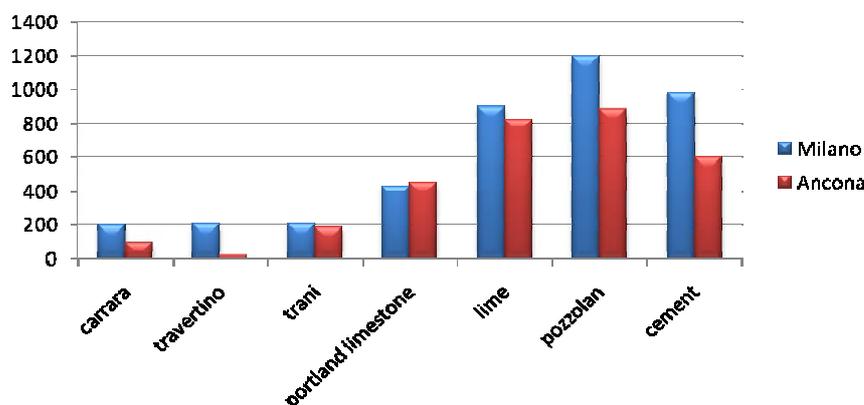
**Figure 1.1.** Total sulphur ( $\mu\text{g cm}^{-2}$ ) measured on stones and mortars exposed for 12 months in Ancona and Milan (Zappia et al., 1998).

1. Sulphation is the main process of degradation that occurs on both stones and mortars specimens.
2. The exposed materials showed different degrees of sulphation (Figure 1.1), highlighted the reactivity to SO<sub>2</sub> of stones and mortars exposed. Considering the total sulphur detected on the samples, mortars have been demonstrated to be more reactive than stones. This is mainly due to the micro-structural properties such a porosity, in fact mortars have a higher porosity than stones, and therefore higher potential of interaction with pollutants.
3. Taking into account the exposition to the rain run-off, the highest amount of airborne ion concentrations (sulphate, sulphite, nitrate, nitrite, chloride, fluoride, oxalate) respect to the bulk material, was observed in the areas completely protected.

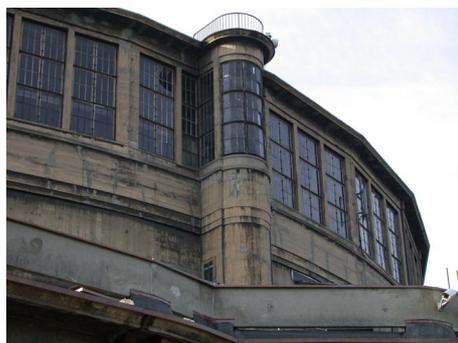
**Figure 2.1.** Centennial Hall, Wroclaw (Poland).

Centennial Hall is a landmark in the history of reinforced concrete architecture; it was one of the world's biggest dome-like structure. This is a pioneering construction of modern architecture, which shows an important interchange of influences in the early 20<sup>th</sup> century, becoming a key reference in the later development of reinforced concrete structures. The building has the form of a symmetrical quatrefoil (Figure 2.3), with an inner diameter of 69 m and a height of 42 m, creating a vast circular central space, with seating for up to 6000 people.

The Centennial Hall (Figures 2.1, 2.2, 2.3) is located in the urban area of Wroclaw, situated in one of the most industrialized and polluted regions of Poland, called Silesian Coal Basin. In this area in 1992 was produced 23 % of Poland's total SO<sub>2</sub> emission, though it occupies only 2 % of the country's area. In the past, Poland was a country having large heavy and power industry based on coal as a primary energy source. Since 1990, due to the Government's effort through legislative, regulatory and economic means, considerable improvements have been achieved in reducing air pollution in the country's industrial areas (Nagy et al, 2006). The Centennial Hall is located in close neighbourhood of coal power stations; the closest one is just 5 km away from the monument.

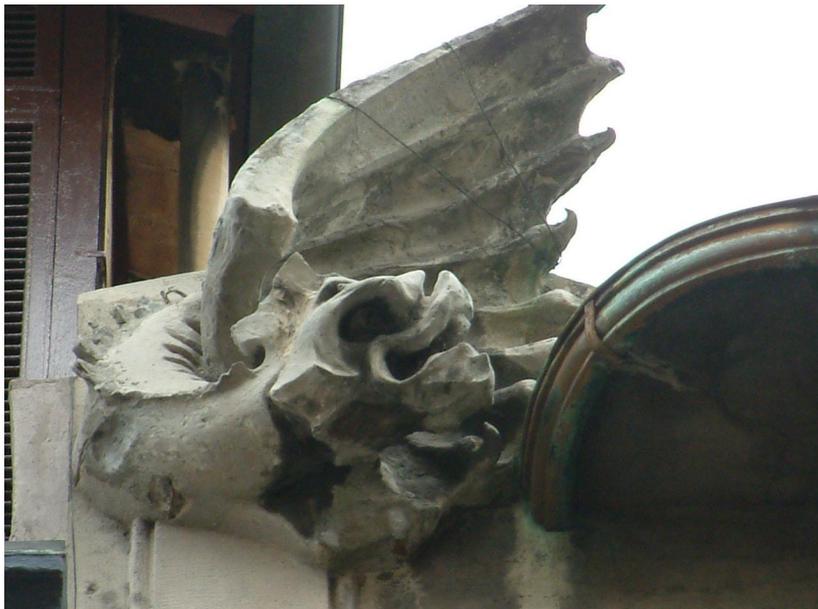
**Figure 2.8.** Dragon on the crown of the façade, Casa Galleria Vichi (Florence).

The Casa Galleria Vichi was designed by architect Giovanni Michelazzi in 1911, commissioned by Argia Marinai Vichi as home and gallery and it still serves this purpose today. The concrete palace was built in the style of art *nouveau* and is the unique example of liberty style in the centre of Florence. The eccentric narrow façade encloses structural and sculptural fantasy motif composed by a mix of artificial stone, steel and glass. Every floor is characterized by a central stained glass window designed following the typical line curve "a colpo di frusta" cut in horizontal elements. The ground and first floor (Figure 2.6) are utilized for commercial use and are more fanciful ornamented with sculptures and reliefs, for example with the eagle holding the lamp, while upper floors to residential use, are less decorated with pilasters around the central windows. The crown of the façade is decorated with two dragons (Figure 2.8).

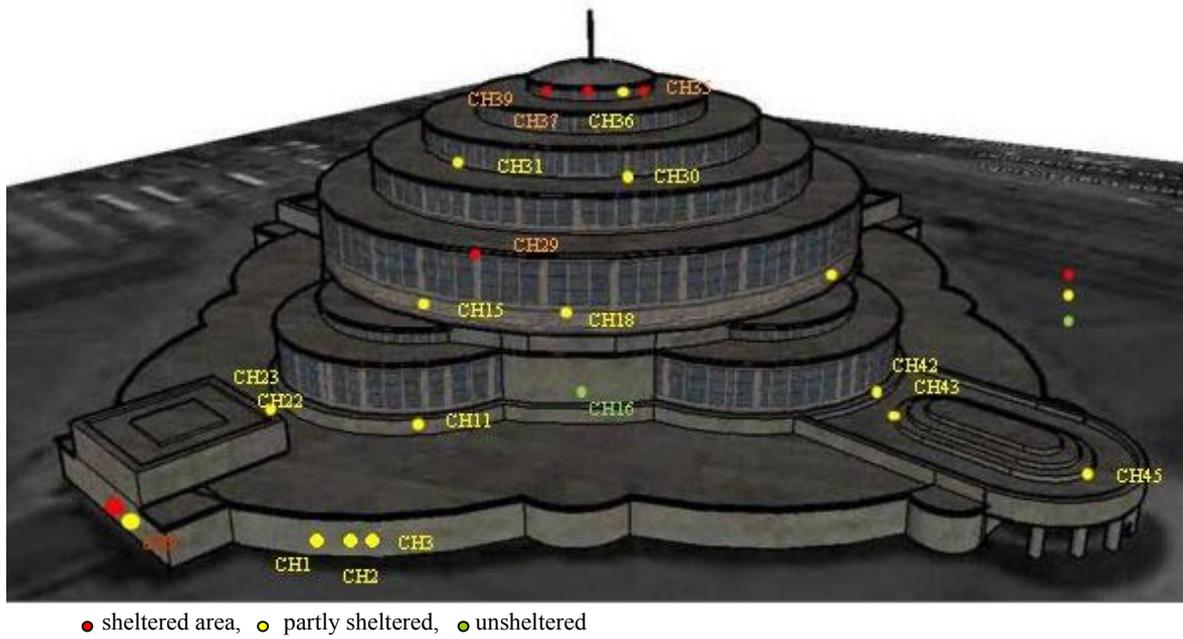
**Figure 3.1.** Plan of the Centennial Hall (North-West), sampled areas within the red, yellow, green circles.

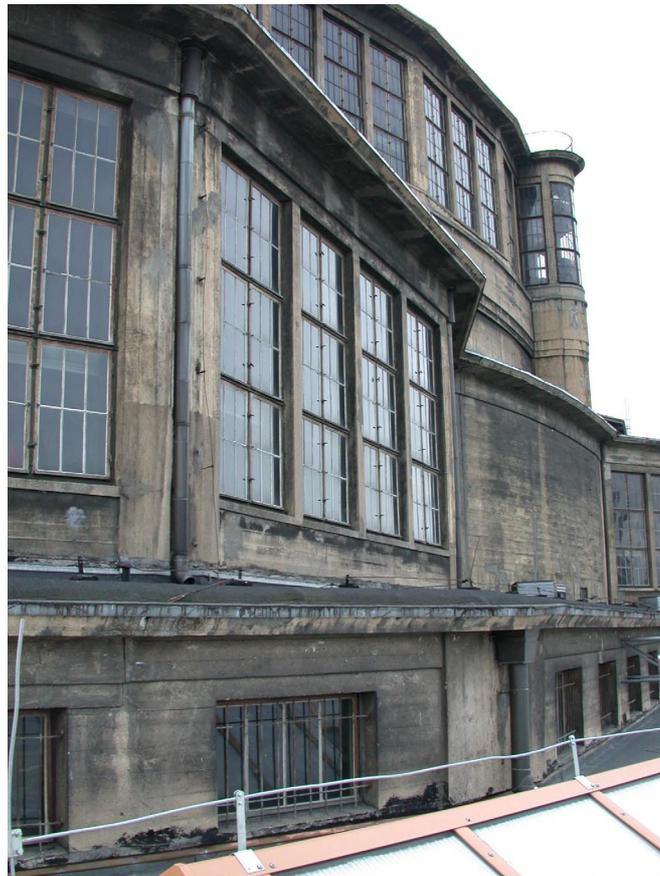
**Figure 3.2.** Centennial Hall (Wroclaw), there are observable areas with black crust.

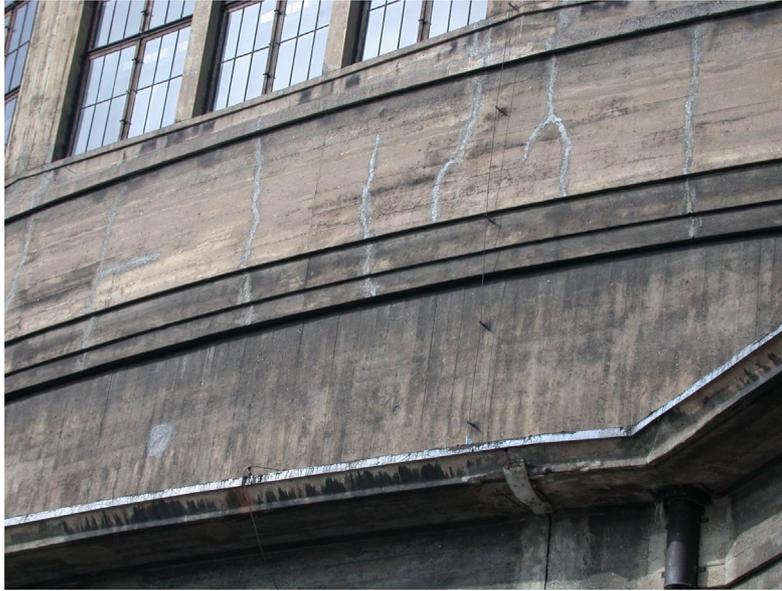
**Figure 3.3.** Centennial Hall, sampled areas with black crust.

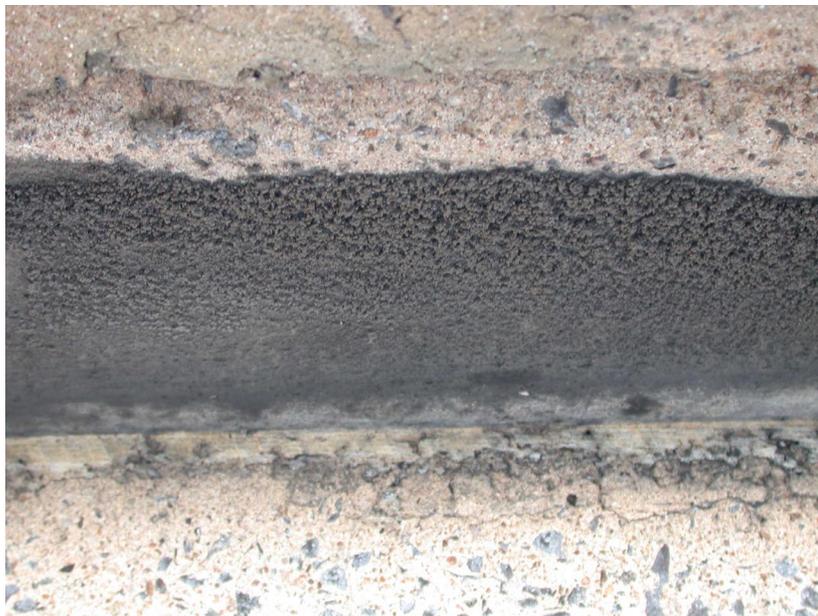
**Figure 3.4.** Centennial Hall, black thick crust in area protected from rain run-off.

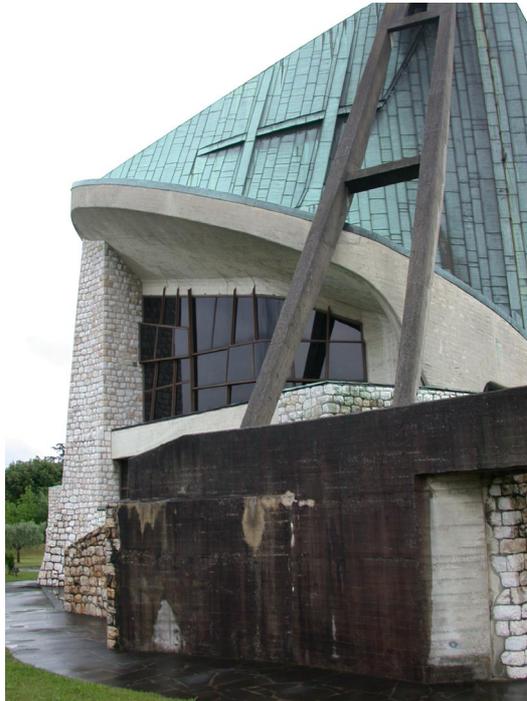
**Figure 3.5.** The concrete wall\* in the northern part of the Chiesa dell'Autostrada del Sole (Florence).  
\*The concrete wall appears black because the picture was taken in a rainy day and the wall was wet.

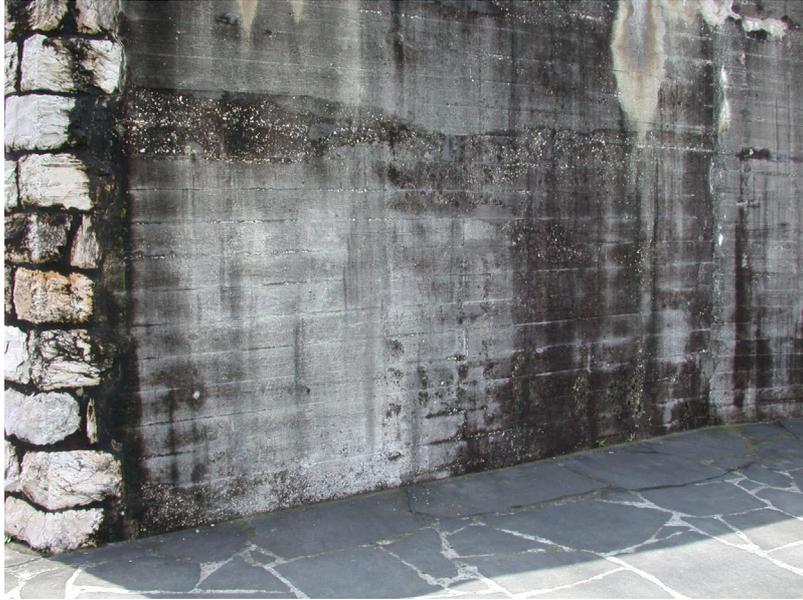
**Figure 3.6.** Chiesa dell'Autostrada del Sole (Florence), sampled area.

Samples were collected from the concrete wall on the northern part of Chiesa dell'Autostrada del Sole as it is shown in Figures 3.5, 3.6 and 3.7. This part as well as the whole Church, was restored (cleaned) two years before sampling. Under visual assessment, the damage layer was not observed on the jointing mortars and on the concrete parts of the church. The samples collected in form of fragments for subsequent analysis are listed with short description in Table 3.2.

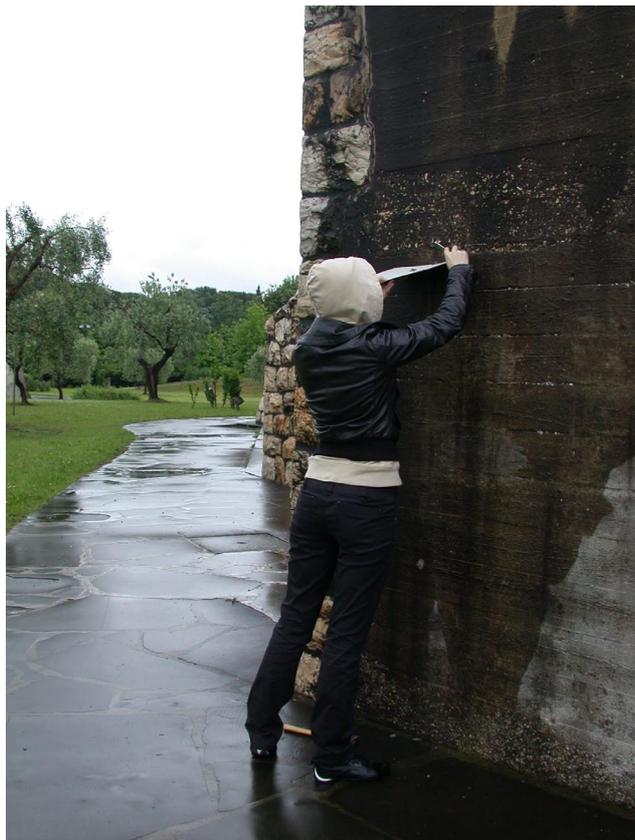
**Figure 3.7.** Sampling on Chiesa dell'Autostrada del Sole (Florence).

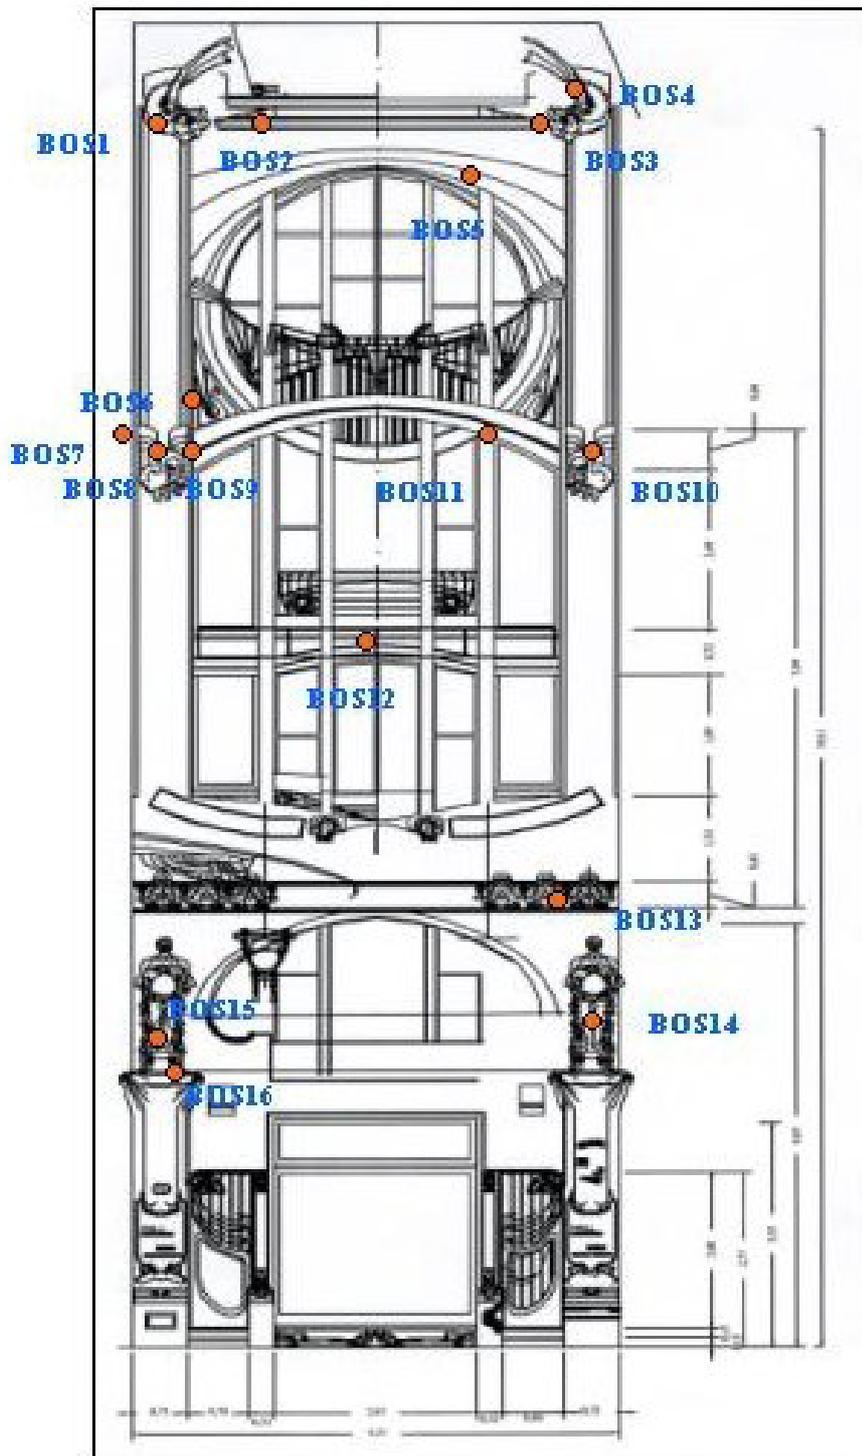
Figure. 3.8. Plan of façade of the Casa Galleria Vichi, sampled area within the red circles.

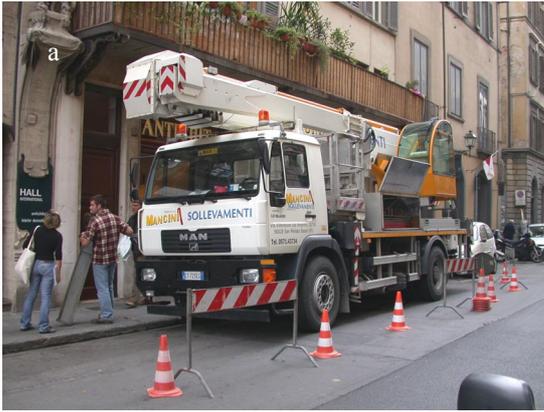
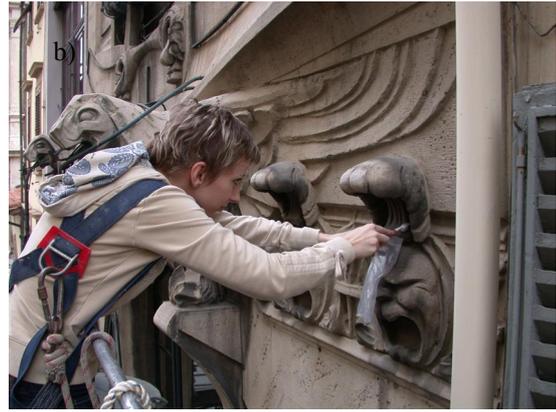
**Figure 3.9.** Sampling: (a) platform lift, (b) collection of the black crust from area protected from rain ran-off.

The samples were collected on the facade (South-West) of Casa Galleria Vichi (Florence, Italy) by scalpel or brush, moving on a platform lift as it is shown in Figure 3.8. Sampling was started from above, at a height of 19 m on the left side, then moved to the centre and went to the right side. The same pattern, with horizontal bands, was repeated at other levels as it is presented in Figure 3.9.

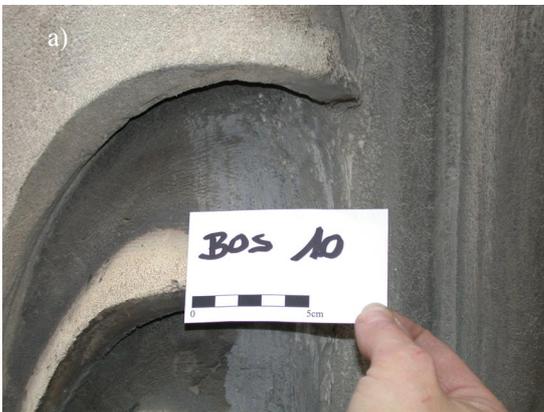
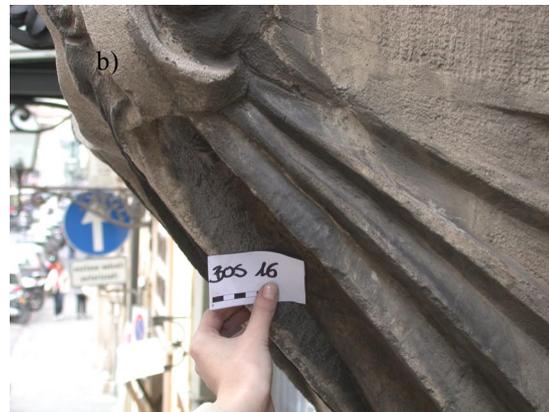
**Figure 3.10.** (a), (b) Sampling points of coherent black crust, Casa Galleria Vichi (Florence).

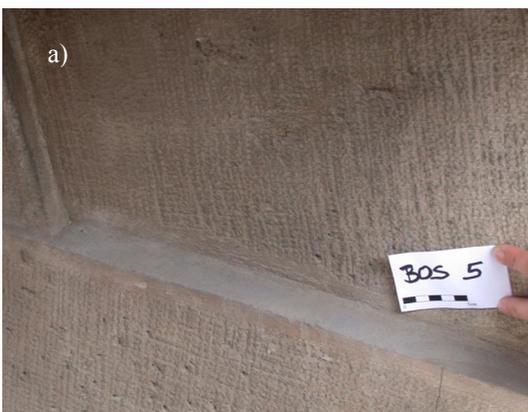
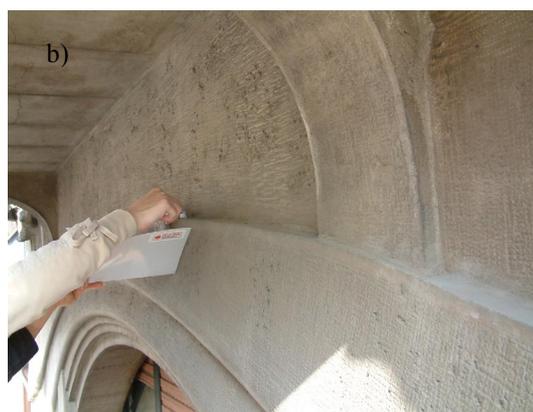
**Figure 3.11.** Casa Galleria Vichi. Sampling point, (a) and (b) incoherent grey deposit, easily collected by brush

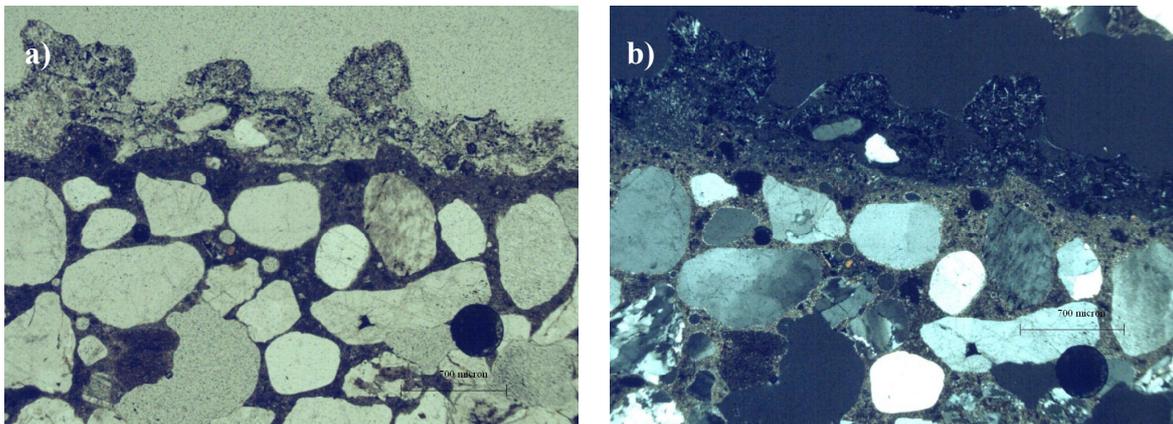
**Figure 4.1.** Optical micrographs (a) planed-polarised light, (b) cross-polarised light of damage layer in sheltered area (CH37).

The optical microscope (OM) observations performed on transversal thin section of specimens CH19, CH21, CH29, CH37, CH39 indicated that external surface of samples was covered by no homogenous damage layer, as it is shown in Figures 4.1 and 4.2.

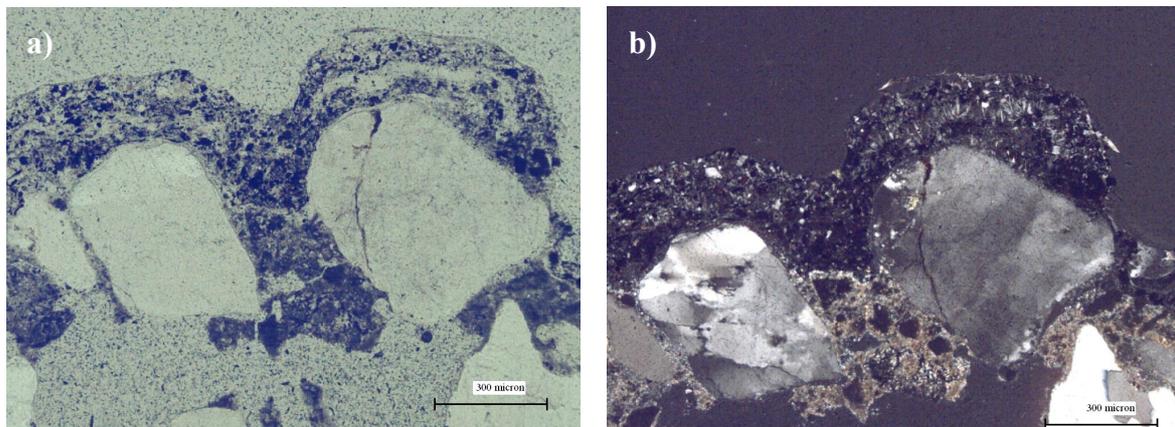
**Figure 4.2.** Optical micrographs (a) planed-polarised light, (b) cross-polarised light of damage layer in sheltered area (CH19). Black carbonaceous particles are clearly identifiable embedded in the gypsum matrix.

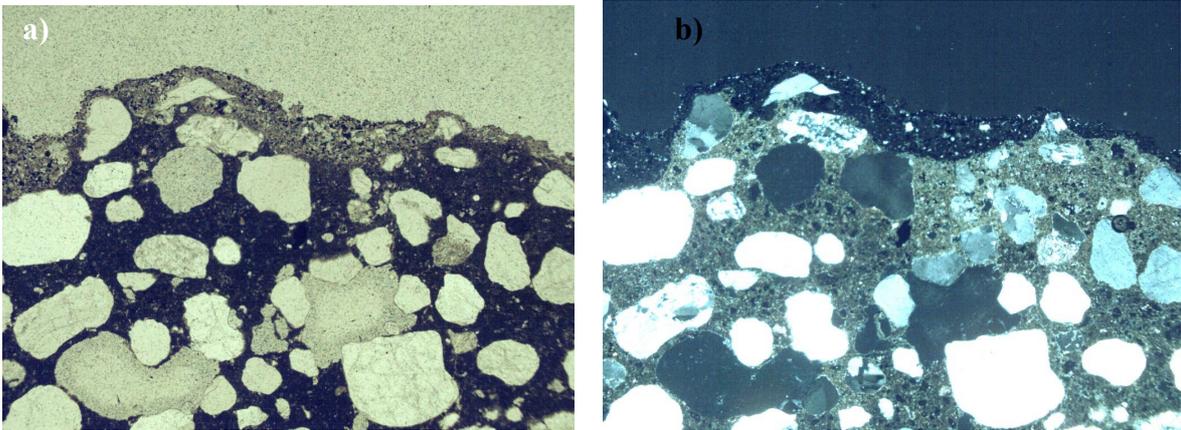
**Figure 4.3.** Optical micrographs (a) planed-polarised light (b) cross-polarised light of damage layer in partly sheltered area (CH29). Gypsum matrix clearly identifiable.

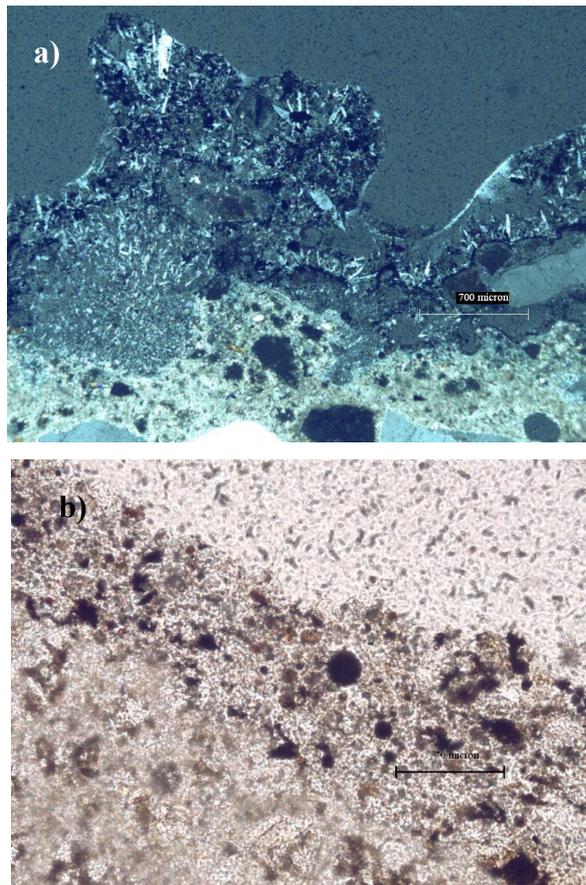
**Figure 4.4.** Optical micrographs (a) cross-polarised light (b) planed-polarised light of damage layer in sheltered area (CH19), black carbonaceous particles, yellow transparent aluminosilicate particles and orange iron oxides are observable.

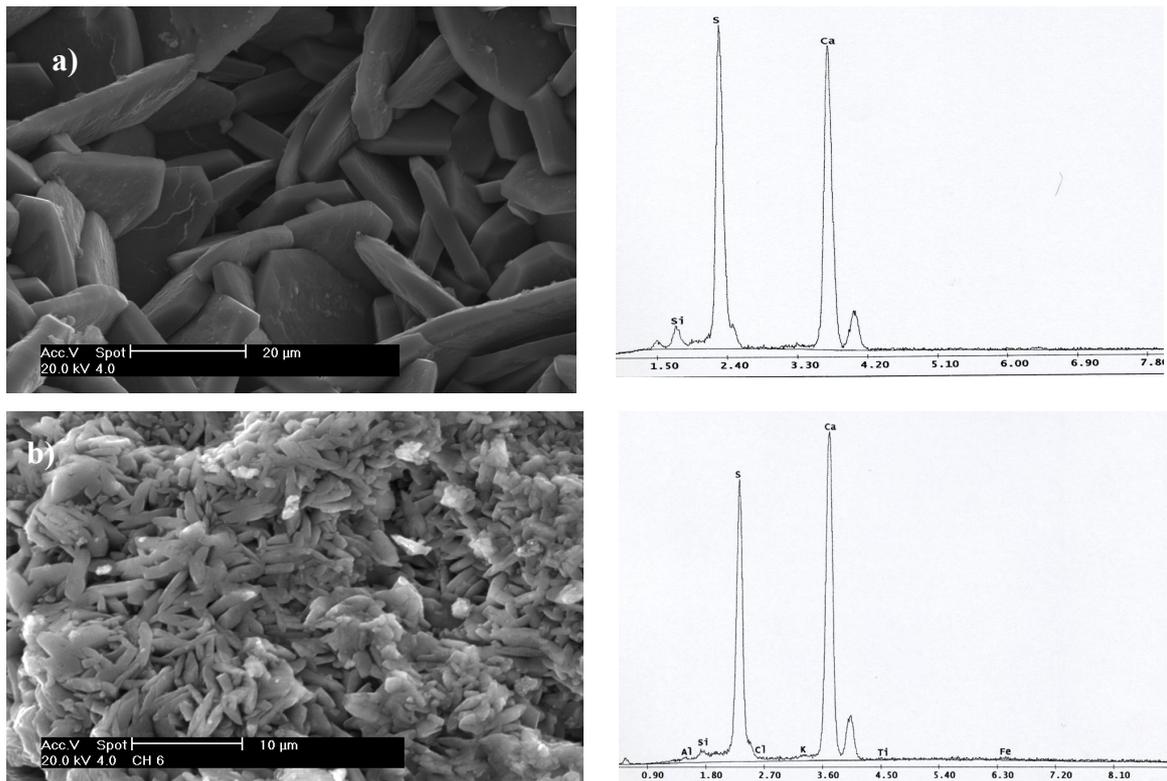
**Figure 4.5.** Scanning electron micrograph showing surface of damage layer on the left, and relative EDX spectrum on the right from (a) partly sheltered area (CH29) and (b) sheltered are (CH6).

The SEM-EDX analysis performed on the sample surfaces CH6, CH8, CH21, CH29, CH37 and CH39 confirmed the presence of gypsum with laminar structure, as it is shown in Figure 4.5. Two typologies of particles were also identified in gypsum matrix: (1) spherical shape particles with smooth surface (Figure 4.6), were characterized by the presence of silicon and aluminium as the main elements, with smaller amounts of Ca, S, K, Mg, Fe, and Ti, typical of aluminosilicate particles from coal combustion (Jabłońska et al., 2003); (2) particles with spongy structure (Figure 4.7) characterized by S as a main element followed by Ca, Si, Al, Fe, K, Cl, Mg, which represented carbonaceous particles from oil combustion (Bacci et al., 1983).

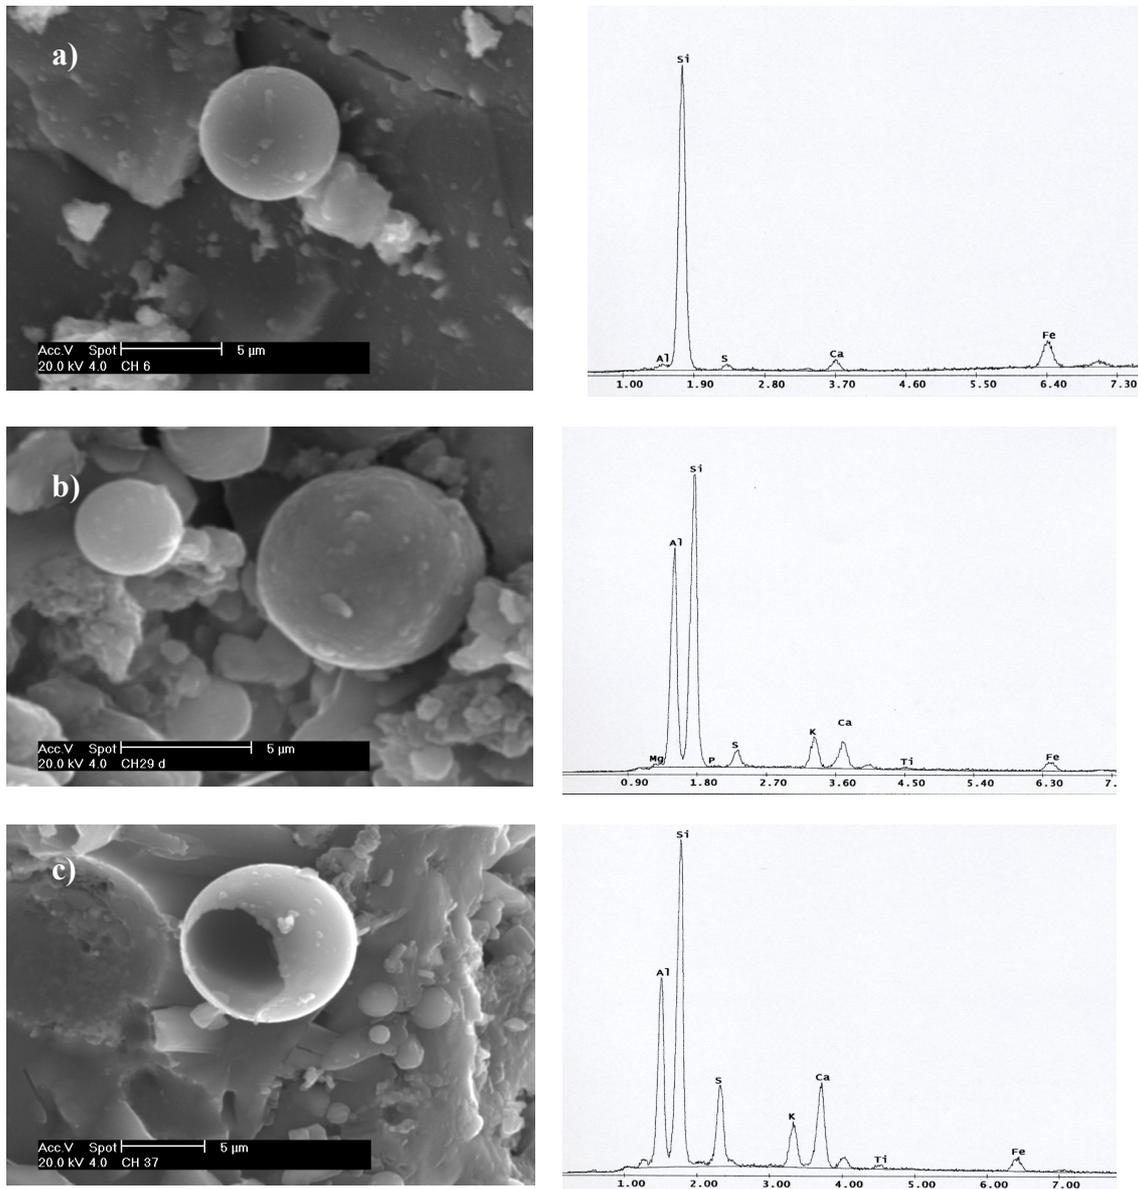
**Figure 4.6.** Scanning electron micrograph of aluminosilicate particles (a) in sample CH6, (b) in sample CH29, (c) in sample CH37 embedded in laminar gypsum with the EDX spectrum on the right.

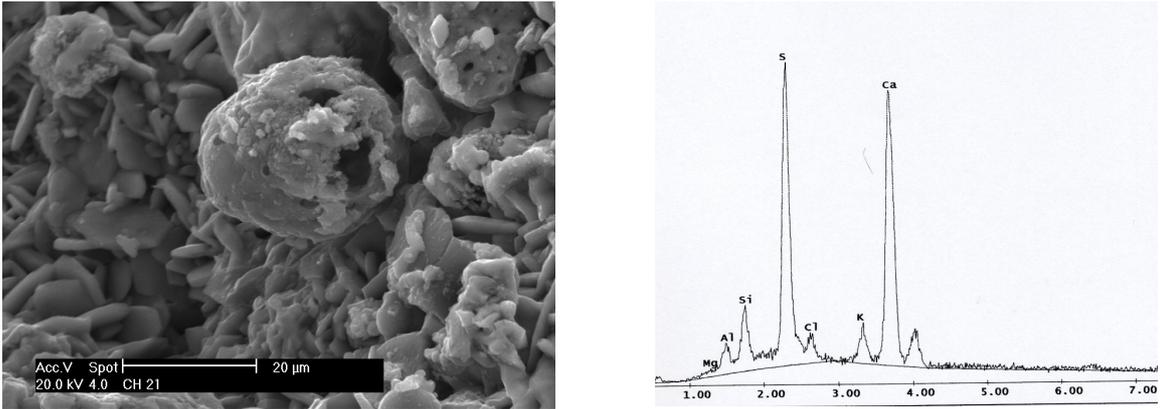
**Figure 4.7.** Scanning electron micrograph showing the carbonaceous particle embedded in lamellar gypsum with the EDX spectrum on the right.

The black carbonaceous particles are responsible for blackening of the surface and can play a catalytic role in sulphation process (Benner et al., 1982; Del Monte et al., 1984).

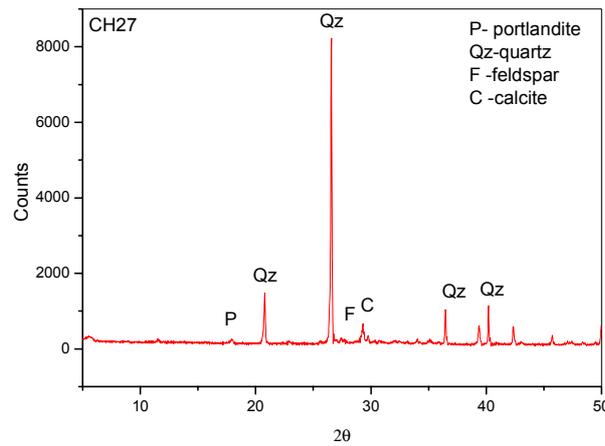
**Figure 4.8.** X- ray diffractogram of substrate (CH27) sample collected from Centennial Hall, Wrocław (Poland).

The presence of quartz and calcite, identified in samples of fragments (CH11, CH41) and of damage layers (CH17, CH38), can be linked to both aggregates of underlying material or atmospheric deposition (solid dust, fly ash). The crystal phases occurring only in damage layers such as gypsum, hematite, ilmenite, magnetite and rutile are related to atmospheric deposition.

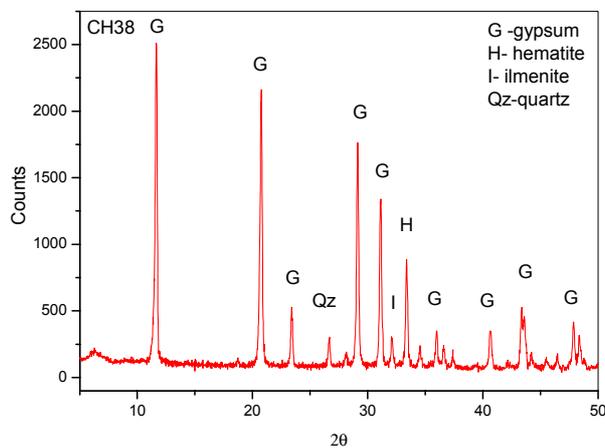
**Figure 4.9.** X- ray diffractogram of damage layer from sheltered are (CH38), Centennial Hall, Wrocław (Poland).

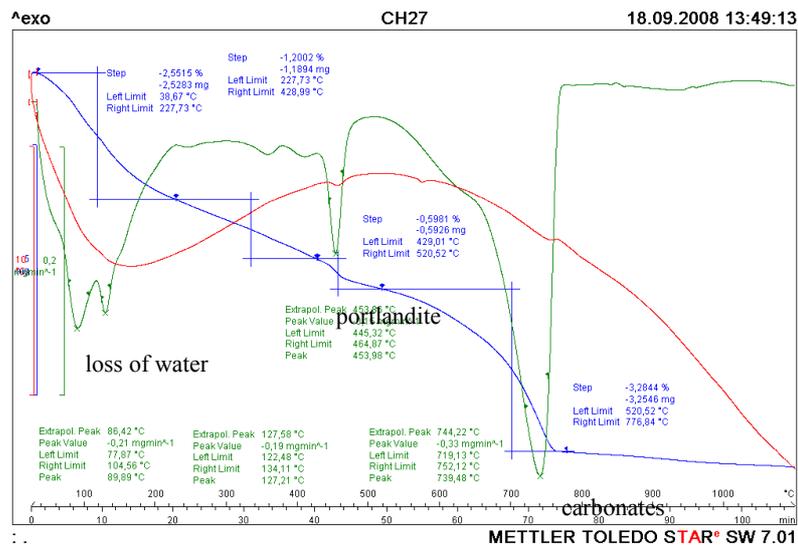
**Figure 4.10.** DTA-TGA graphs of sample representative substrate (CH27) from Centennial Hall.

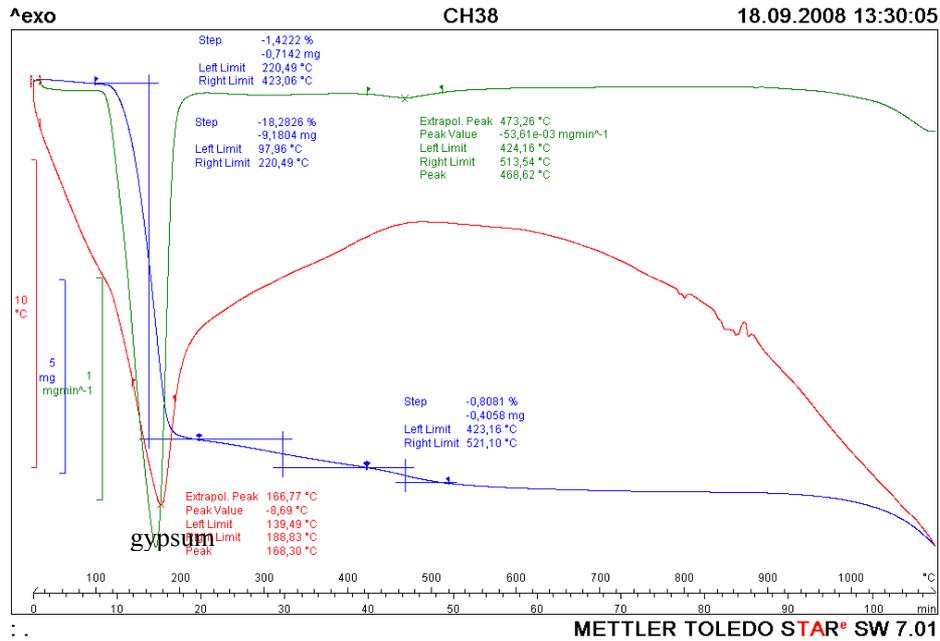
Figure 4.11. DTA-TGA graphs of sample representative of black crust (CH38) from Centennial Hall.

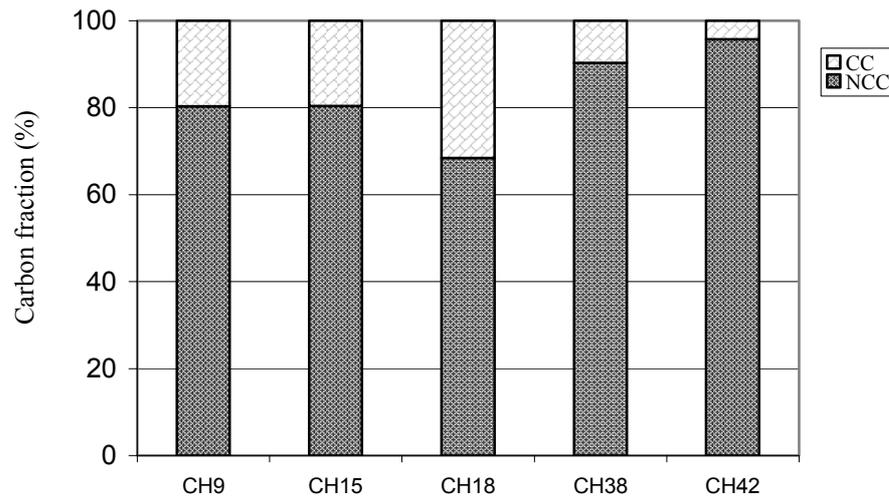
**Figure 4.12.** The non carbonate carbon (NCC) and carbonate carbon (CC) percentage fraction of total carbon in samples of damage layers collected from Centennial Hall (Poland).

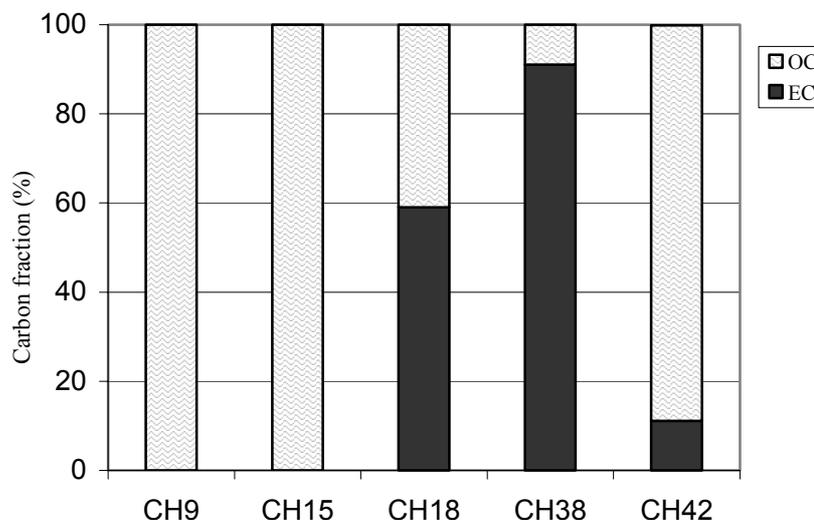
**Figure 4.13.** The organic carbon (OC) and elemental carbon (EC) percentage fraction of NCC.

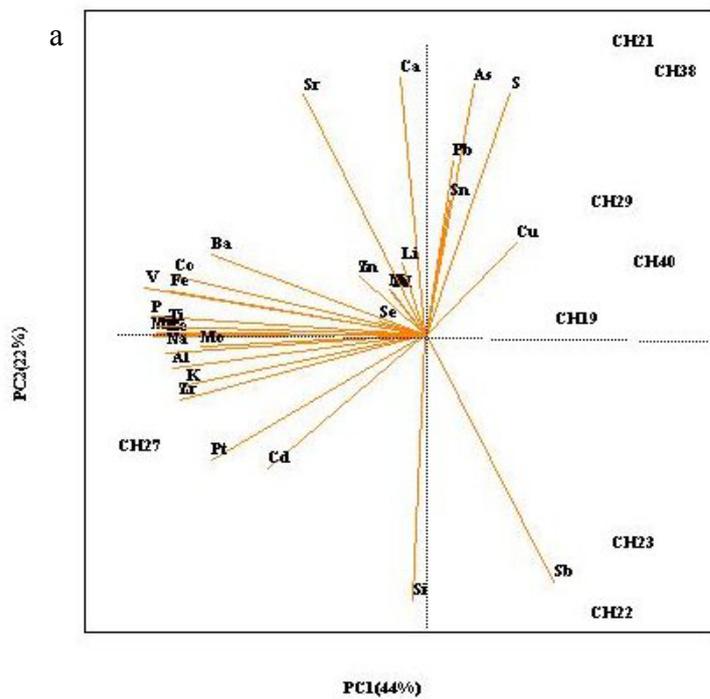
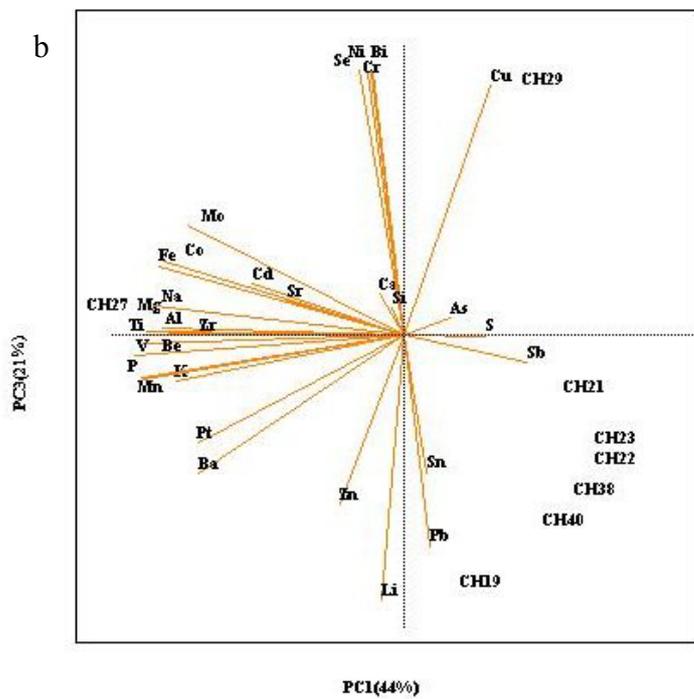
**Figure 4.14.** Principal Components Analyses, maps generated for results of ICP-OES, Centennial Hall (Wroclaw), a) PC1 versus PC2, b) PC1 versus PC3.

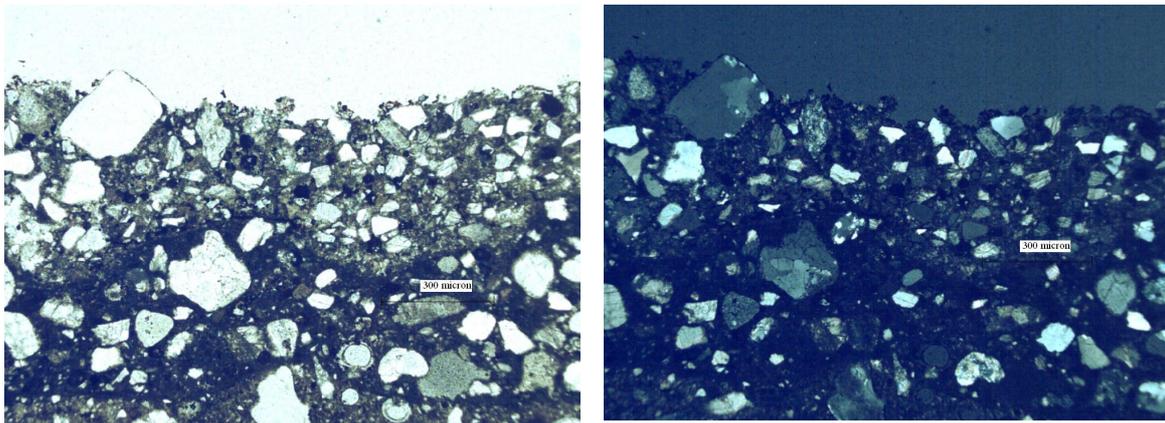
**Figure 4.15.** Optical micrographs (a) planed-polarised light, (b) cross-polarised light of sample (FIC2) collected from Chiesa dell'Autostrada del Sole. The external surface of sample is not affected by sulphation process.

The optical microscope observations of thin section of sample FIC2 collected from Chiesa dell'Autostrada del Sole indicated the absence of gypsum layer on the surface (Figure 4.15). There were recognizable on the material surface yellow and orange transparent iron oxides, as it is shown in Figure 4.16. This result shows that surface is not affected by sulphation process, this fact is closely connected to the frequent restoration works performed at the building (every 2-3 years).

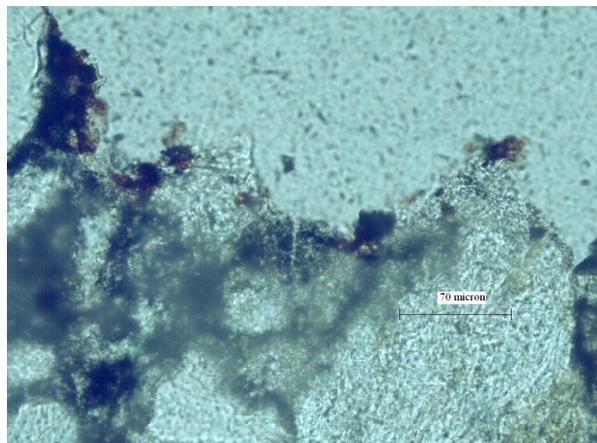
**Figure 4.16.** Optical micrograph, planed-polarised light of sample (FIC2) collected from Chiesa dell'Autostrada del Sole; yellow-orange iron oxides are observable on the external surface.

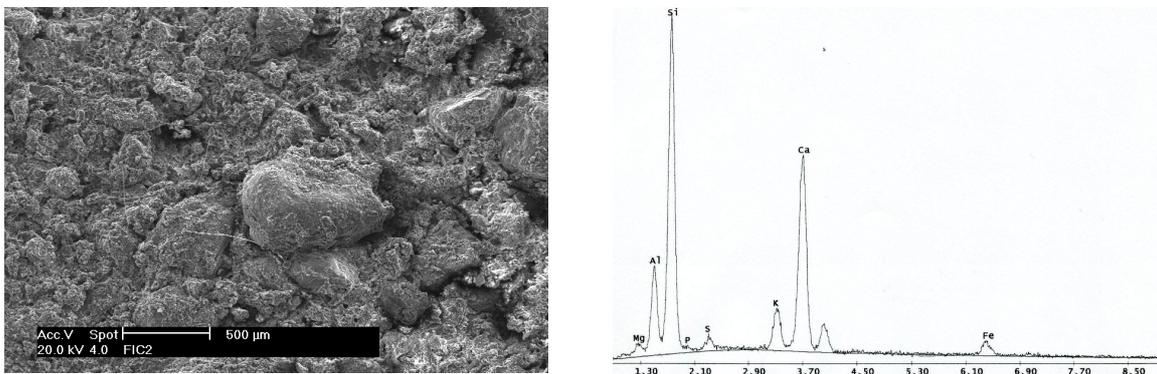
**Figure 4.17.** Scanning electron micrograph showing the surface of sample from Chiesa dell'Autostrada del Sole, with relative EDX.

The scanning electron micrograph of a sample from Chiesa dell'Autostrada del Sole presented in Figure 4.17, shows that surface is not covered by lamellar gypsum. The EDX analyses indicate that the main elements are Si, Ca, Al and K, typical for Portland cement: this additionally confirms the lack of sulfation process on the surface, that was also revealed during the optical microscope observations.

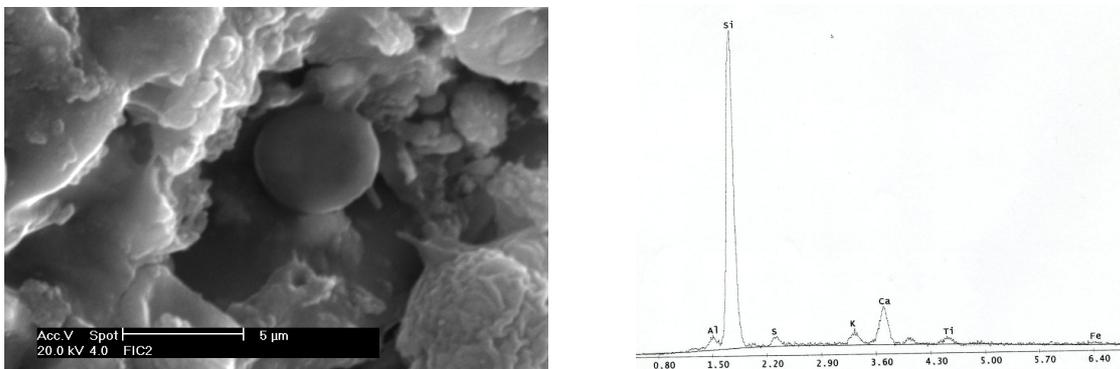
Sporadically, on the surface were observed smooth aluminosilicate particles, presented in Figure 4.18. The nature of particles is confirmed by EDX showing Si as major element and Al, Ca, S, K and Ti as minor. Those particles are delivered from combustion processes (Jabłońska et al., 2003).

**Figure 4.18.** Scanning electron micrograph of damage layer surface showing aluminosilicate with the EDX spectrum on the right.

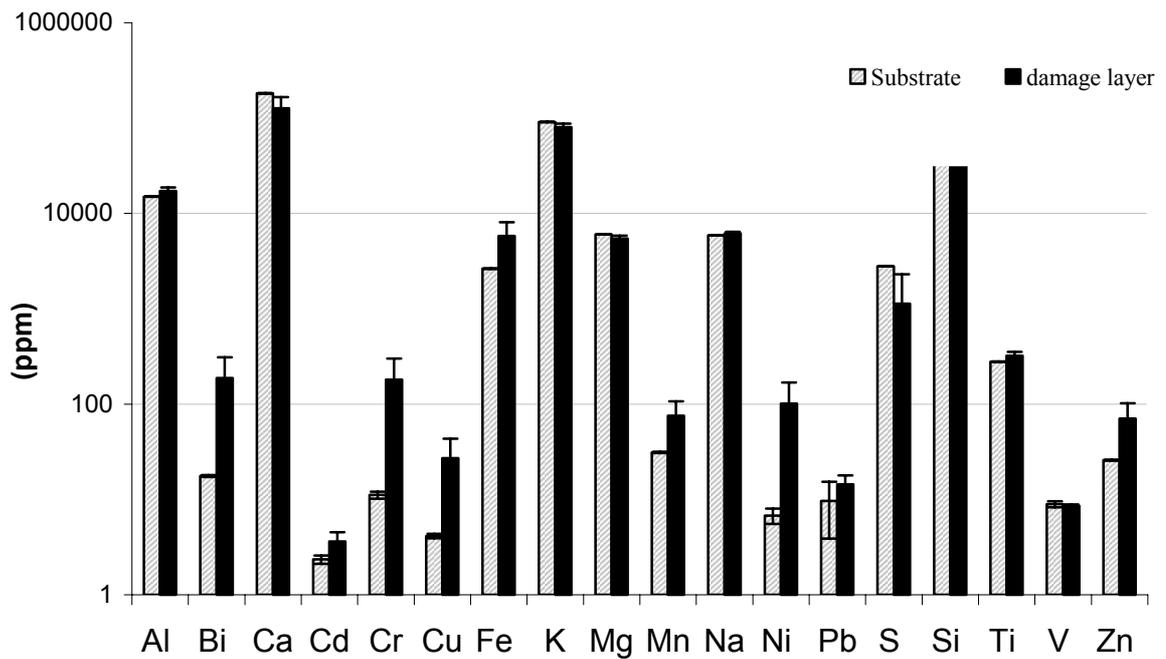
**Figure 4.19.** Mean element contents in substrate and damage layer taken from Chiesa dell'Autostrada del Sole.

Sulphur in this case had higher concentration in underlying material than in damage layers, this fact confirmed the lack of sulphation process and therefore gypsum formation on the building surface, as it was revealed during the optical and scanning electron microscope observations.

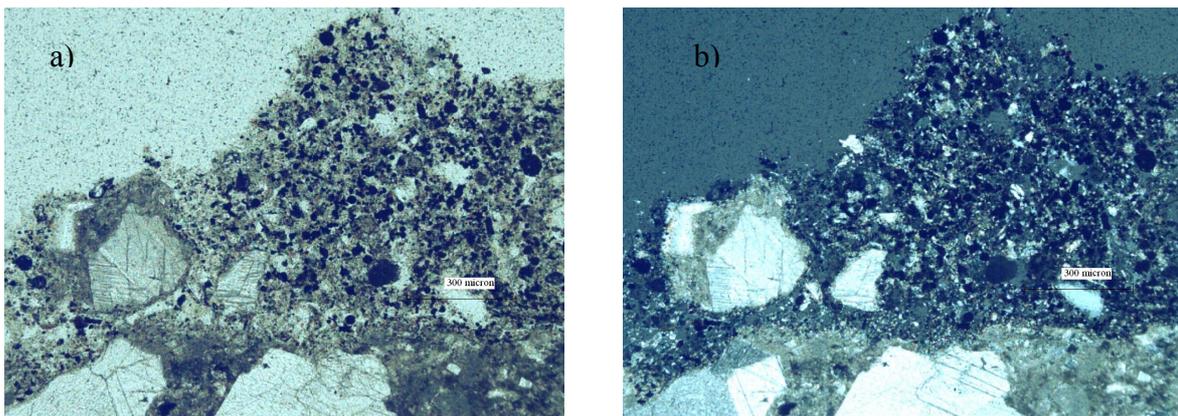
**Figure 4.20.** Optical micrographs (a) planed-polarised light, (b) cross-polarised light of damage layer in sheltered area of sample (BOS10), Casa Galleria Vichi (Florence).

Optical microscope observation of transversal thin section of samples from sheltered areas (BOS2 and BOS10), indicated the presence of dark damage layers as it is shown in Figure 4.20 and 4.21. The black crusts appeared in an irregular shape with maximum thickness of 400  $\mu\text{m}$ . It is composed of gypsum with frequently embedded black carbonaceous particles and iron oxides, presented in Figure 4.22. There were two sizes of carbonaceous particles small with diameter ranging from 15  $\mu\text{m}$  to 25  $\mu\text{m}$  and bigger with maximum diameter of 45  $\mu\text{m}$ .

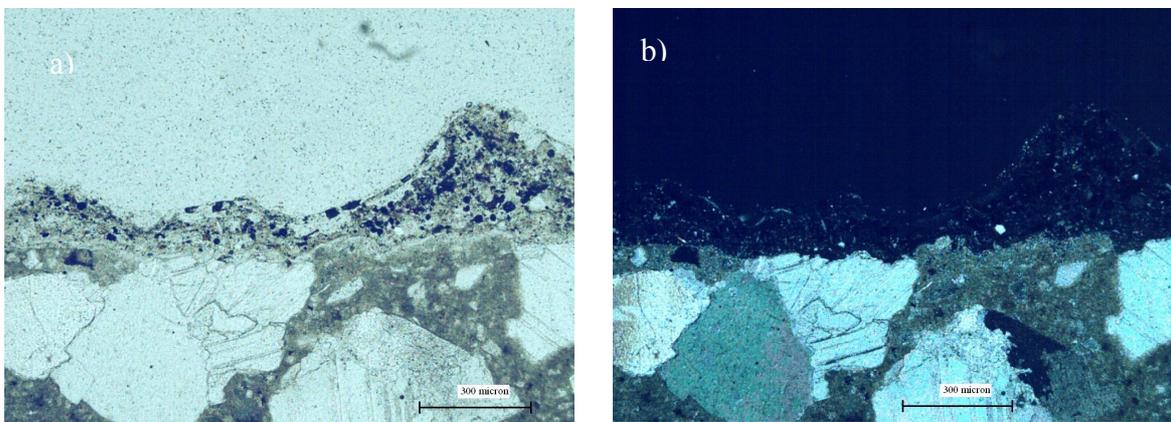
**Figure 4.21.** Optical micrographs (a) planed-polarised light, (b) cross-polarised light of damage layer in sheltered area of sample (BOS2), collected from Casa Galleria Vichi. Several black particles are clearly identifiable embedded in the gypsum matrix.

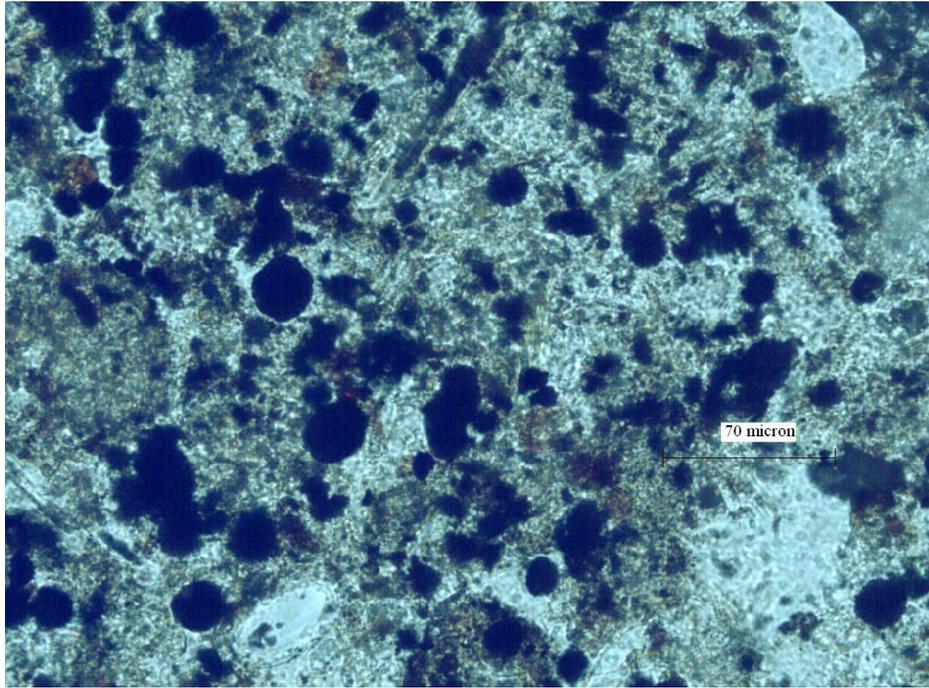
**Figure 4.22.** Optical micrograph (planed-polarised light) of damage layer in sheltered area (BOS10); black carbonaceous particles and yellow-orange iron oxides are observable.
