**Alma Mater Studiorum – Università di Bologna**

**Science for Conservation**

**MULTI-POLLUTANTS IMPACT ON MODERN CEMENT  
BUILT HERITAGE**

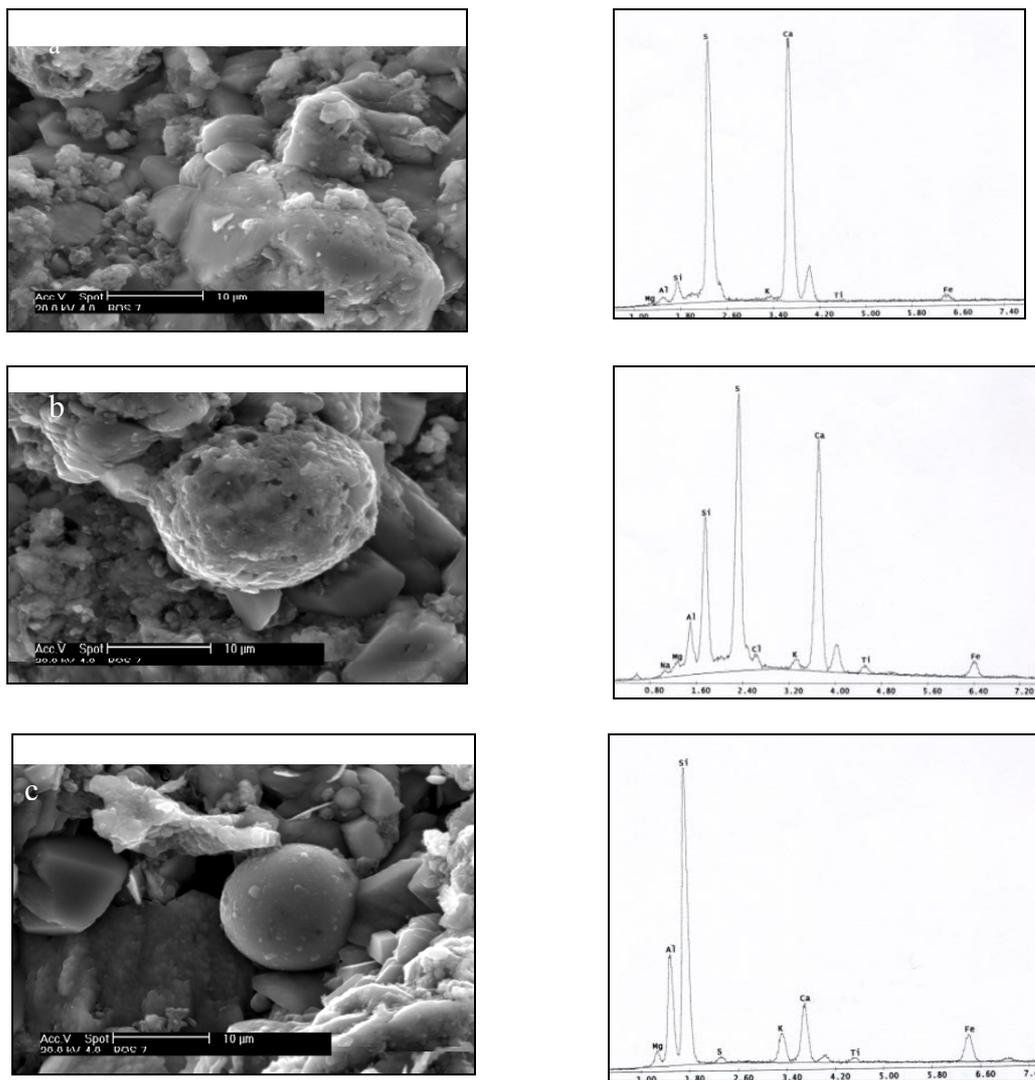
**Figure 4.23.** Scanning electron micrographs (on the left) with relative EDX (on the right) of sample BOS7, showing: (a) surface covered by lamellar and globular gypsum, (b) carbonaceous and (c) aluminosilicate particles.

The SEM-EDX analysis performed on samples BOS2 and BOS7 presented in Figure 4.23, confirmed the optical microscope observations, indicating that gypsum, in both laminar and globular form, covered the external surface (Figure 4.23 a). The airborne particulate matter was observed embedded in gypsum matrix.

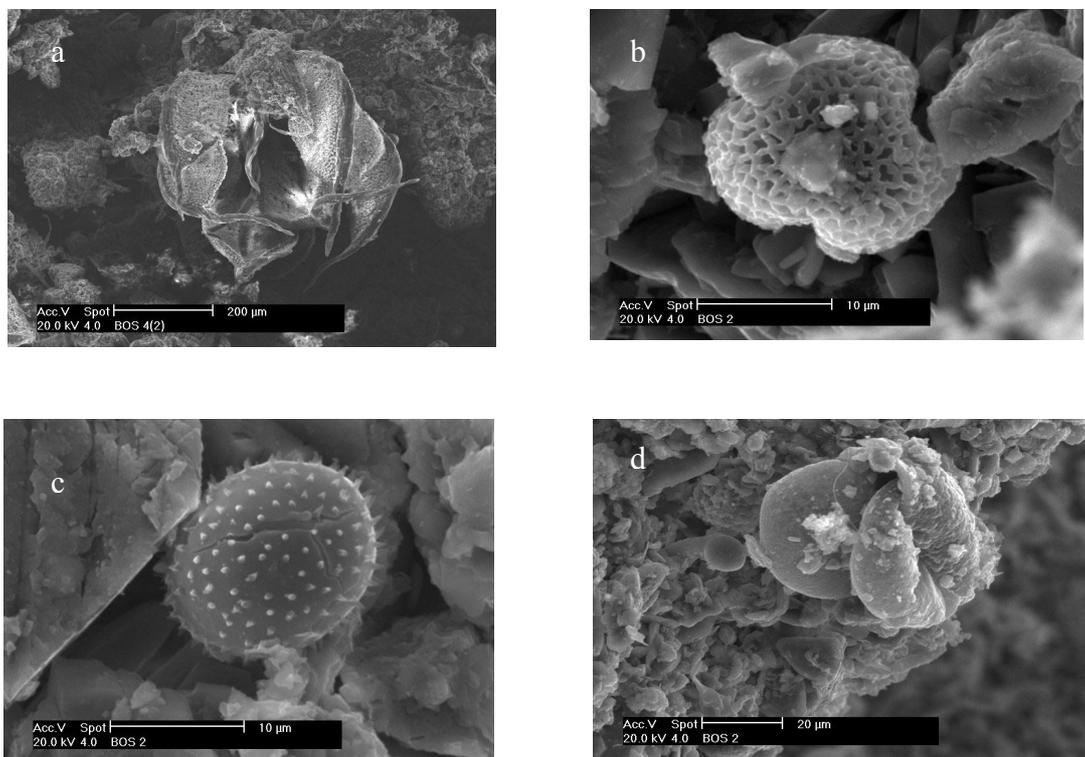
**Figure 4.24.** Scanning electron micrographs (a), (b), (c), (d) of biological particles on surface of the sample BOS2.

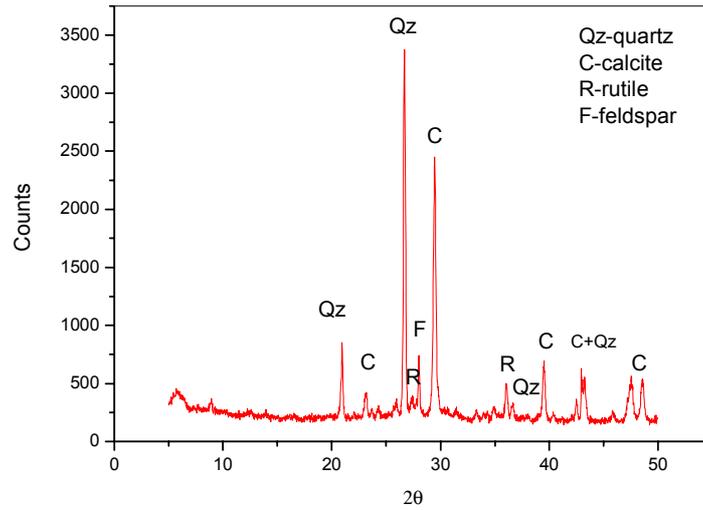
**Figure 4.25.** X- ray diffractogram of substrate, Casa Galleria Vichi (Florence).

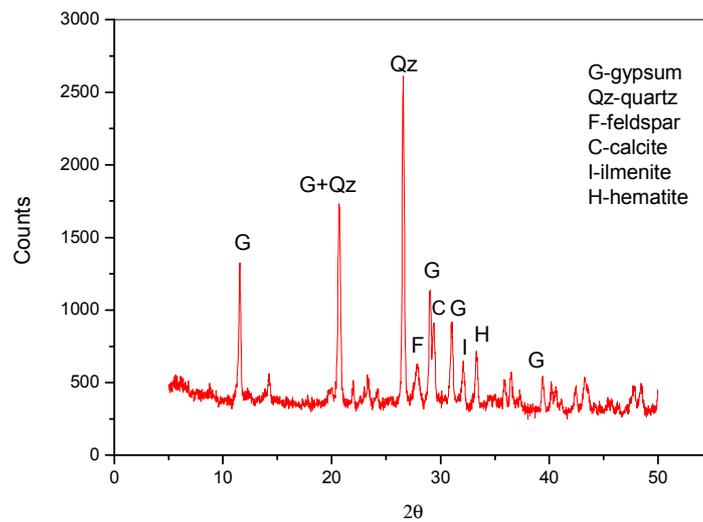
**Figure 4.26.** X- ray diffractogram of surface damage layer sample on the concrete façade, Casa Galleria Vichi in Florence.

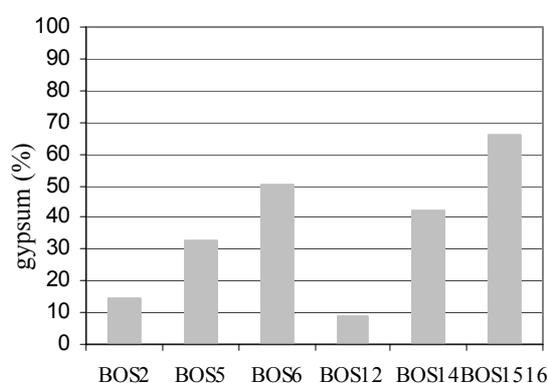
**Figure 4.27.** Concentration of gypsum (%) measured by DTA-TGA analyses in samples collected from Casa Galleria Vichi.

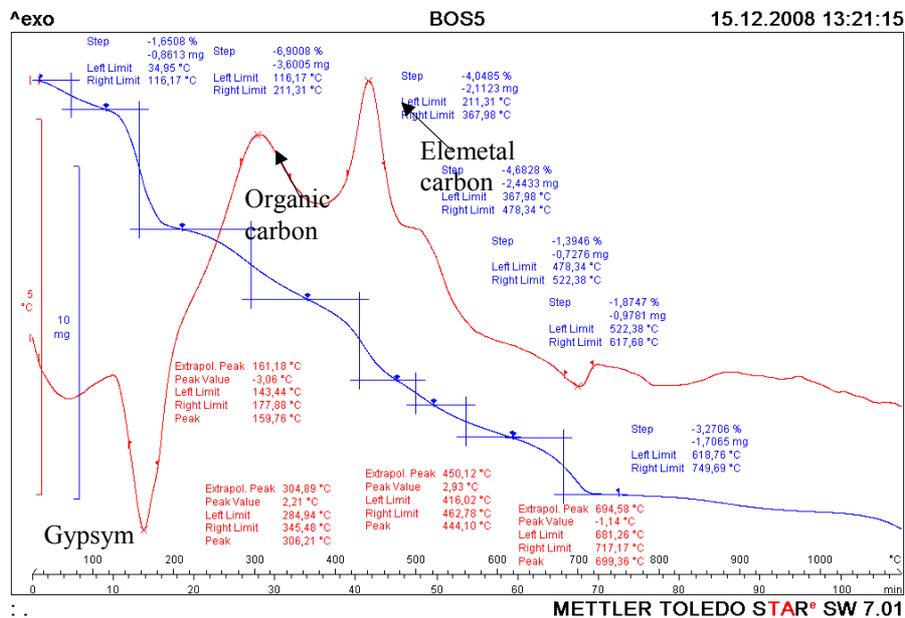
Figure 4.28. DTA-TGA graphs of black crusts collected on Casa Galleria Vichi.

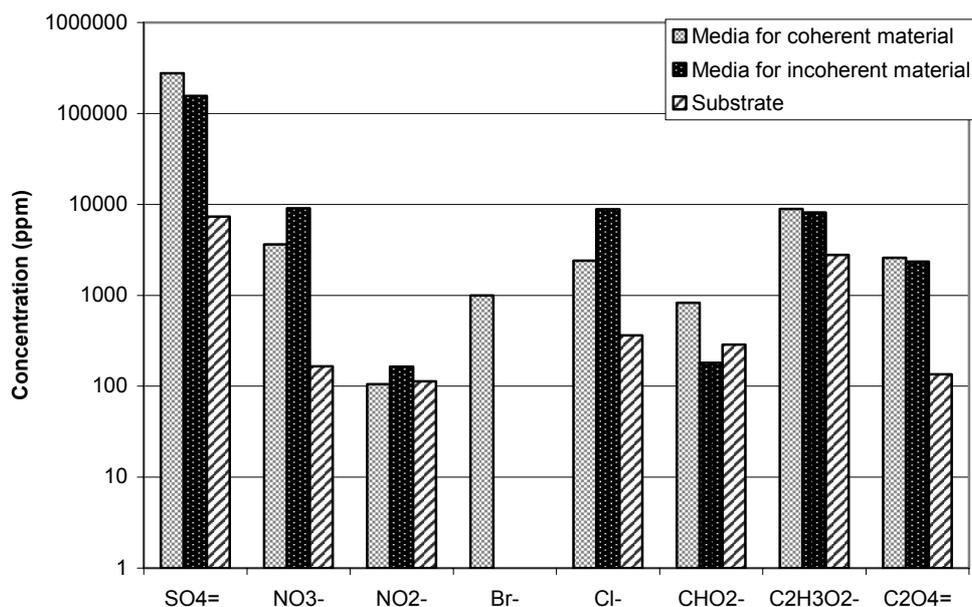
**Figure 4.29.** Mean concentration of anions in coherent crust, incoherent deposit and substrate samples collected at Casa Galleria Vichi.

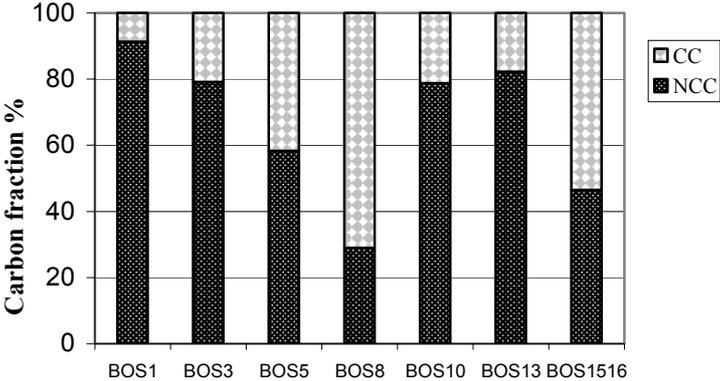
**Figure 4.30.** The non carbonate carbon (NCC) and carbonate carbon (CC) percentage fraction of total carbon in samples of damage layers collected from Casa Galleria Vichi (Florence).

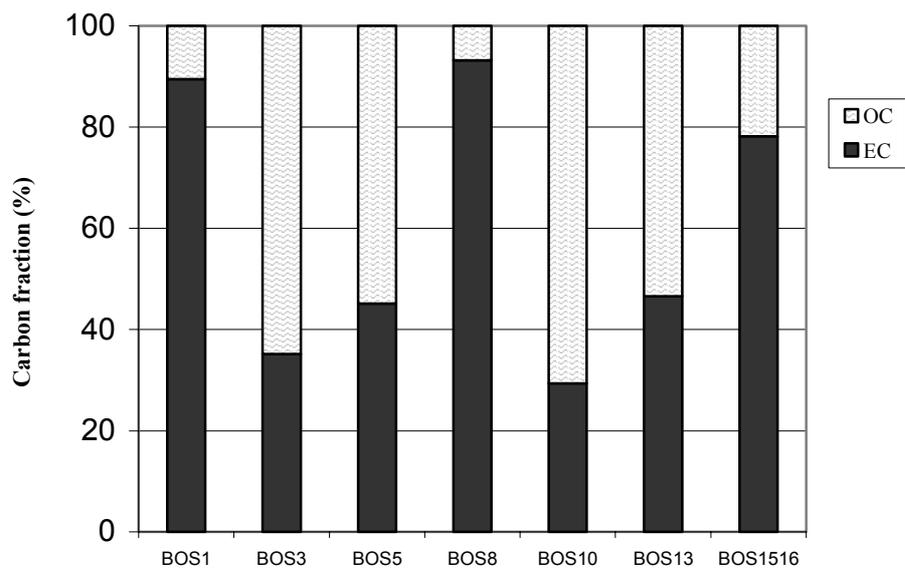
**Figure 4.31.** The percentage fraction of organic carbon (OC) and elemental carbon (EC) of NCC in sample of crusts from Casa Galleria Vichi.

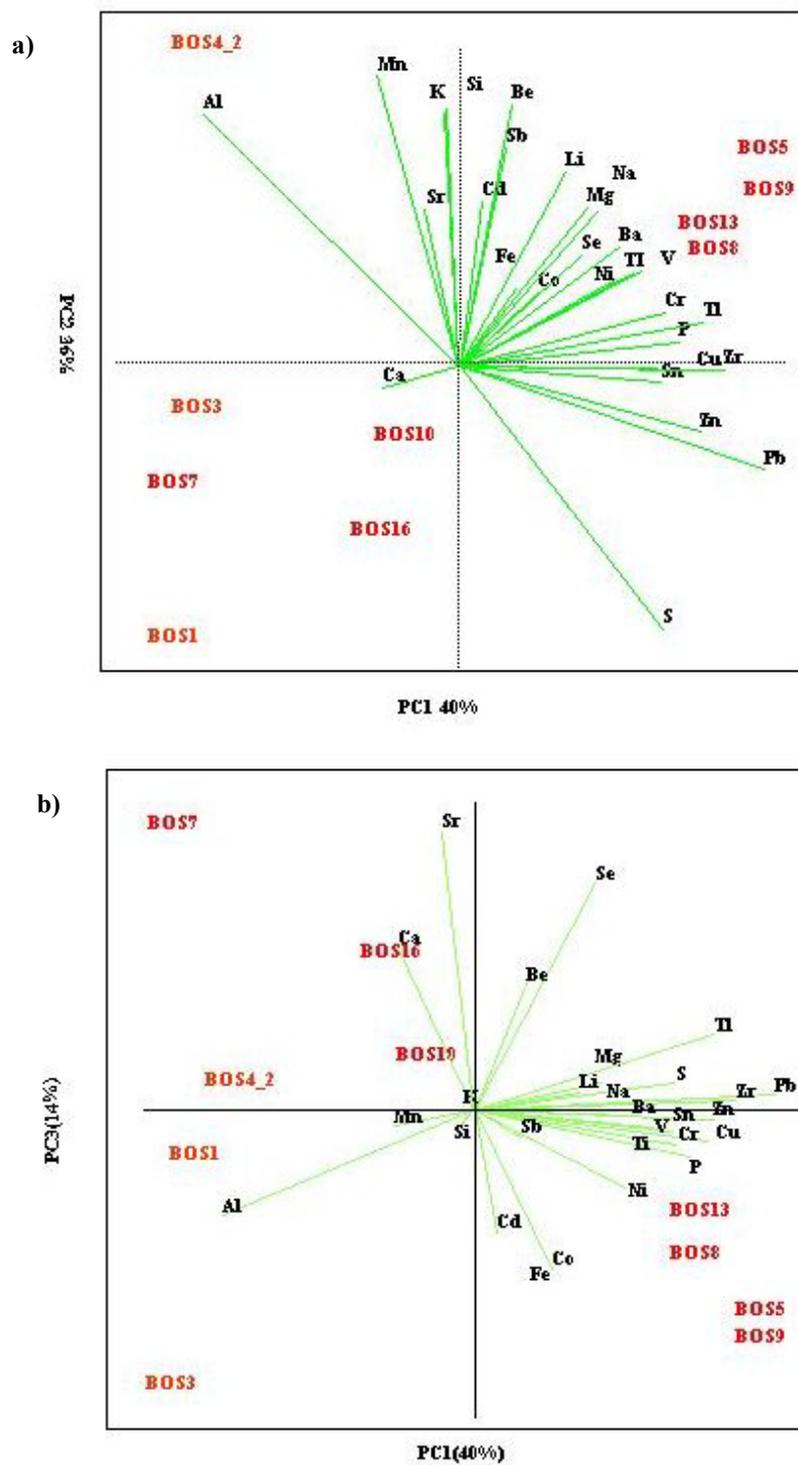
**Figure 4.32.** Principal components analyses, maps generated for results of ICP-OES, sample collected from façade and dragons of Casa Galleria Vichi, BOS7 substrate of façade, BOS4(2) substrate of dragon (a) PC1 versus PC2, (b) PC1 versus PC3.

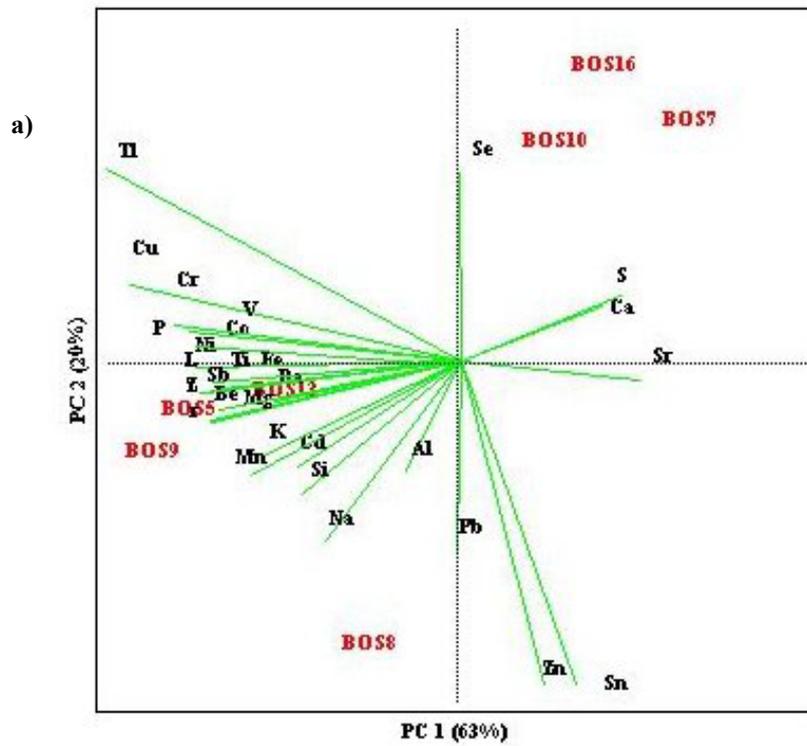
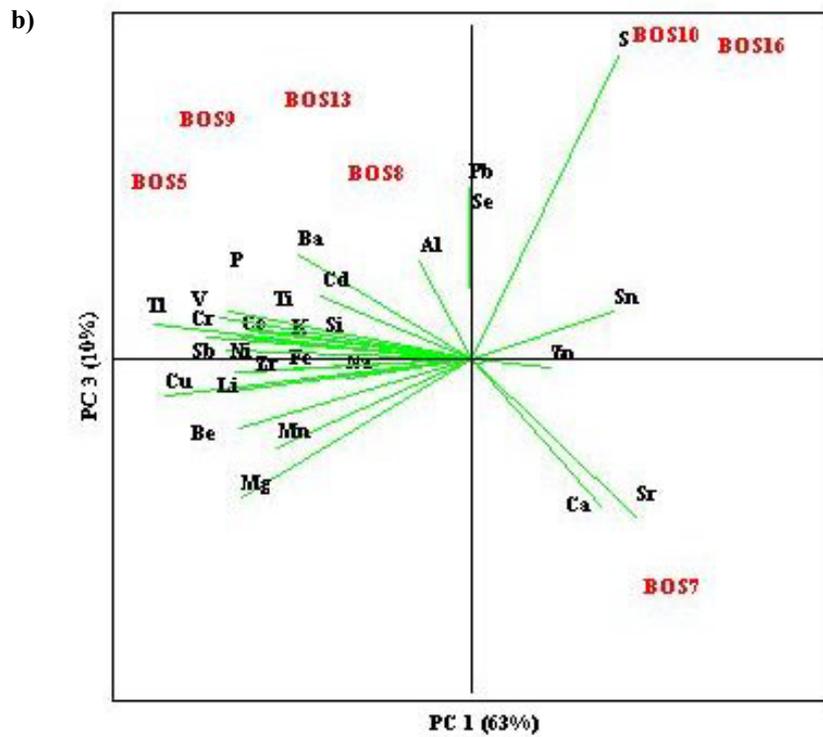
**Figure 4.33.** Principal components analyses, maps generated for results of ICP-OES, sample collected from façade of Casa Galleria Vichi, BOS7 substrate, (a) PC1 versus PC2, (b) PC1 versus PC3.
